Title	Diagnostic Trouble Codes (DTC) P2080, P2084, P242B Lighting The Malfunction Indicator Lamp (MIL) - US14+OBD16, US17+OBD16, And US17+OBD18 Emissions, Model Years 2017 To 2019
Mack Models	
Mack Model	LR, MRU - TerraPro, AN - Anthem, CHU - Pinnacle, Axle back, CXU - Pinnacle, Axle front, GU - Granite
Volvo Models	
Volvo Model	VNL, VNM, VNR, VNX, VAH, VHD
Emission Standard	
Emission Standard	US14+OBD16, US17+OBD16, US17+OBD18
Engine family	
Engine family	11L Engine, 13L Engine, MP7, MP8

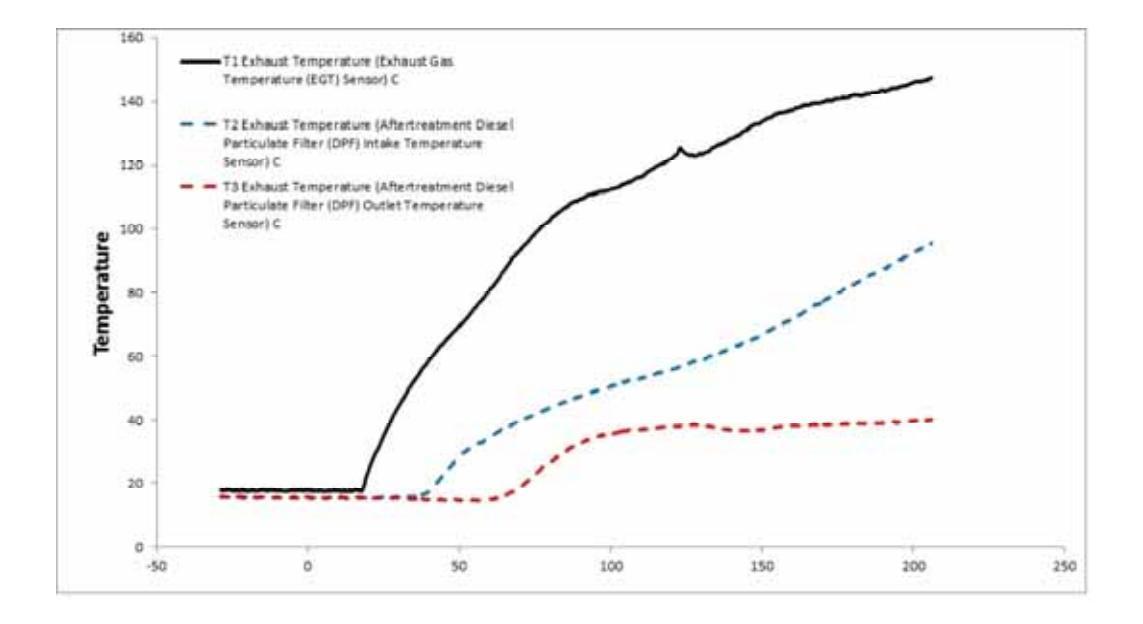
An example of proper temperature sensor function can be found below:
