Technical Service Bulletin

SUBJECT:		No: TSB-19-52A-006	
DAMAGED FRONT SEAT CUSHION PAD		DATE: December 2019	
		MODEL: See below	
CIRCULATE TO:	<input type="checkbox"/> GENERAL MANAGER	<input checked="" type="checkbox"/> PARTS MANAGER	<input checked="" type="checkbox"/> TECHNICIAN
<input checked="" type="checkbox"/> SERVICE ADVISOR	<input checked="" type="checkbox"/> SERVICE MANAGER	<input checked="" type="checkbox"/> WARRANTY PROCESSOR	<input type="checkbox"/> SALES MANAGER

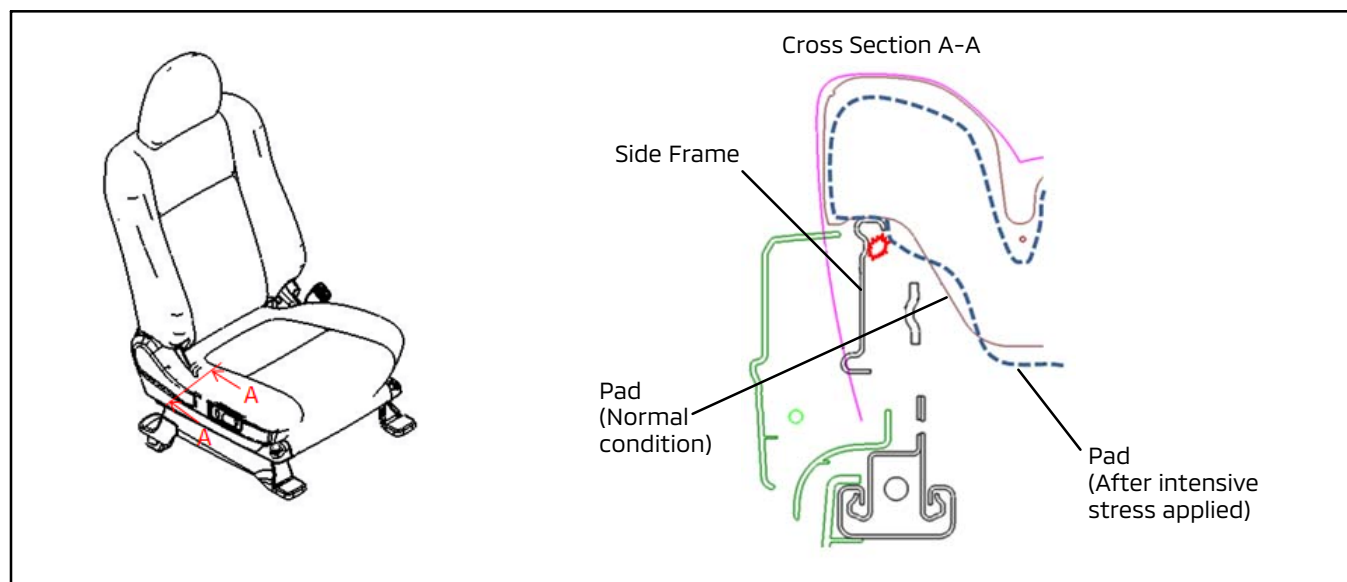
Due to stress applied intensively onto the left and right rear end portion of the seat cushion by a passenger, the cushion may sink down and rub against the edges of the metal seat frame. This in turn may cause the damaged urethane material to turn to powder and fall on the floor carpet.

This TSB provides a repair procedure to replace the damaged seat cushion pad, and apply tape on the frame to help prevent future damage
