Bulletin No.: PIC5903C Published date: 01/17/2020

PIC5903C Spark EV Chevrolet Volt Opel Ampera Models With Or Without Service Vehicle Soon Lamp - SVS - or Check Engine Lamp On With DTC P0534 Set Current Or History

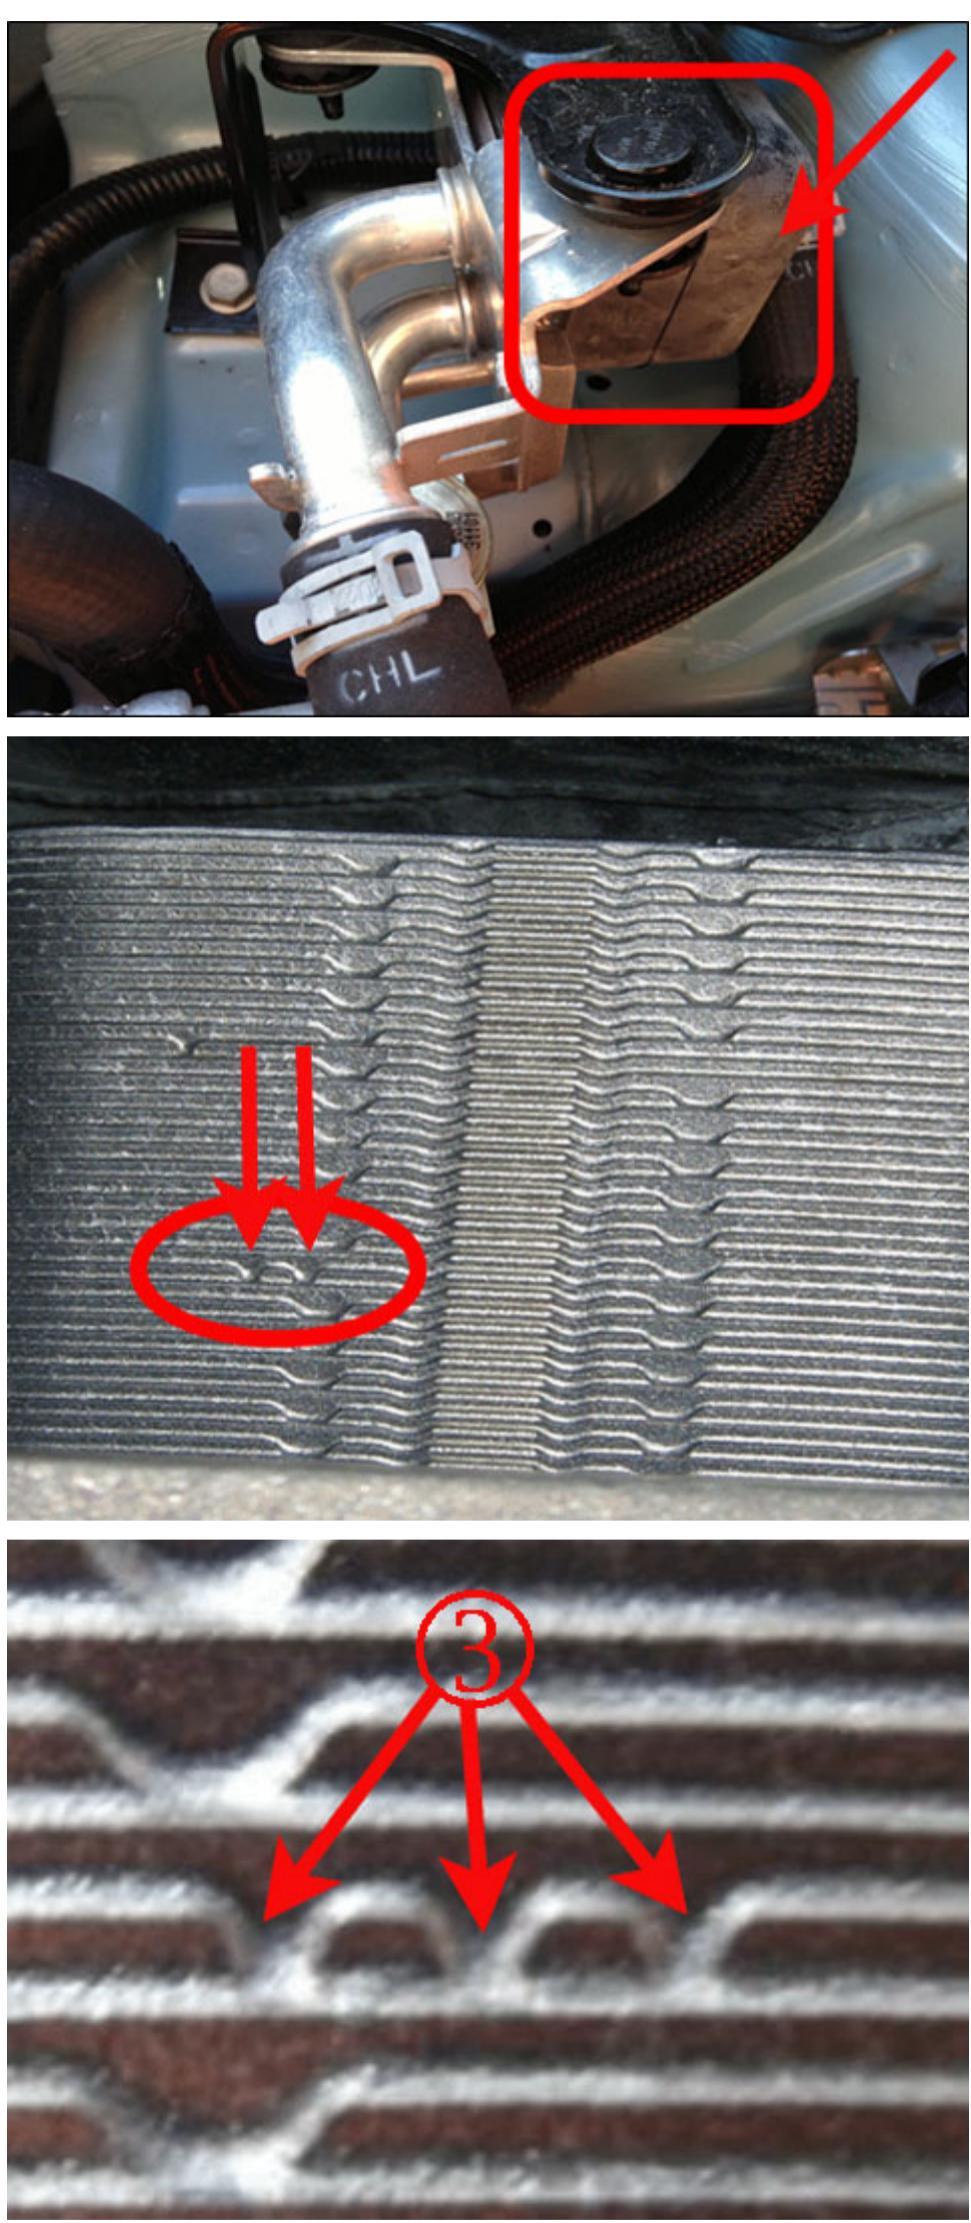
A. <u>:</u> Shown below is a picture of the RESS Cooler from the Spark EV. The black insulator cover can be easily pulled back to inspect the Cooler Plate notches without removal.

3 Notches equals replace cooler.

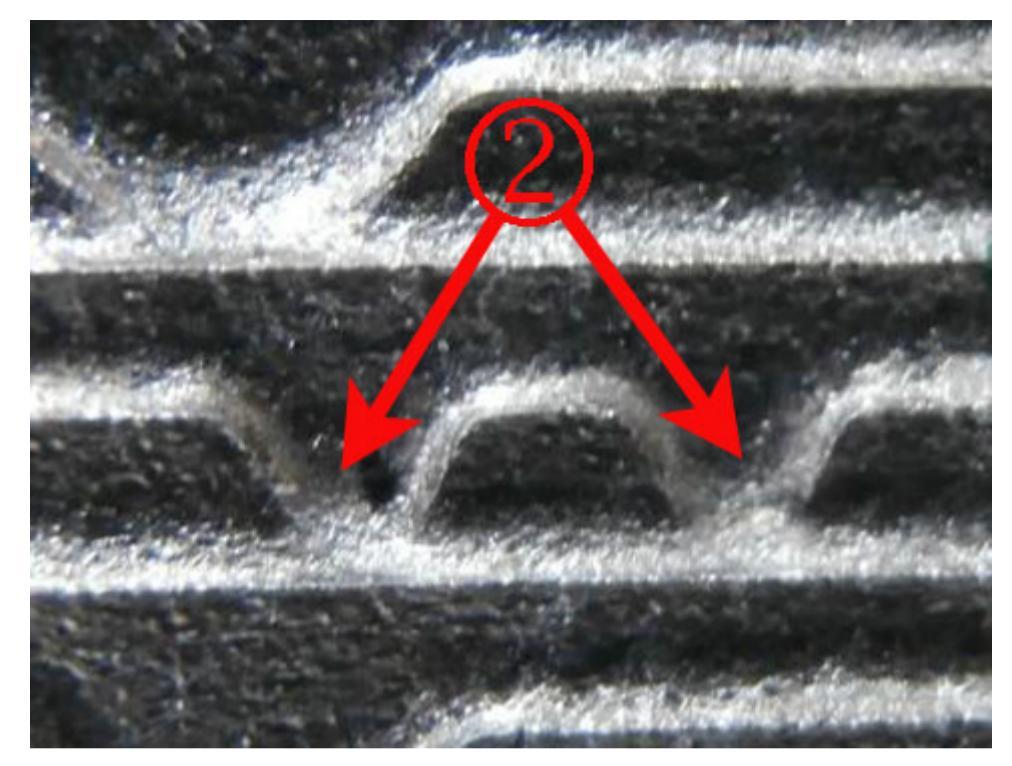
2 Notches equals DO NOT replace cooler.
