Title: J1939 Data Link Troubleshooting

Applies To: All Models with 250k Baud Data Link (Black 9-Pin Diagnostic Connector); Overview information for 500k Baud Data Link

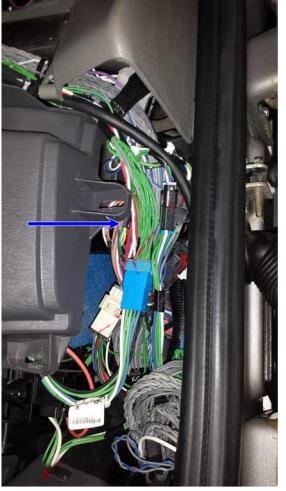
• A poor connection on the splice the ties the ABS module into the Back-bone of the data link was found on multiple units

Crimp location: Right side of cab above the ABS module, next to the HVAC box. The condensation module (if installed) will be zip tied to or near the splice.

• Inspecting the splice is destructive, you will need to remove the splice section use a closed barrel butt connector to crimp, solder and heat shrink the splice location. Use proper wire repair techniques as outlined in <u>IK0800269 - Proper Wire Repair</u>

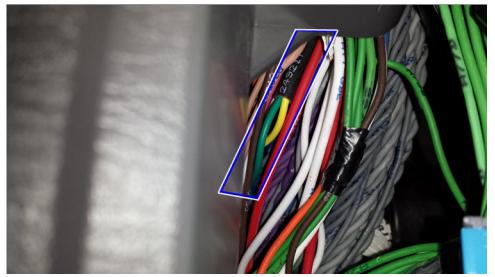
Close view of crimp location

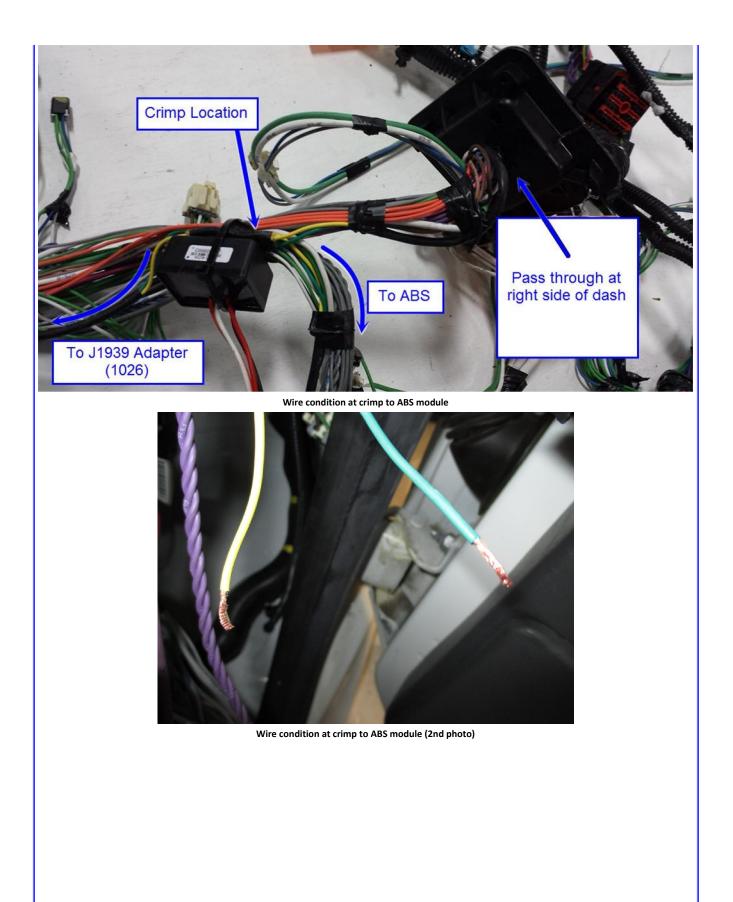
Harness removed from truck for identification
