SERVICE BULLETIN

ITB13-057B

2013 JX35, 2014-2015 Q50 & QX60; ONE OR BOTH INTELLIGENT KEYS LOST PRIOR TO CUSTOMER DELIVERY

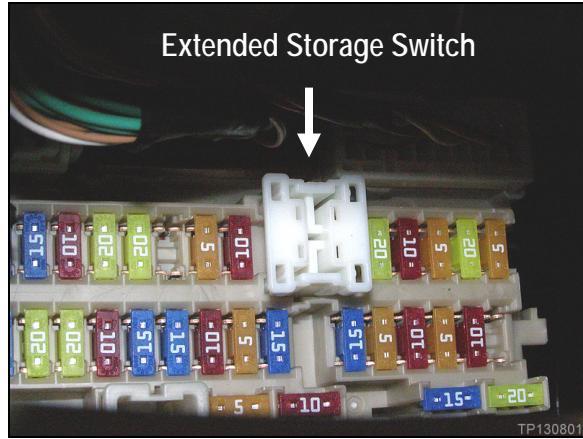
Figure 1 (Example only. Your vehicle may look different.)

1. Remove the fuse panel cover and check the position of the Extended Storage Switch (ESS).

If the ESS is pushed IN:

- a) Reattach the fuse panel cover.
- b) Replace the lost Intelligent Key.
- c) Register both Intelligent Keys using CONSULT-III (C-III) plus.

NOTE: Make sure to register the replacement key <u>second</u>.

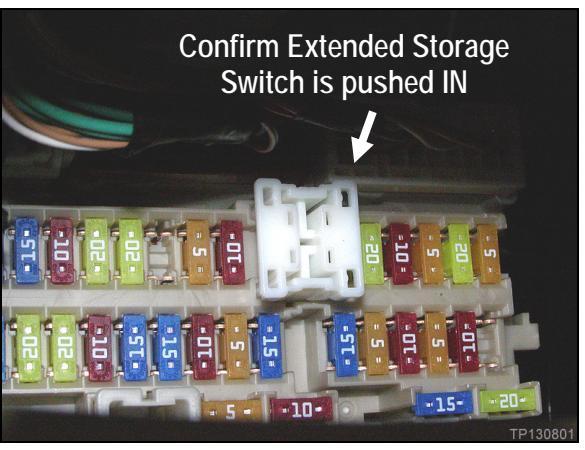
Figure 2 (Example only. Your vehicle may look different.)

- 1. Remove the fuse panel cover and check the position of the Extended Storage Switch (ESS).
- 2. If the ESS is not pushed IN, push it IN.
- 3. Reattach the fuse panel cover.

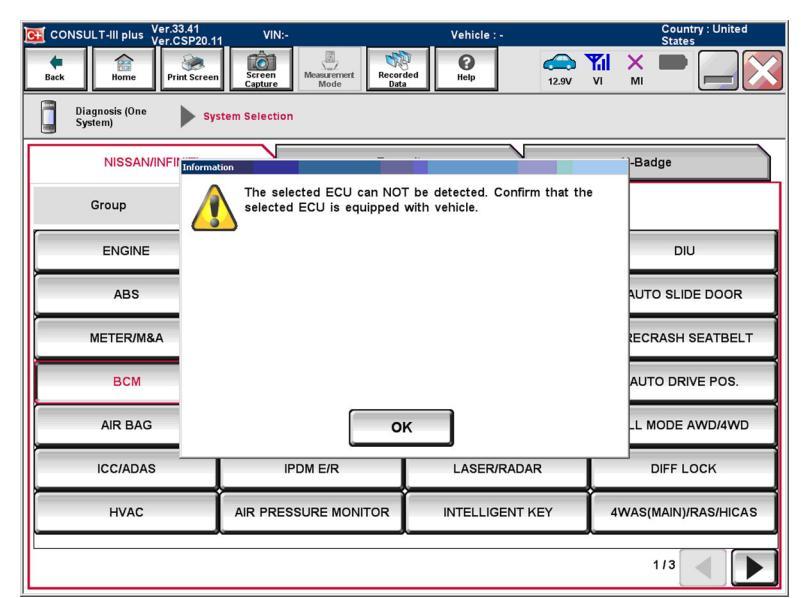
Figure 6

- 8. If the screen in Figure 5 displays, the BCM is not in Transit Mode.
 - a) Select Home.
 - b) Replace the lost Intelligent Keys.
 - c) Register both replacement Intelligent Keys using CONSULT-III (C-III) plus.
 - d) Once successfully registered, this procedure is complete.
- If an error message indicates the ECU cannot be detected (see Figure 6), the BCM is in Transit Mode.
 - a) Replace the BCM.
 - Replace the lost Intelligent Keys and have the new ones available before proceeding to the next step.
 - c) Contact TECH LINE for Intelligent Key registration procedure guidance.
