# **Technical** Bulletin

Bulletin No: TCH-27-001

#### Bendix<sup>™</sup> SmarTire<sup>®</sup> Tire Pressure Monitoring System (TPMS) Electronic Control Unit Subject: (ECU) Update for PACCAR Vehicles

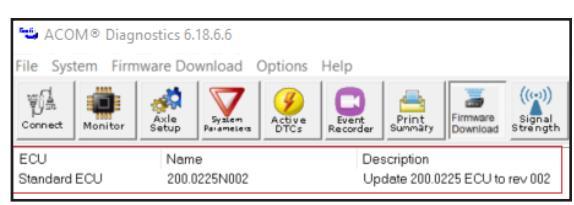
Figure 5 – ECU Window

- 2. Once connected to the TPMS ECU, select the *Firmware Download* icon in the toolbar. *See Figure 4.*
- 3. If the TPMS ECU requires updating, there will be an entry displayed in the ECU window *as shown in Figure 5*. If no entry exists, then it is possible the ECU is already updated. Please read the instructions to check if the ECU requires updating.

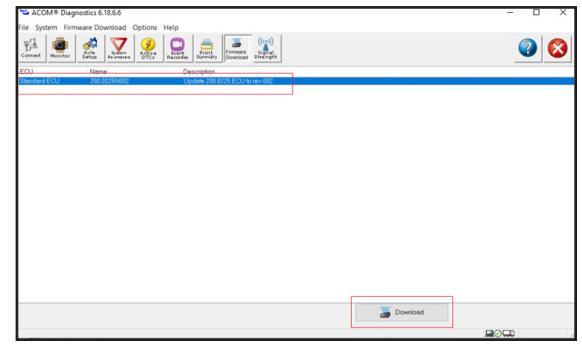
- 4. To start the update, select the ECU as shown in Figure 6. This will enable the Download icon on the bottom of the window. Select the Download icon to start the update process. The process should then begin (See Figure 7) and the ECU firmware will be updated.
