Re: 49 C.F.R. § 579.5 Compliance Report

Subject: Gen2 Electronic Clutch Actuator (ECA) Interference

Document Number: TAIB0862

Date: February 22, 2016

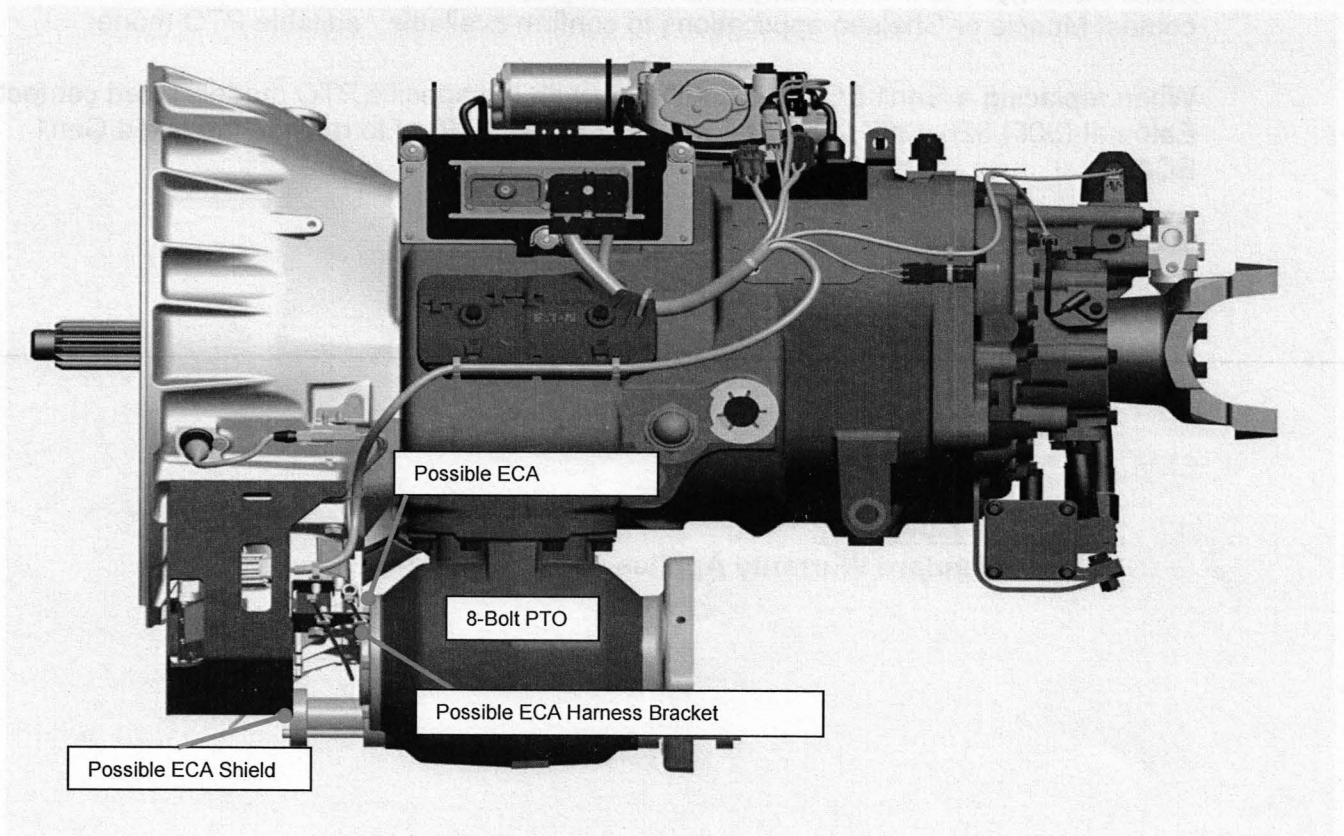
When replacing a Gen1 ECA with a Gen2 ECA, the Gen2 ECA can interfere with specific 8-bolt countershaft PTO models. Interference varies, and depending on the PTO model the interference could be with the ECA, ECA Shield or the ECA Harness Bracket.

Affected Models/Population: UltraShift *PLUS*, Fuller Advantage Automated with Gen2 ECA and specific 8-bolt PTO installations.

Field Strategy: Prior to ordering the PTO for a new installation with a Gen2 ECA, contact Muncie or Chelsea applications to confirm available / suitable PTO model.

When replacing a Gen1 ECA in combination with the specific PTO models listed contact Eaton at (800) 826-4357 to order a K-3936RX (Gen1 ECA) to replace the failed Gen1 ECA.

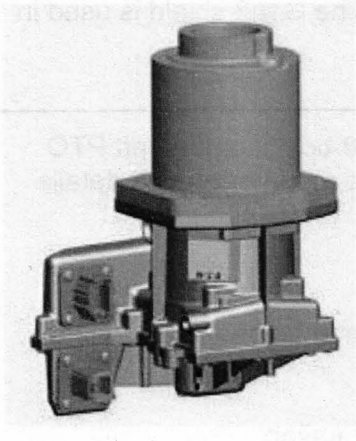
Gen2 ECA (New)

The Gen2 ECA introduces a new motor with Deutsch Connectors, and a redesigned shield that surrounds the ECA. The new shield maintains protection for the ECA while enhancing connector accessibility. It also allows for direct, straight alignment of the connector and harness thus eliminating potential side loading of the connector by the use of a separate harness retention bracket mounted directly to the ECA. Two tie-wrap locations on the harness retention bracket are provided to secure the power harness as it is routed in the vehicle.

An all-aluminum enclosure provides improved reliability through enhanced sealing capabilities. The new connectors provide positive locking features with a secondary lock system to improve connection integrity.
