(Back Office Only) Volvo Chassis - Equipped With A Catalyzed Exhaust Aftertreatment System (EATS) - Regeneration (Regen) Failure Diagnostic Process - US07 to US16 Emissions

Engine Turbocharger Compressor Bypass Valve Deletion Kit, Installation

V-258-029

REGENERATION FAILURES

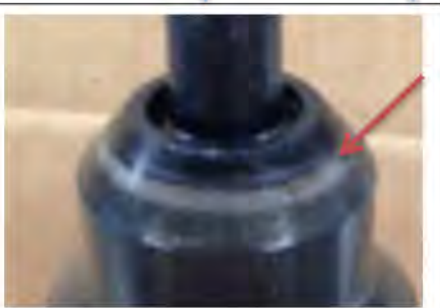
Picture 1

Notice on a properly sealed injector you will have a uniform ring around the injector

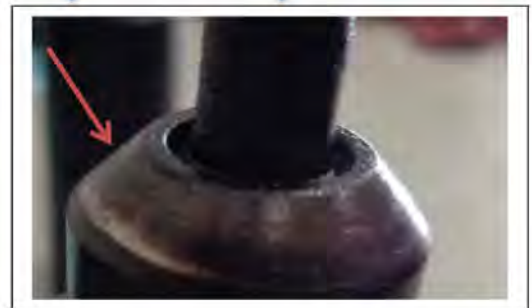
Picture 2

This is a picture of a failed injector that is no longer seating properly in the injector sleeve. Notice there is no sealing ring around the injector like picture 1

Replace only the injectors that show sign of leakage like picture 2 on page 1. After replacement of the injector perform regen if no more spikes issue is resolved

If we find an injector that was not sealing properly only change that injector.

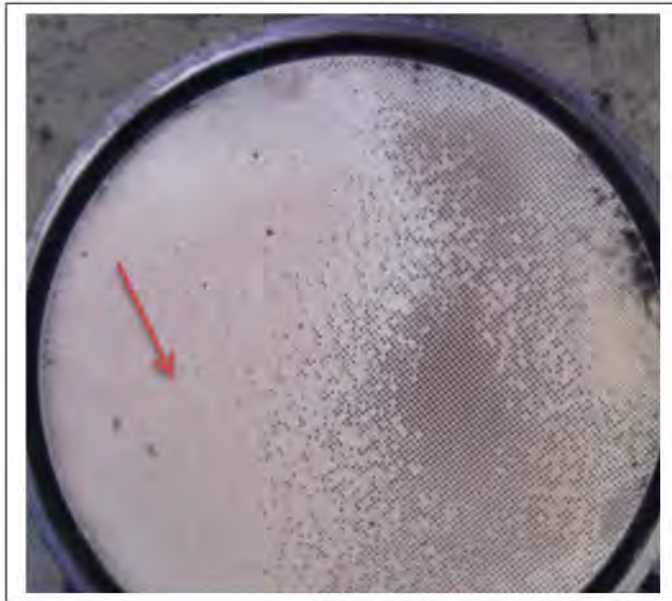
Here is an example of a failed flex pipe that has coated the DPF with insulation.

In the case of the flex pipe failure cleaning of the DPF and DOC is required but if temperature spikes remain then most likely the DOC has been damaged and will need replaced along with the DPF.
