### **DEF Level (UQLS) Sensor Troubleshooting Guide -US17+OBD16 Emissions and Newer**

# 25068-9 FSB 258-040, Aftertreatment Diesel Exhaust Fluid (DEF) Tank, Level Sensor, Replacement

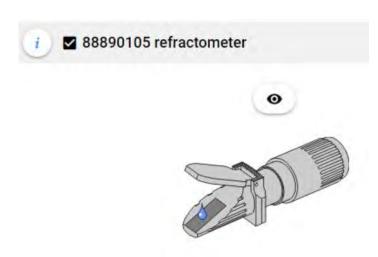
- 2. Verify the DEF quality is at an acceptable value.
  - Use refractometer part number 88890105 to verify the DEF quality. See illustration below.

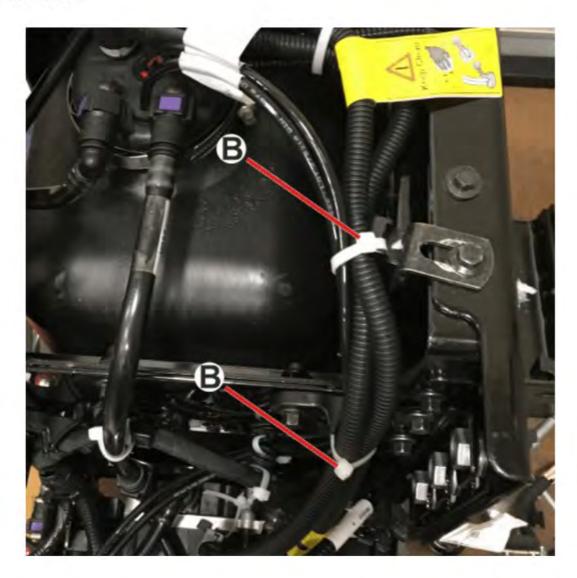
Maintain minimum 40 mm bend radius of UQLS (Urea Quality and Level Sensor) control module routing (A) at sensor head.

Note: Do not kink the UQLS control module routing.

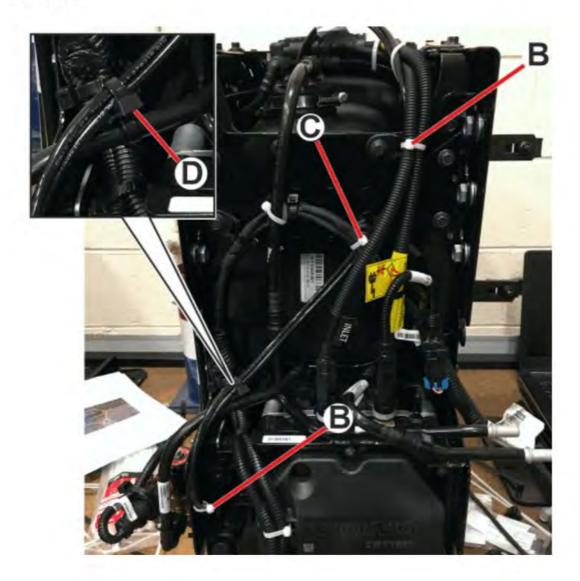
2. Route and tie the UQLS control module routing with the urea harness.

Note: Use regular cable tie (B).

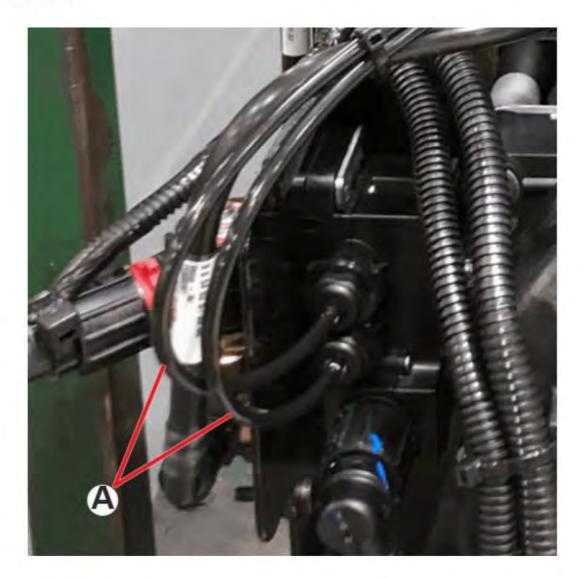
3. Route and tie the UQLS control module routing with the electrical harness.

Note: Use helicopter cable tie (C).

4. Route and tie UQLS control module routing with the coolant lines.

Note: Use double head cable tie (D).

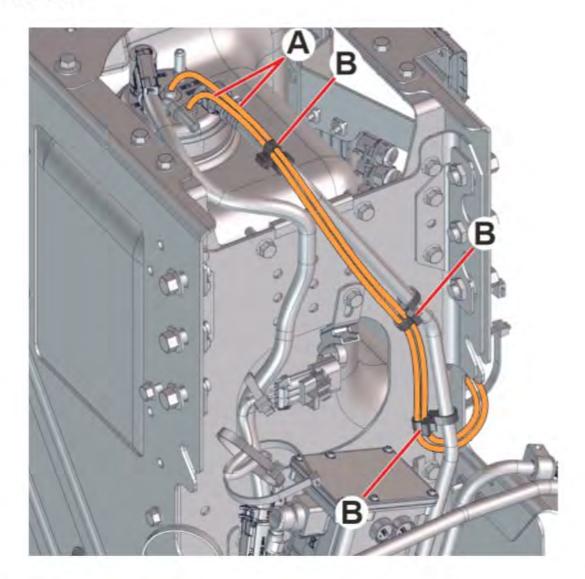
5. Maintain minimum 40 mm bend radius of UQLS control module routing(A) at electrical junction box.

Note: Do not kink the UQLS control module routing.

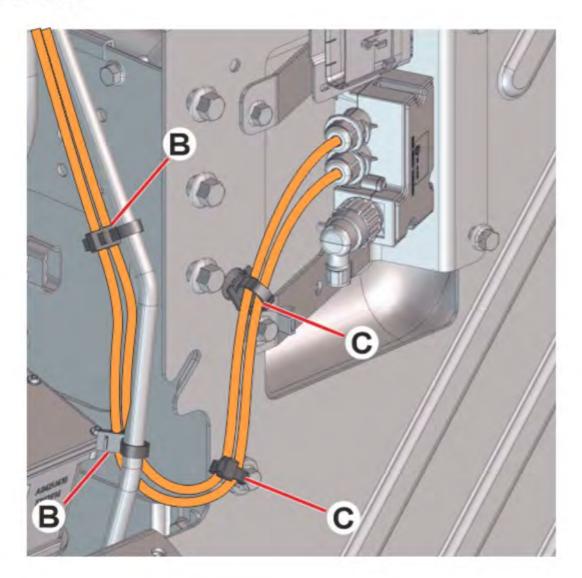
2. Route and tie the UQLS (Urea Quality and Level Sensor) control module routing with the coolant pipe.

Note: Use double head tie (B).

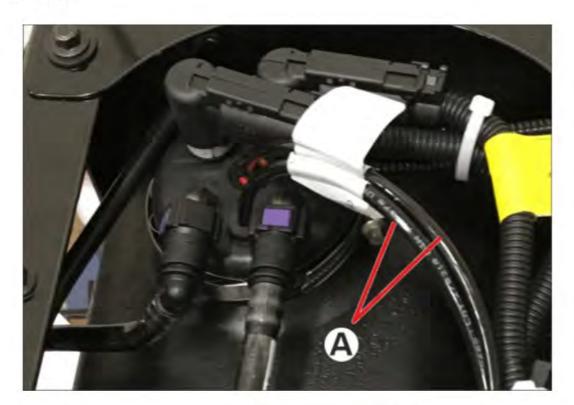
3. Route and tie the UQLS control module routing with the bracket.

Note: Use cable tie (C).
