93 "Drive system: fault" displayed in cluster, vehicle does not start or drive. DTC's P0A6300, P0A5D00, P0A6000 stored

97 23 92 2069917/1 April 14, 2023.

Model(s)	Year	VIN Range	Vehicle-Specific Equipment
Q5 e quattro	2021 – 2023	All	Not Applicable

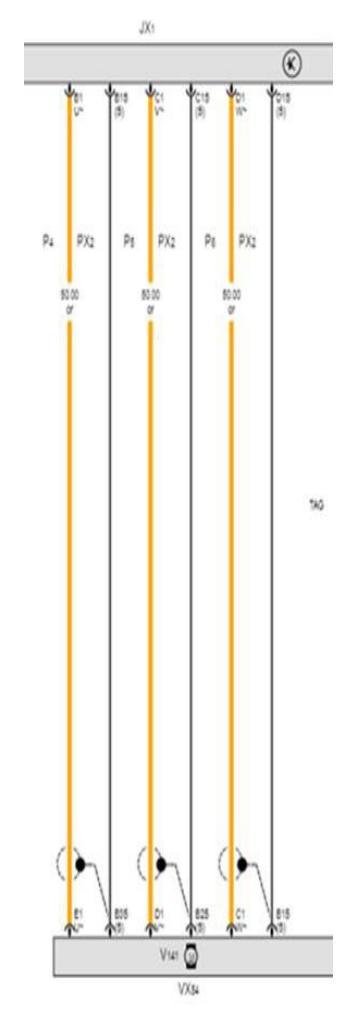
Variances in the welding process of the high-voltage wiring may lead to a malfunction of the cable.

Figure 1: High voltage cables to be tested.

- After the high voltage system has been de-energized, check the resistance of the internal conductors of each phase between JX1 and V141 (Figure 1) using a DVOM or similar.
 - Extra attention should be placed on the phase specified by the DTC(s).
 - Carefully inspect the connections and routing at each end BEFORE disconnecting the connections.

While testing the cables, it is necessary to wiggle test, pull/manipulate the cable and/or connector ends.

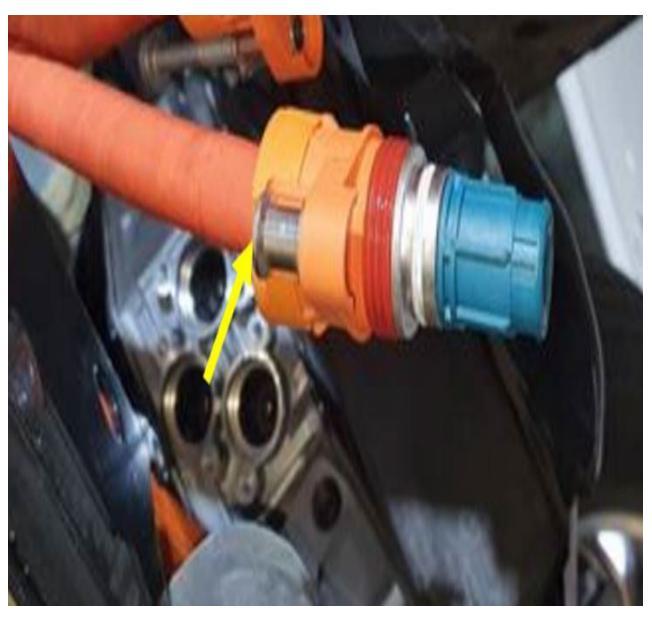
Figure 2: Connector end at the power electronics module.

2. While testing, also wiggle test the connector on the power electronics side during measurement (yellow arrow, Figure 2).

If the resistance increases and changes, replace the high-voltage wiring harness.

If the resistance does not change but you can rule out all other possible causes of the fault, replace the high-voltage wiring harness for drive motor.
