Recall Bulletin

PRODUCT SAFETY RECALL

SUBJECT: Driver Door Switch Short Circuit

MODELS: 2006-2007 Buick Rainier
2006 Chevrolet TrailBlazer EXT
2006-2007 Chevrolet TrailBlazer
2006 GMC Envoy XL
2006-2007 GMC Envoy
2005-2007 Saab 9-7X

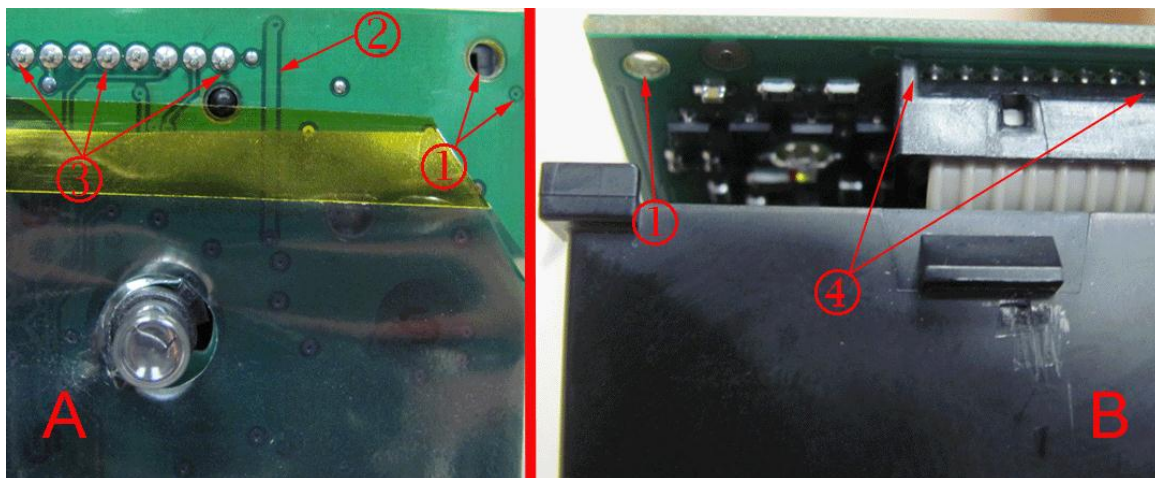
2917380

Top “A” and bottom “B” views of the contact board include examples of connector (4), connector pins (3), traces (2), and vias (1).

10. Ensure the protective coating covers the connector pins, traces and vias (holes) in the application area of the contact board.

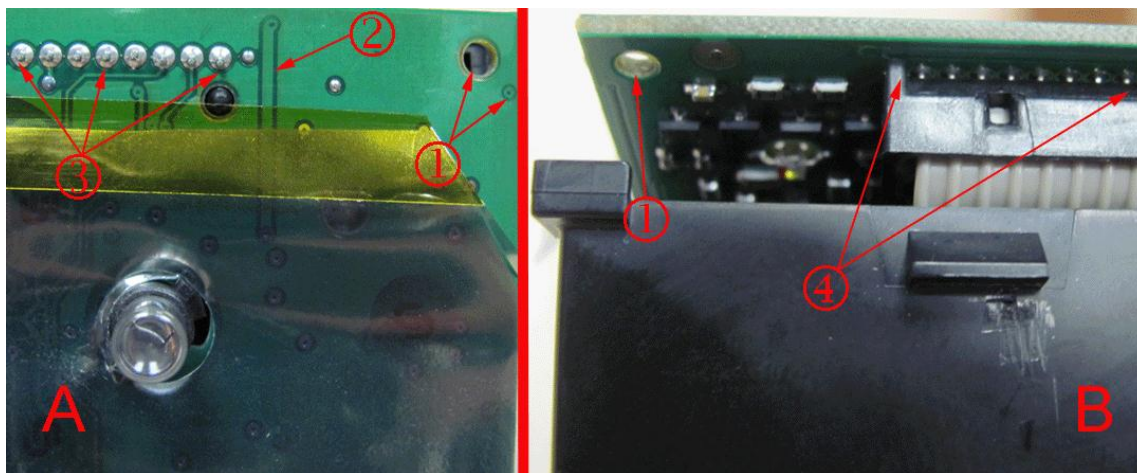
2917380

Top “A” and bottom “B” views of the contact board include examples of connector (4), connector pins (3), traces (2), and vias (1).

- 12. Ensure the protective coating covers the connector pins, traces and vias (holes) in the application area of the contact board.

Caution: *The cure time for the material is 1 hour. To avoid part damage, do NOT proceed to Step 13 until the material has cured for 1 hour.*

- 13. Wait 60 minutes to allow the liquid material to cure to a “tacky” state.
- 14. Remove ESD protective barrier from the contact board of the door module.
