TECHNICAL SERVICE BULLETIN

AN22-031A

NTB23-004A

MISSING OR CORRUPTED MAP DATA

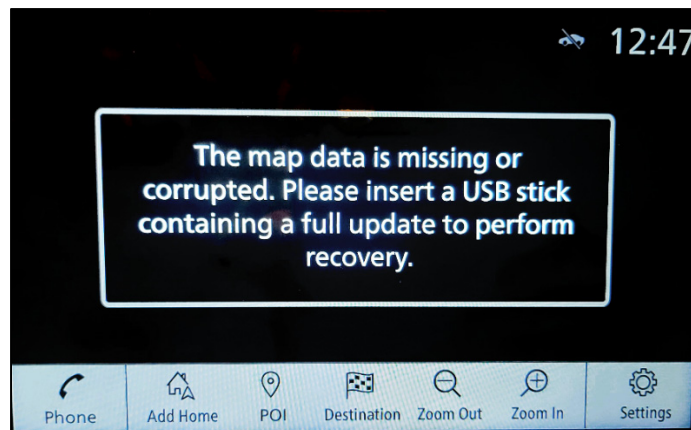
Customer states the error screen shown in Figure 1 appears when using navigation.

Follow the **SERVICE PROCEDURE** in this bulletin to download the map data from the Infotainment Software Update Utility, and then update the AV Control Unit with the map data.
