Release Date 03/21/2024	
---------------------------------	--

49A4 UPDATE

Brake System Software Update – (NVLW)

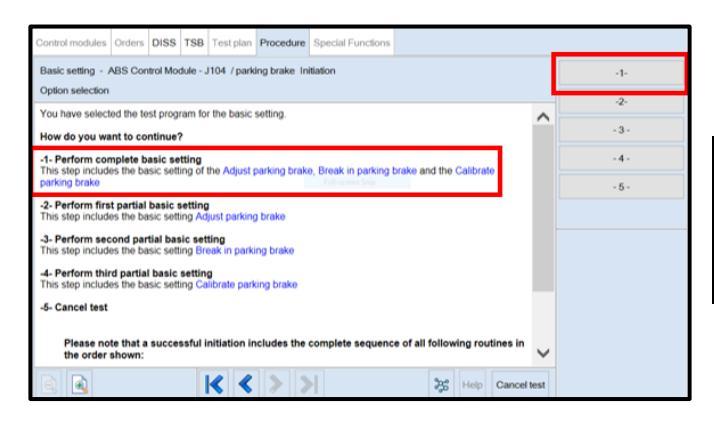
Control modules	Orders	DISS	TSB	Test plan	Procedure	Special Functions		
Basic setting - /	ABS Con	trol Mor	dule - J	104 / parki	ing brake In	itiation		Yes
Preconditions	Preconditions							No
Were the rear b	ling forc bination age is p	e of the of brai	e parki ke pad	ng brake! is and brai	e pads repl	aced?	therwise personal injury or

After the SVM update, the following fault may have been logged: C10E1F2 – "Parking brake motor position not plausible". This fault must be addressed before performing the brake system bleeding steps.

- Scan the vehicle using GFF.
- If the fault is not present or it is able to be cleared, continue with the brake bleed procedure.
- If fault code C10E1F2 is present and is not able to be cleared:
 - Perform the test plan "0003 Brake Button Initiation" through guided functions of DA 0003.
- Select option #1 for "Perform complete basic setting".
- Follow the on screen prompts.

- When asked if the rear brake rotors or parking brake pads were replaced, select the option for "No".
- Complete the remaining test plan steps.
- After the test plan has completed, cycle the ignition switch off and back on.
- Continue with the brake bleed procedure.
