Technical product information

Transaction No.: 2030348/3

New Continental GT and GTC steering shimmy/vibration-21 Inch wheels only

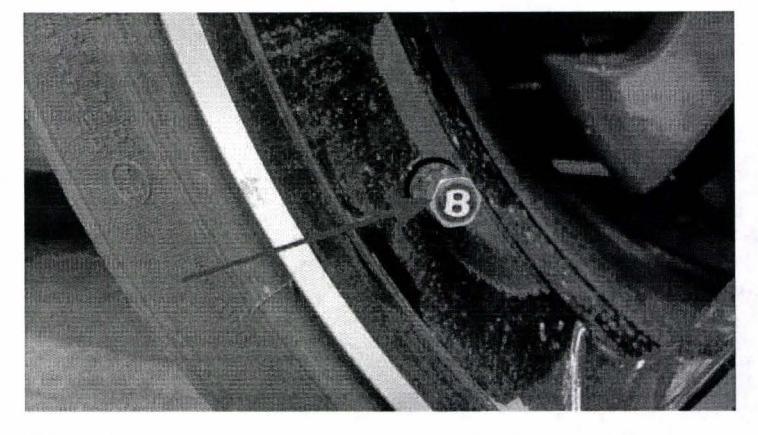
Figure 1

Does the vehicle have accessory valve caps fitted as shown in Figure 1? If Yes please ensure the force match and balance process is always conducted with the accessory valve caps fitted.

IMPORTANT: Apply a thin smear of silicon based grease for example Dow Corning high vacuum grease to the external threads of the valve stem prior to fitting the accessory valve cap. Grease should be applied any time the cap is removed and the grease is not evident

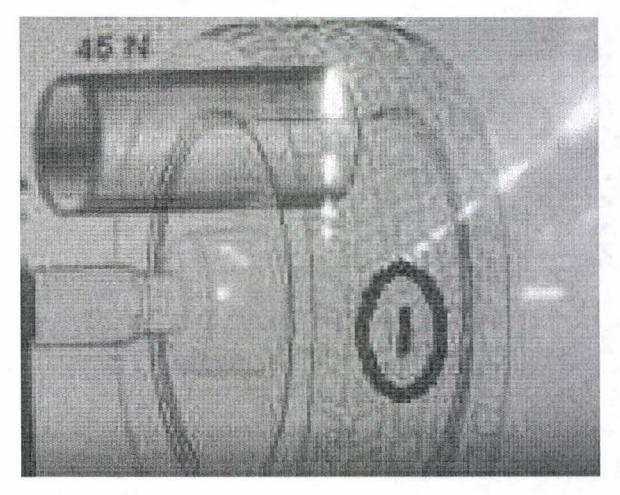
Figure 4

- The assembly high spot is identified with a brown dash (Figure 4).
