# Service Bulletin

File in Section: -

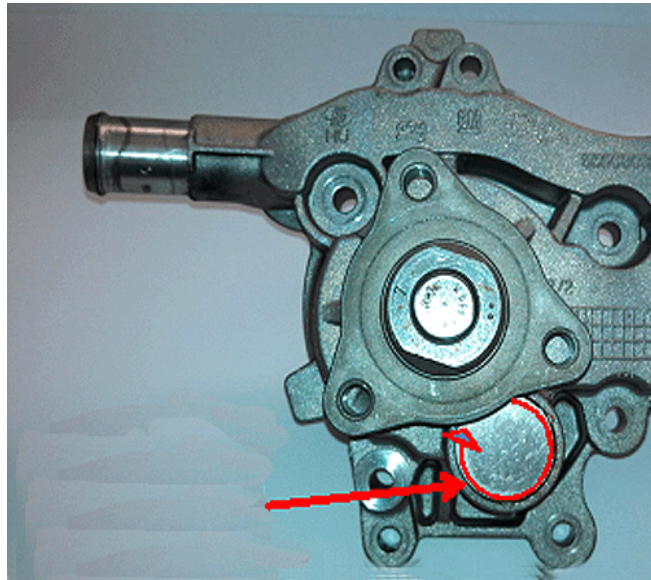
1. Use GM Low VOC Brake Parts Cleaner, P/N♦19287401 (in Canada, P/N 88901247) or an equivalent, to clean the area around the cup plug on the replacement pump assembly.
2. Dry the area with compressed air.
