# Service Bulletin

## PRELIMINARY INFORMATION

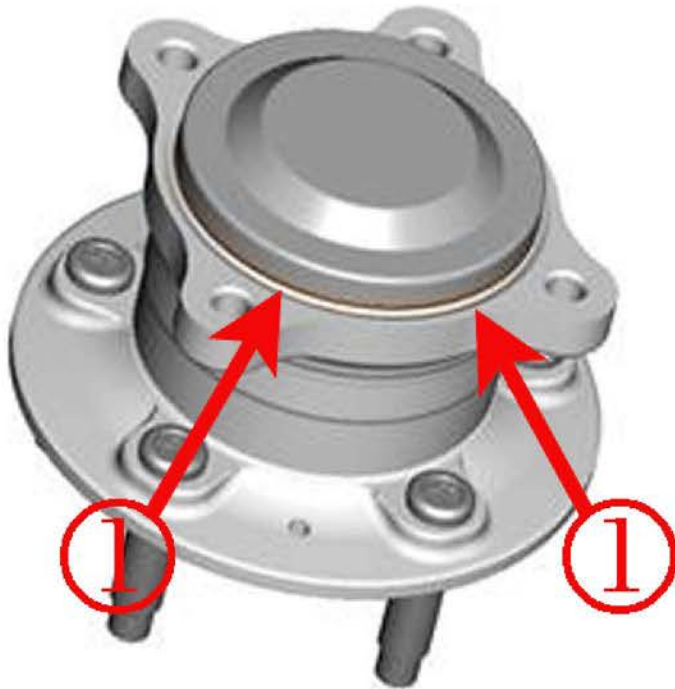
(1.) Capped Wheel Bearing

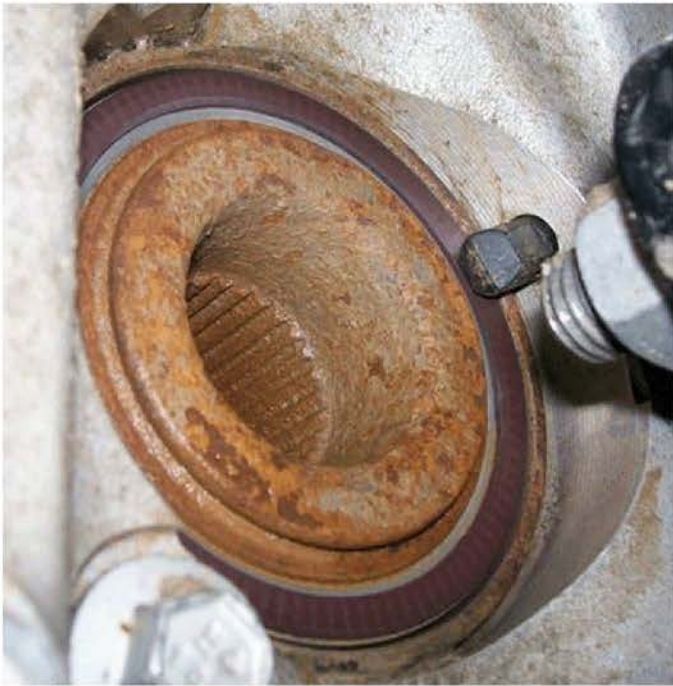
1. Connect a scan tool to the vehicle. Turn ON the ignition. Clear the DTCs.
2. Perform vehicle diagnostic repair verification procedure for DTC: C0035-C0050. Refer to SI.
