Front Passenger Interior Door Assist Grip Cover Loose

Service Category Vehicle Interior

Section Interior Panels/Trim

YEAR(S)	MODEL(S)	ADDITIONAL INFORMATION
2011 – 2013	CT200H

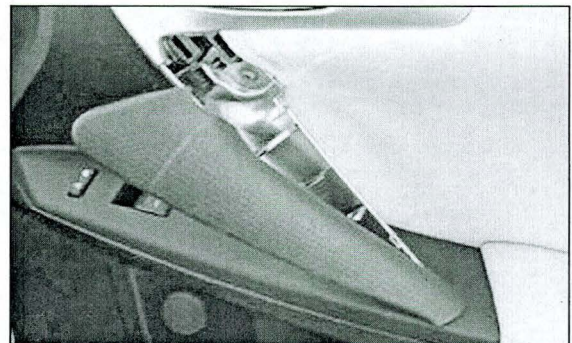
Figure 1.

1. Confirm that the door assist grip cover is loose.
 - A. If the door assist grip cover is loose, proceed to step 2 for door assist cover replacement.
 - B. If the door assist grip cover is not loose, this bulletin does not apply.

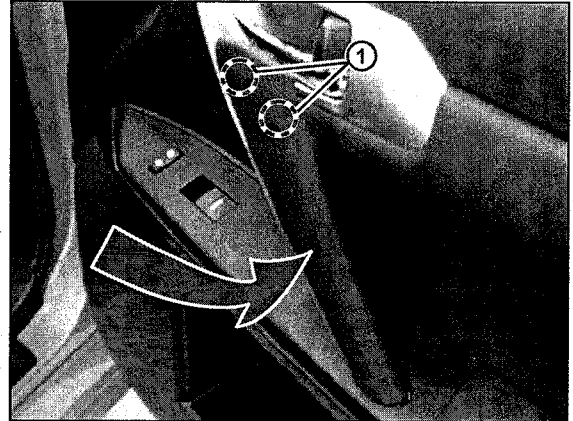
Figure 4.

1	Click Sound
---	-------------

4. Install the assist grip cover.

Refer to TIS, applicable model and model year Repair Manual:

- 2011 / 2012 / 2013 CT 200h:
*Vehicle Exterior – Door/Hatch – “Door/Hatch:
Front Door: Reassembly”*

5. Confirm the click sound from the two clips when the assist grip cover is installed in the door trim panel.
