PRODUCT CAMPAIGN BULLETIN

APPLICABILITY: 2010 and 2011MY Subaru Legacy and Outback 2006 through 2012MY Tribeca vehicles sold before January 2012
 2009 through 2012MY Forester vehicles sold before January 2012

NUMBER: WQE-41
DATE: February 2013

SUBJECT: Optional Genuine Subaru Puddle Lights

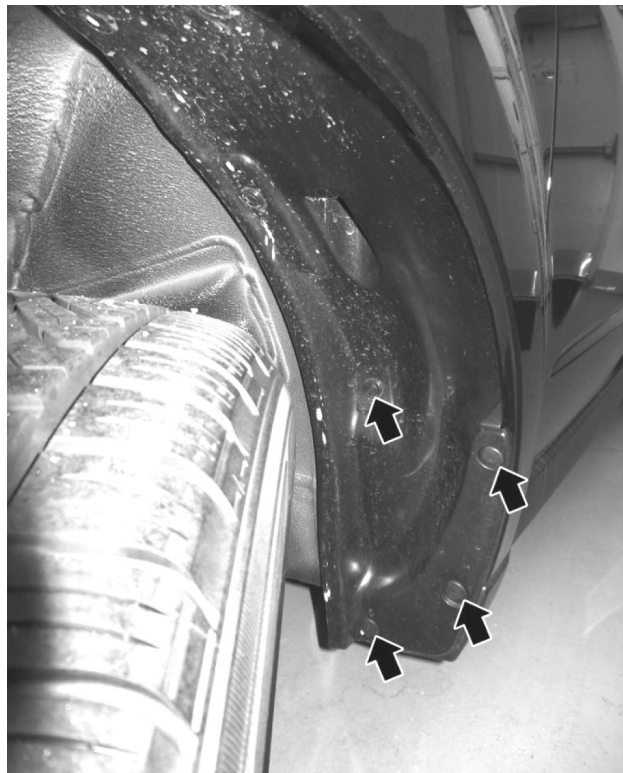
1. Raise the vehicle as necessary to access the inner fender splash shields. Wheel removal is generally not required.
2. Remove the accessory splash guard (if equipped) and the retaining clips at the rear portion of the front wheel opening. Move just enough of the splash shield to expose the puddle light wiring and body harness connectors

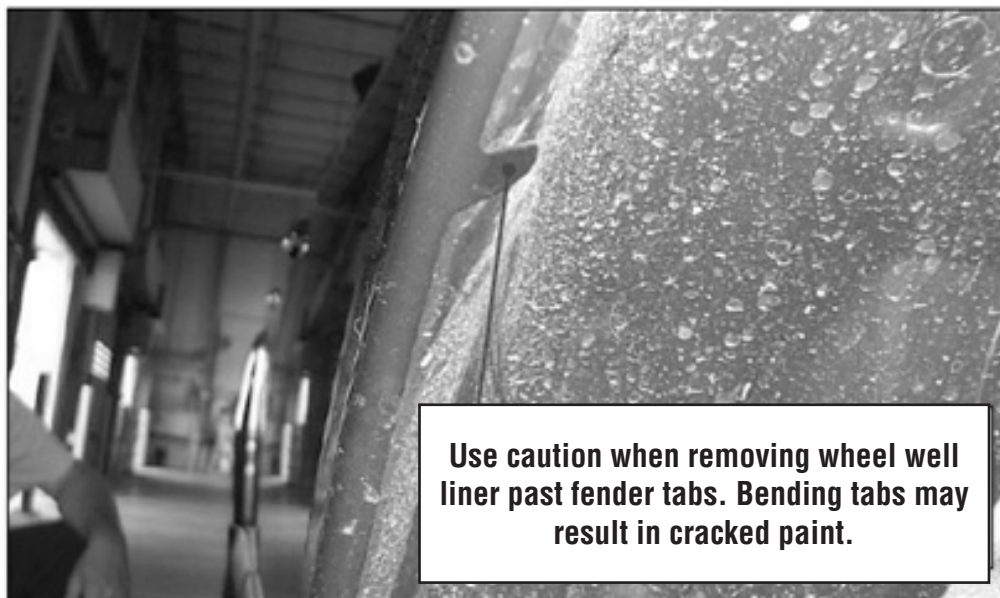
On Legacy, Outback and Forester models, locate the two metal tabs along the inside edge of the front fender. Use caution and support these small painted fender tabs inside the wheel arch when removing the splash shield. These tabs are painted body color and cracking of the paint is likely if the tabs are bent. Place one hand on the tab to secure it while pushing the splash shield up and over the tab with your other hand. Use the same method when you reinstall the splash shield. Touch-up any damaged tabs to minimize any future possibility of rust.

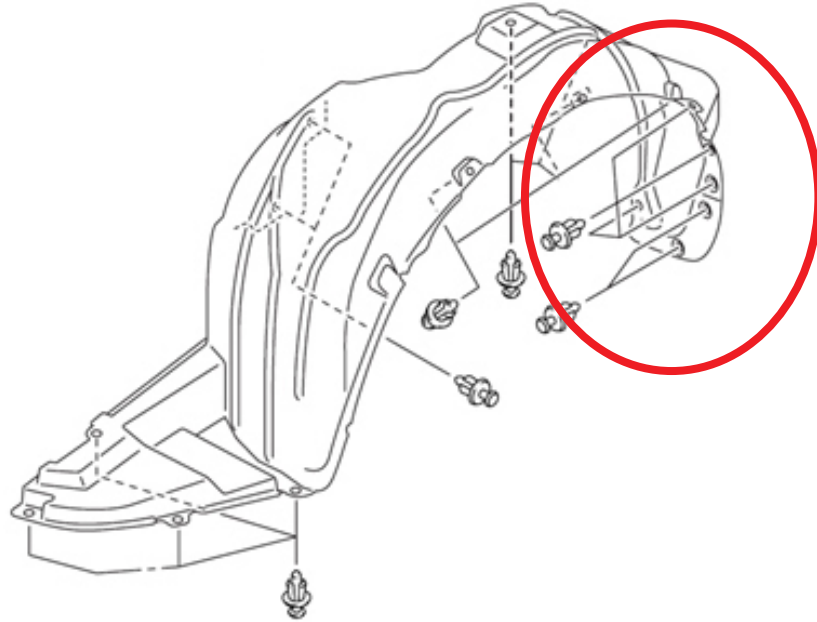
2006-2007 B9 Tribeca (5 clips)

Reminder: Splash guard /mud flap removal may also be required in some cases to access the retaining clips. Splash guards vary by model, but most involve removal of one horizontal clip, two horizontal screws, and one vertical screw. **Tip:** When reinstalling splash guards install the screws loosely and lift up lightly on the splash guard while giving the screws a final tightening. This will help reduce the possibility of a gap forming between the splash guard and the fender.
