CMBS™ Indicator On with CMBS DTC P2583-97

AFFECTED VEHICLES

All models with CMBS where the millimeter wave radar looks through the front grille upper molding

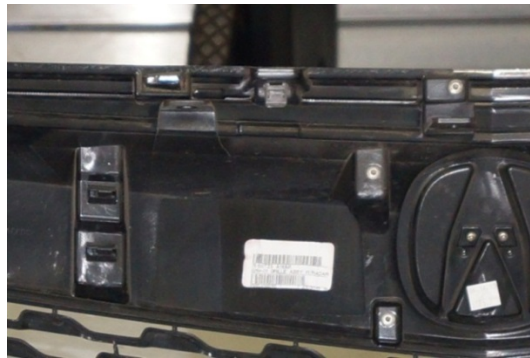
Front Grille Upper Molding (2014 MDX with CMBS)

The back surface of the CMBS front grille upper molding is **dull black**; the one for the non-CMBS molding is **metallic-looking**. Here's a view of the moldings from a 2014 MDX with and without CMBS. We've removed the front grilles from the vehicles for clarity. You're looking through the driver's side opening in the front grille base.

If you find the vehicle has the non-CMBS molding, replace it with the CMBS molding and clear the DTC. If the vehicle has the CMBS molding, then continue with normal system troubleshooting.

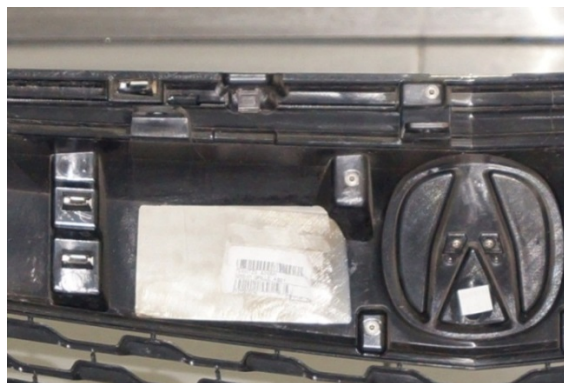
Front Grille Upper Molding (2014 MDX Without CMBS)

Is the CMBS indicator on with CMBS DTC P2583-97 (dust or dirt on the millimeter wave radar)? Before going into heavy troubleshooting, make sure the vehicle doesn't have a non-CMBS front grille upper molding. This could happen if the vehicle has some body work done and a non-CMBS molding was installed. The millimeter wave radar can't see through that type of molding and you wind up with this problem.
