MODEL  
2015~16MY  
Soul EV (PS EV)

NUMBER  
PS425

**SUBJECT:** AVN DISPLAYS "UNABLE TO START VEHICLE" WARNING MESSAGE

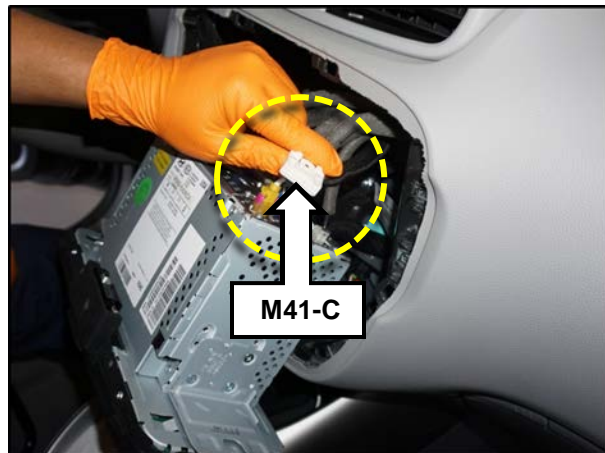
1. Record the customer's radio presets.
2. Remove the head unit from the dash by referring to the applicable Service Information on KGIS. **NOTE: Connector M41-C is shown for reference.**
