Subject: Update – Limited Service Campaign 9SM

**LIMITED SERVICE CAMPAIGN 9SM**

**REAR FRAME CROSS MEMBER REPLACEMENT**

**2000 THROUGH 2003 MODEL YEAR TUNDRA**

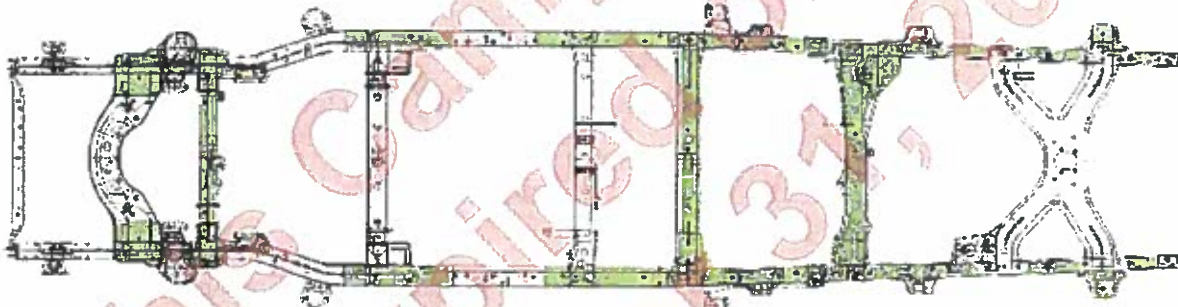
- Visually inspect the specific areas (highlighted in green) of the frame assembly as shown for visible signs of perforation.

Judgement Criteria	Result	Action
Perforation (hole) of 10 mm or more	NG	<ul style="list-style-type: none"> <li>• Replace the frame under A0F</li> </ul>
Perforation (hole) of less than 10 mm	OK	<ul style="list-style-type: none"> <li>• No action required</li> <li>• Proceed to Rear Cross Member Inspection</li> </ul>

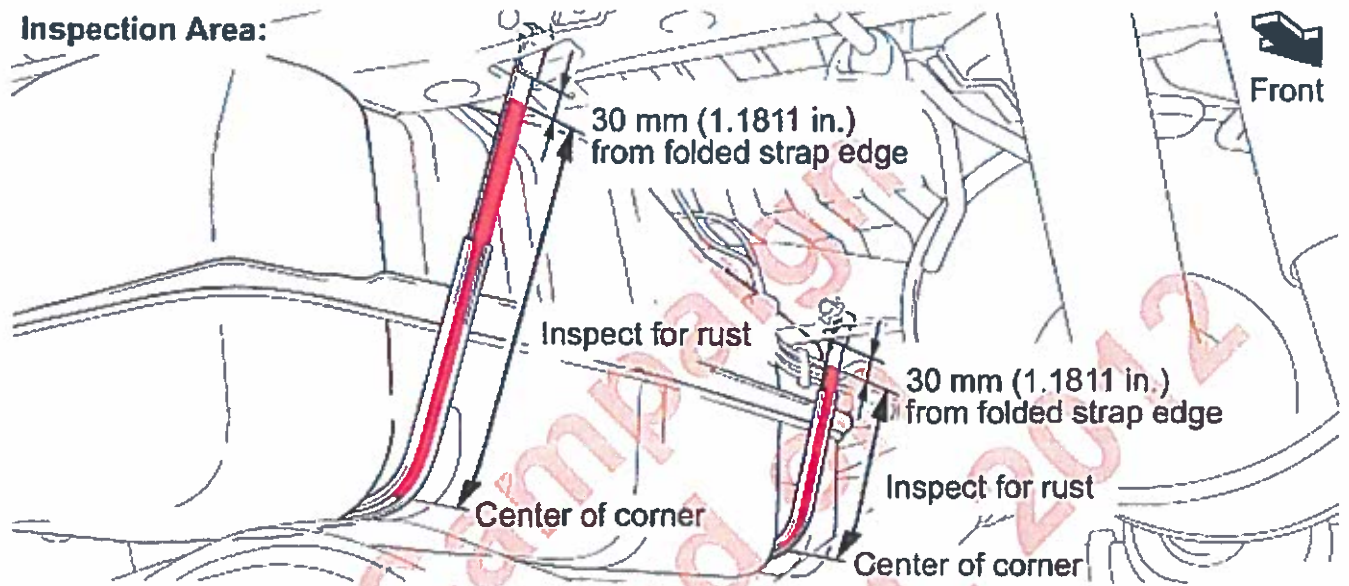
**Inspection Area:**

- a) Using a piece of cloth, clean the outside surface of the front and rear fuel tank mounting straps to remove any dirt and debris.
- b) Inspect the outside surface of the fuel tank mounting straps, does the rust span the width (front to rear) of either fuel tank strap as shown.

Judgment Criteria	Action
NG	Replace the fuel tank strap(s) <i>For part number information, please reference Section V "Parts Information"</i>
OK	Replacement not required

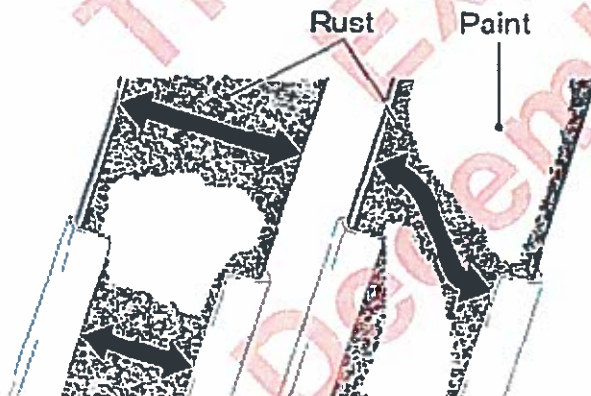
**NG**

Rusting occurs continuously along the entire width of the strap.

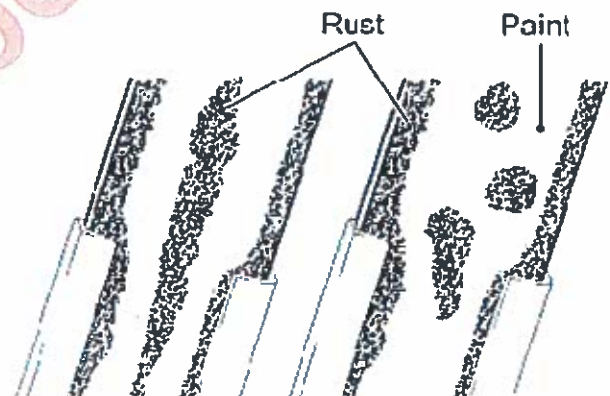
**OK**

Rusting does not occur continuously along the entire width of the strap.

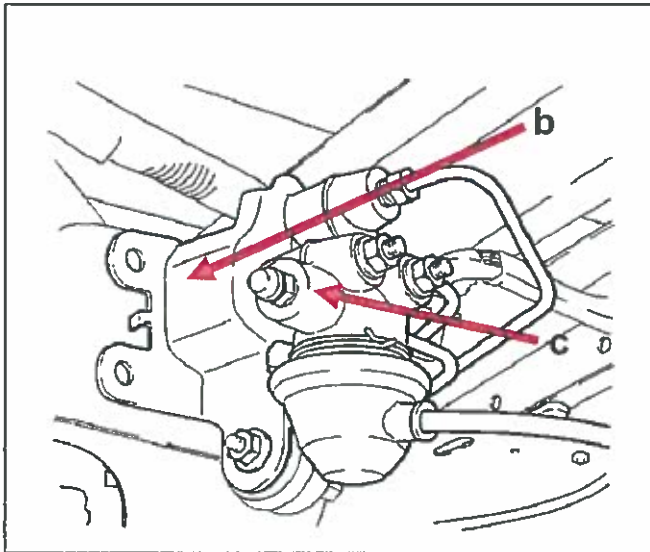
## 2. INSPECT THE LSPV

- a) If there are signs of excessive rust and brake fluid leakage on the LSPV, replace the damaged parts.
- b) With one hand using minimal force, attempt to wiggle the valve bracket (b).
  - If the valve bracket is loose, replace the damaged part.
- c) With one hand using minimal force, attempt to wiggle the valve body (c).
  - If the valve body and/or associated components are loose or show any signs of leakage, replace the damaged parts.

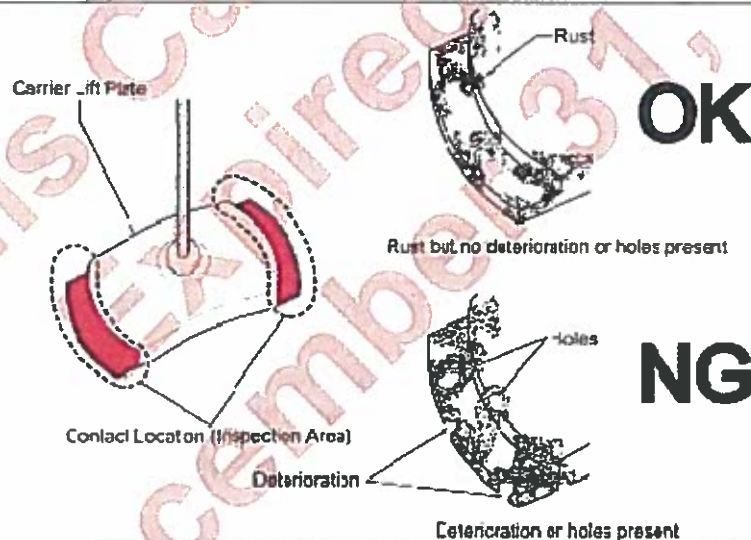
## 3. INSPECT THE SPARE TIRE CARRIER FOR DETERIORATION

- a) Inspect the spare tire carrier lift plate as shown.

Judgment Criteria	Result	Action
Deterioration Found	NG	Replace the spare tire carrier For part number information, please reference Section V "Parts Information"
No Deterioration	OK	Replacement not required

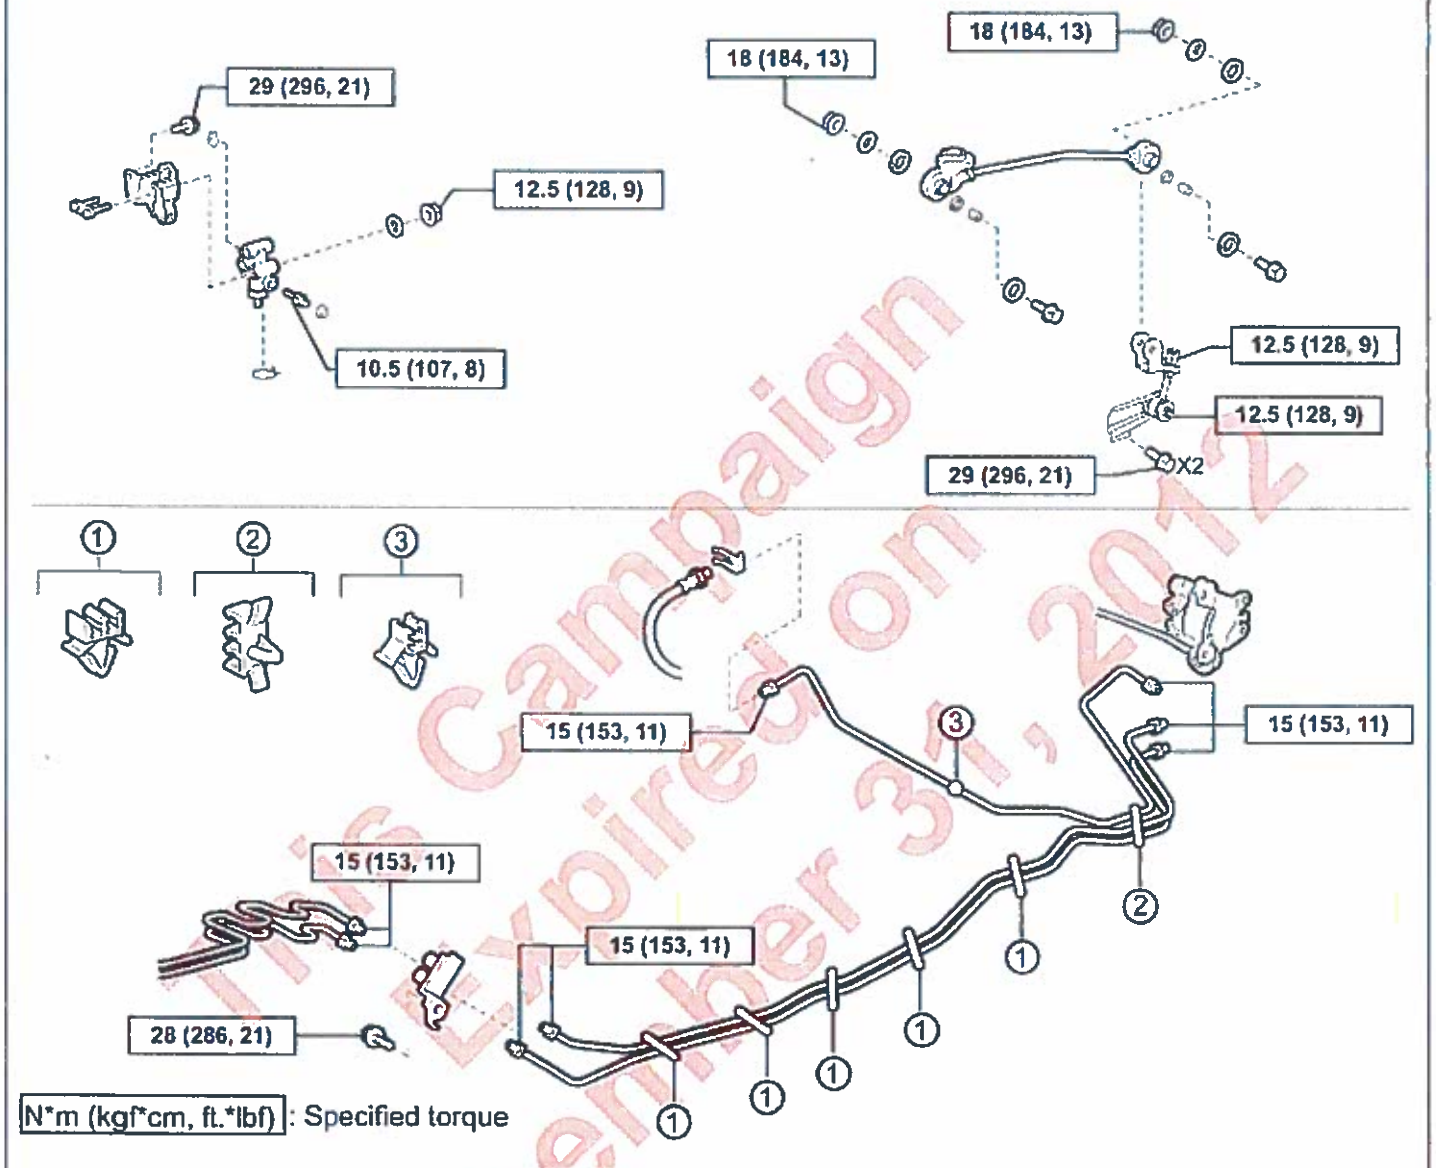
#### D. LOCATION AND TORQUE SPECIFICATIONS FOR SURROUNDING COMPONENTS IF REPLACED

Location reference diagram and torque values for replacing brake harness and LSPV.

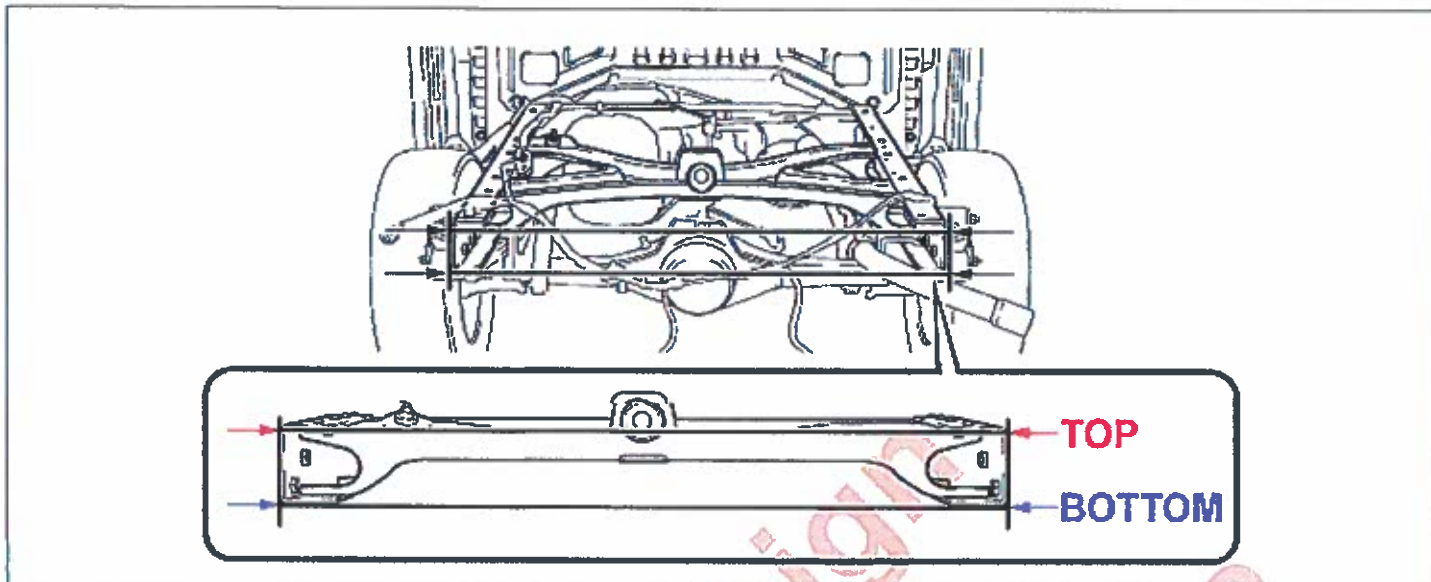
**10. MEASURE THE DIMENSIONS OF THE REAR FRAME END**

- a) Measure and record the distance between the left and right frame rails for the **TOP** and **BOTTOM** edges of the rear frame end as shown.

Make sure to measure and record the distances. These measurements will be used for adjustment purposes after the cross member has been installed.

- b) After temporarily installing the bolts and nuts, measure the distance between the left and right frame rails for the **TOP** and **BOTTOM** edges of the rear frame end.
- c) Compare the new measurements to the ones taken in step "9. MEASURE THE DIMENSIONS OF THE REAR FRAME END" during rear frame cross member removal process, and adjust the frame expansion bar until they match.

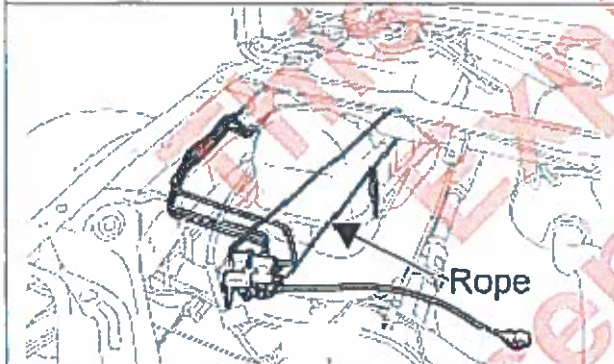
- DO NOT damage the brake line clip during removal.
- Visually inspect the LSPV for any damage of fluid leakage. Replace the LSPV if damage or fluid leakage is found.

- e) Suspend the LSPV with a rope this will protect the brake lines from damage and deformation.

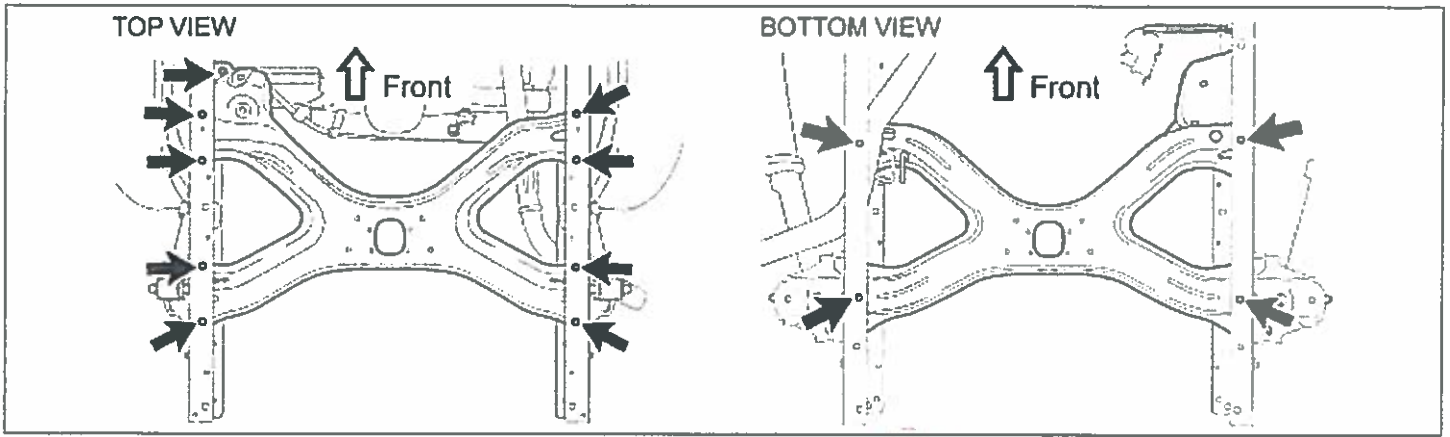
**17. REMOVE THE REAR FRAME CROSS MEMBER**

- a) Using an air chisel cut off the 13 rivet heads.

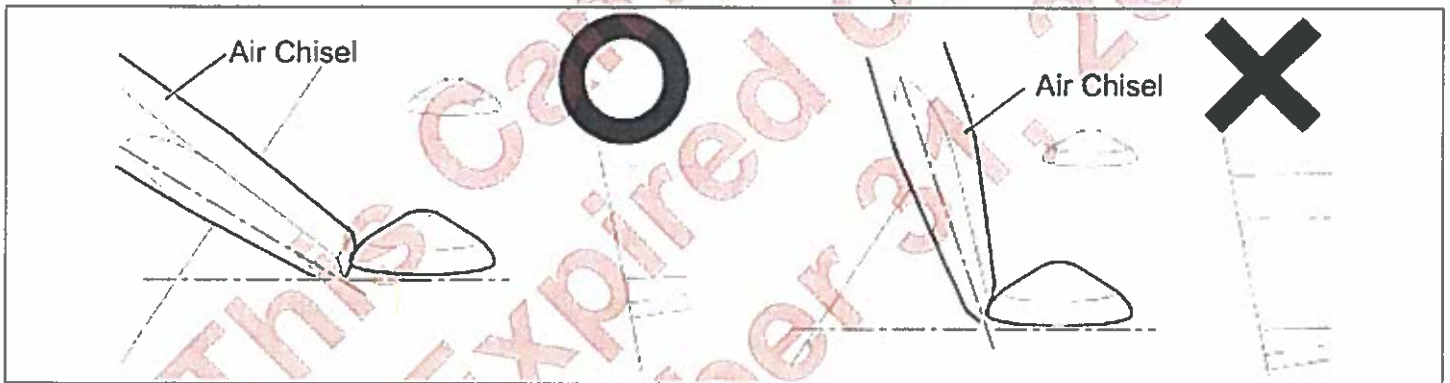
- b) Position the air chisel in between the rivet and side member. DO NOT increase the angle the air chisel, doing so may damage frame side member.

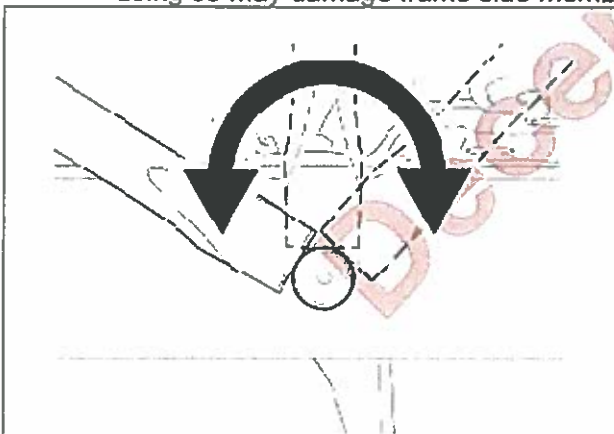
- c) When cutting the rivet head, alternate the position of the air chisel between 3 to 4 different spots.

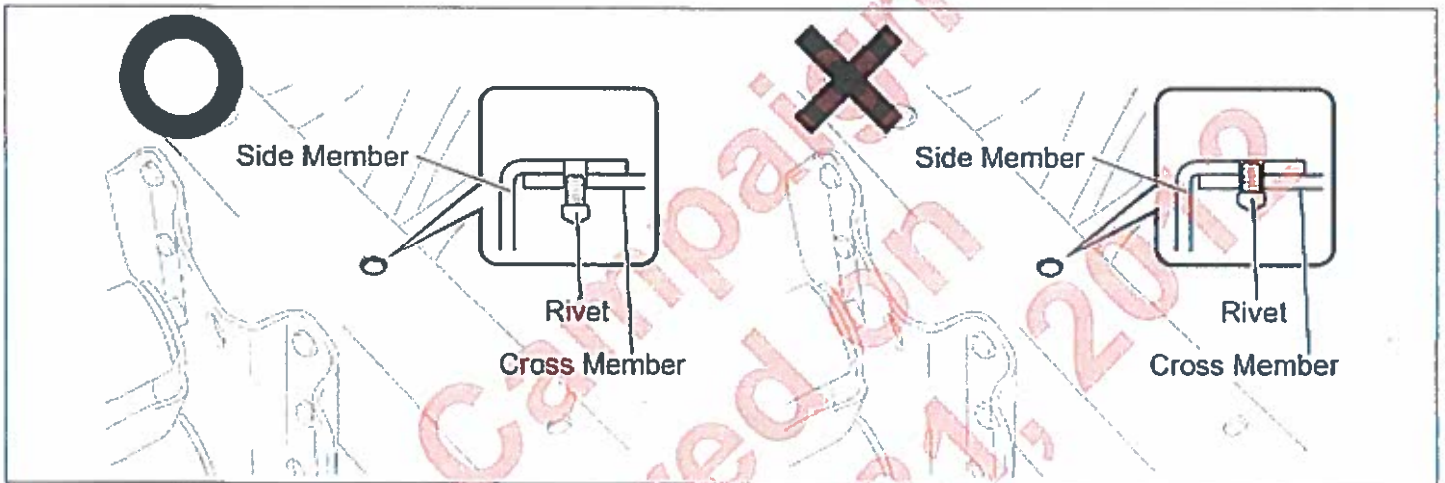
e) The rivet may expand preventing removal with the air punch.

- If the rivet is attached only to the cross member no further action is required.
- If the rivet is attached to the side and cross member, drill a hole in the rivet. Then use a hammer and punch to knock the rivet out.

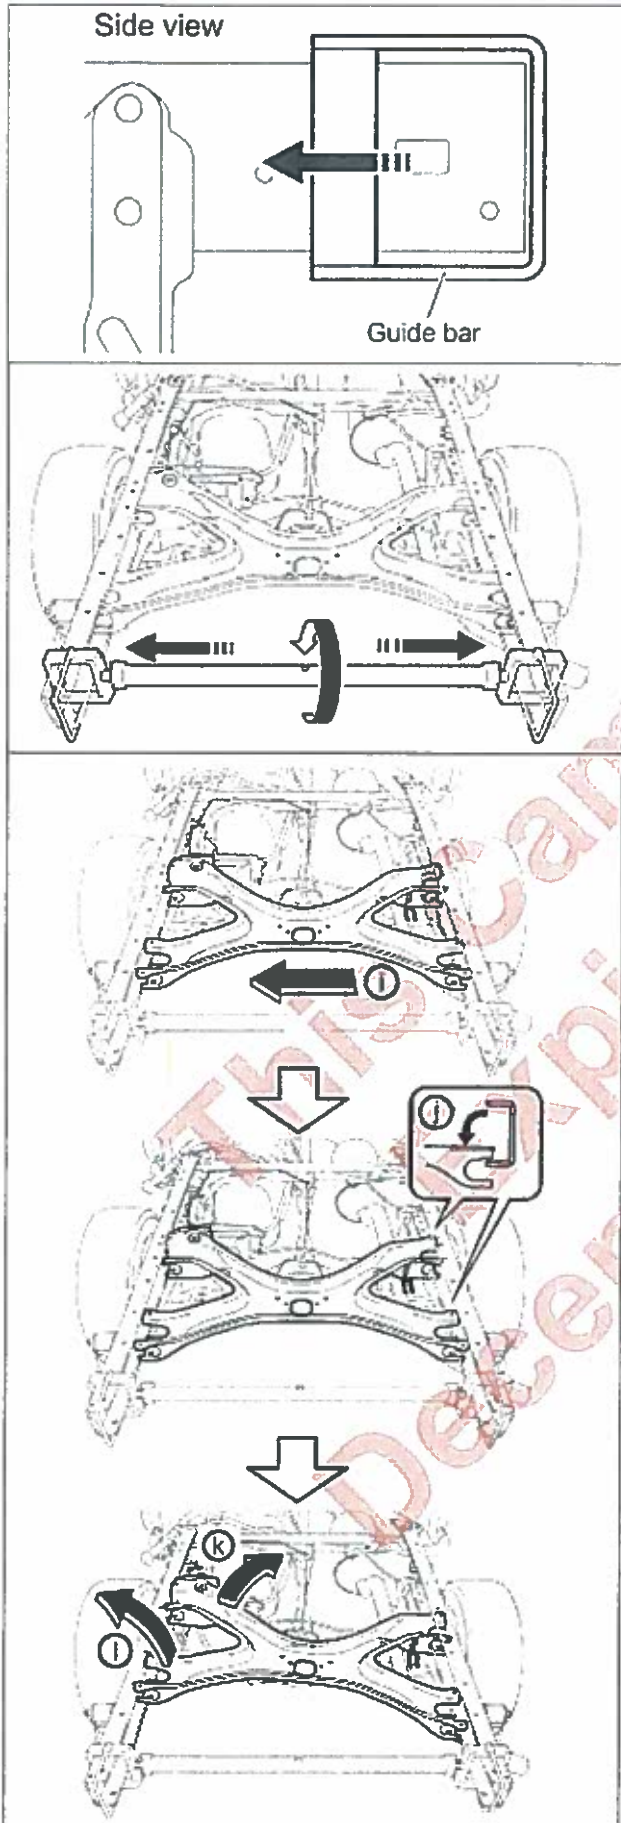
- g) Push the expansion bar until both guide bars contact the frame.
- h) Using the frame expansion bar, expand the ends of the frame rails by 4.33 in. (110 mm).
- i) Push the rear frame cross member towards the left of the vehicle as shown.
- j) Lower the right side of the rear frame cross member one notch as shown.
- k) From the left side of the vehicle, slightly twist the rear frame cross member to the right and lift up to remove as shown.

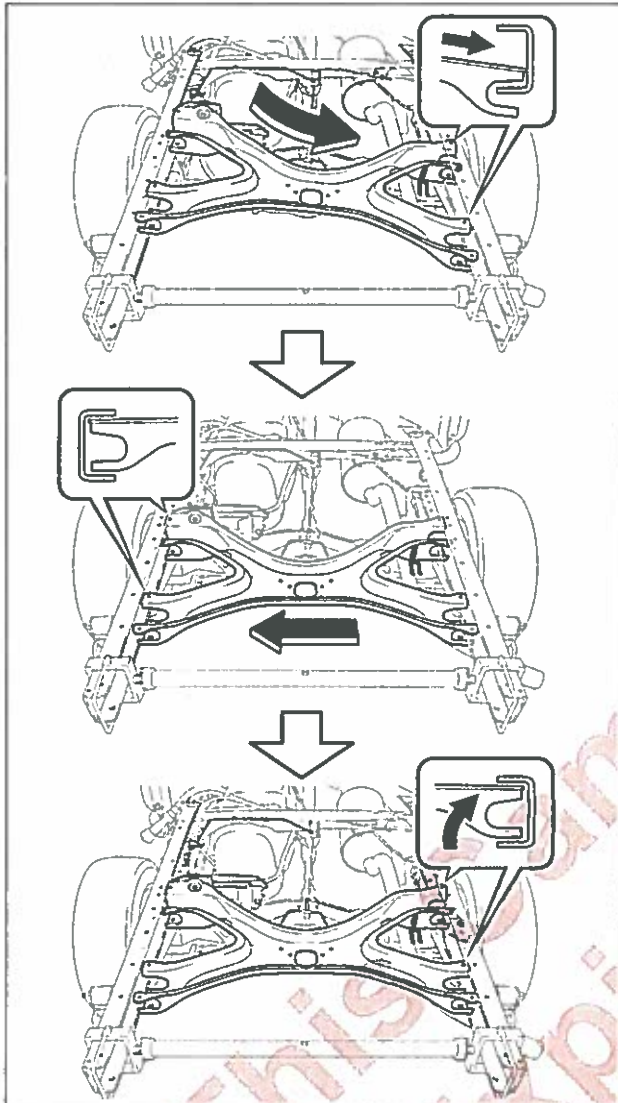
## 2. INSTALL THE **NEW** FRAME REAR CROSS MEMBER

- a) From the left side of the vehicle, insert the **NEW** rear frame cross member and set the right notches in the position shown.

- b) Slightly twist the **NEW** frame rear cross member and set the left side in the side member as shown.

- c) Push the **NEW** frame rear cross member towards the left and set the right side in the side member as shown.

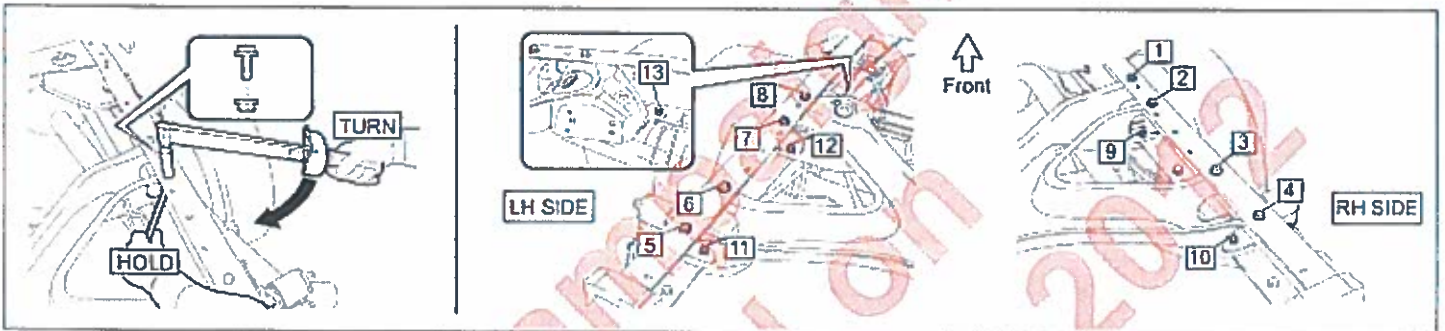
#### 4. TIGHTEN THE BOLTS AND NUTS

- a) In the order illustrated, **tighten each bolt to specification while holding the nut.**

**Torque Specification: 54 N·m (551 kgf·cm, 40 ft·lbf)**

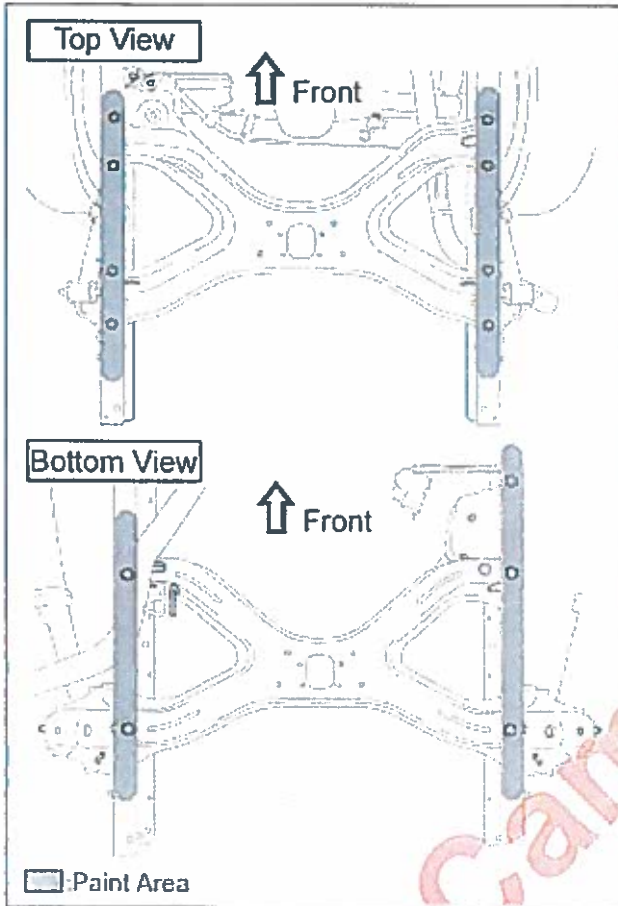
- d) Apply paint (chassis black or black anti-corrosive paint) to the top and bottom areas on the side member as shown.

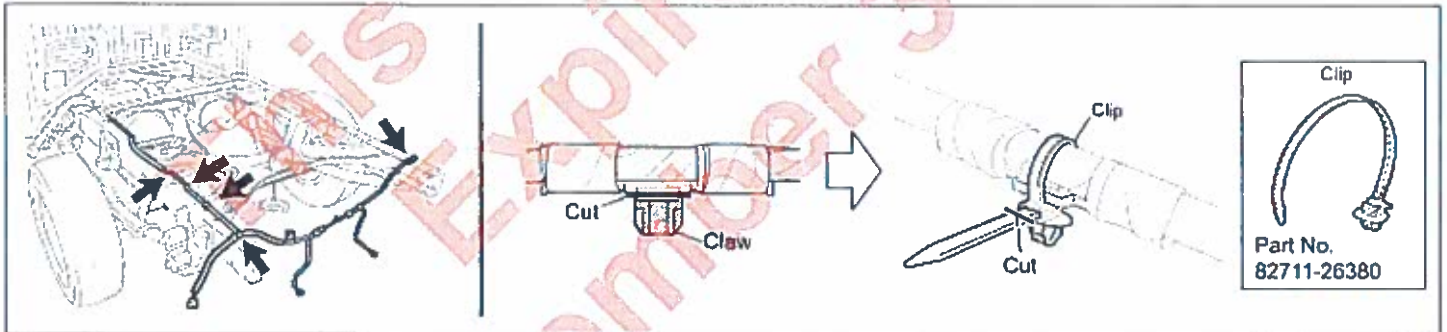
- b) Reinstall the 5 wire harness clips.

If the clip(s) indicated for the frame wire harness is damaged or broken, cut off the damaged claw and replace it with part number 82711-26380 as shown above.

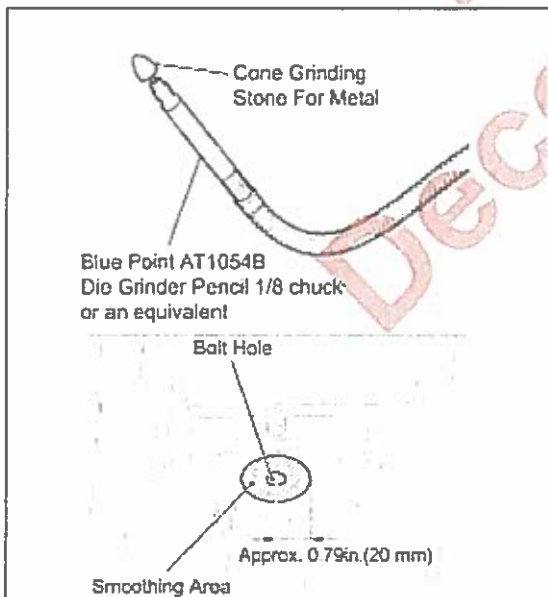
### 3. SMOOTH THE FRAME SURFACE

- a) Smooth the frame surface where the weld nut has been removed with a pencil type grinder and a cone grinding stone.
  - (1) Remove paint and rust from the frame surface surrounding the bolt hole. (Approximately 0.79in. or 20mm radius from the center of the bolt hole.)
  - (2) Carefully grind the surface flat.

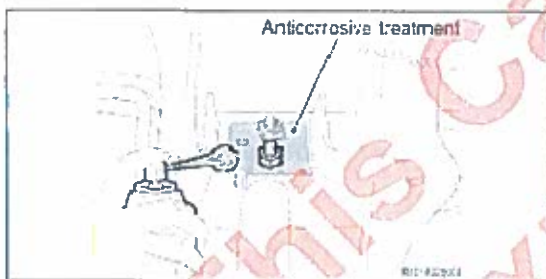
5. **APPLY ANTICORROSIVE TREATMENT TO THE FRAME**

- a) Apply an anti-corrosive paint to the frame surface, bolt, and nut shown in the figure.
