# Technical Bulletin

50 16 05 June 7, 2016 2038981 Supersedes V501603 dated February 8, 2016 to update Claim Processing statement.

### Front Fender - Corrosion on Wheel Arch

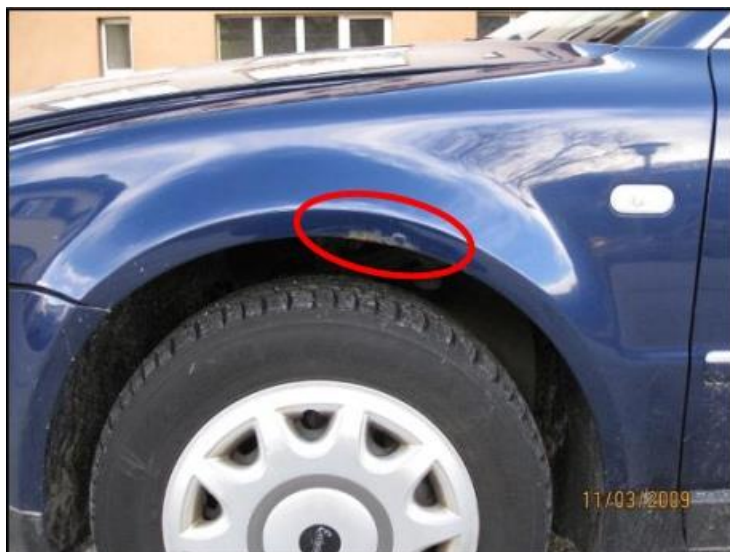
Corrosion on the wheel arch area of the front fender (Figure 1).

Figure 1 (corrosion on left wheel arch)

The wheel liner touches the arch area of the fender and rubs off the paint in the contact area.

The corrosion is caused by dirt accumulations and movements of the wheel liner.

**1. Repair the fender:** If the edge area is only slightly corroded (no through-corrosion/perforation), proceed as follows:

- Remove the front bumper according to the repair manual. See Repair Manual Group 63 in Elsa.
- Remove the side indicator (in fender, if equipped) according to the repair manual. See Repair Manual Group 94 in Elsa.
- Remove the front wheel liner according to the repair manual. See Repair Manual Group 66 in Elsa.
- Remove the corrosion with the pneumatic brush grinder VAS 6446.
- Apply a VOC compliant epoxy primer as an anti-corrosion treatment and primer (locally sourced).
- On the inner fender apply (in the complete contact/edge area) adhesive/sealer (part number: D 511 500 A2) as further edge protection (Figure 2, green line).
