Reference	SSM72234
Models	Discovery Sport / L550
Title	SD Card Check
Category	Electrical
Last modified	27-Apr-2015 00:00:00
Symptom	204000 Instrumentation
Attachments	SD Card Inspection1.pdf

SD Card Visual Inspection

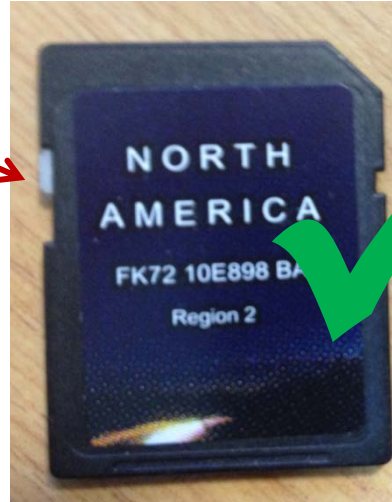
Unlocked (Correct)

1. Ensure the SD card is in the unlocked position (see attachment).
2. Ensure the card is correctly located with the label facing down (see attachment).

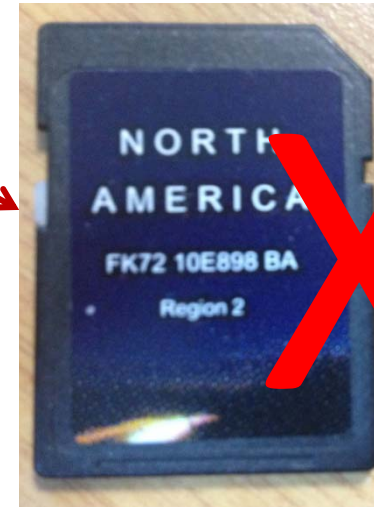
Locked (Incorrect)

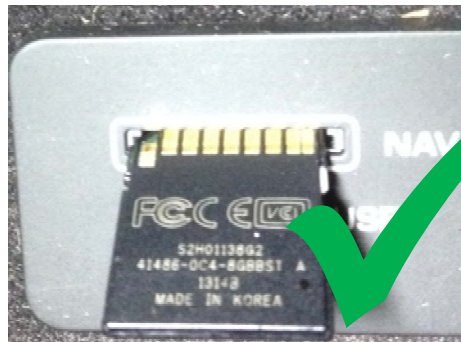
label facing down (Correct)

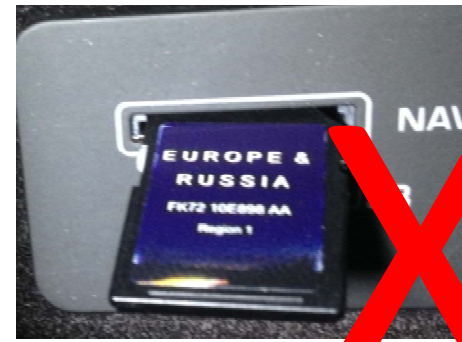
Label facing up (Incorrect)
