Technical Bulletin

87 16 13 July 26, 2016 2044165 Supersedes Technical Bulletin V871611 dated July 11, 2016 to include a corrected Refrigerant Circuit Adapter in the parts table.

Air Conditioning Does Not Cool and or Compressor is Noisy

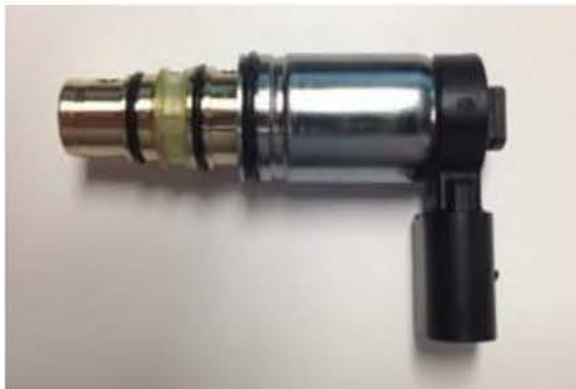
Figure 1 N280 Refrigerant Regulating Valve 1K0260839

The condition may be caused by a faulty A/C compressor regulator valve N280 (Sanden). The internal components of the valve can be obstructed and incapable of full function. This loss of refrigerant regulation from N280 can cause noise from the air conditioning compressor and/or affect the HVAC cooling.

This bulletin applies to vehicle built with Sanden 1K0820803, 1K0820808 and 5C0820803 compressors only. The replacement N280 valve is not compatible with other Sanden compressors. The N280 valve is not compatible with any Denso compressors.

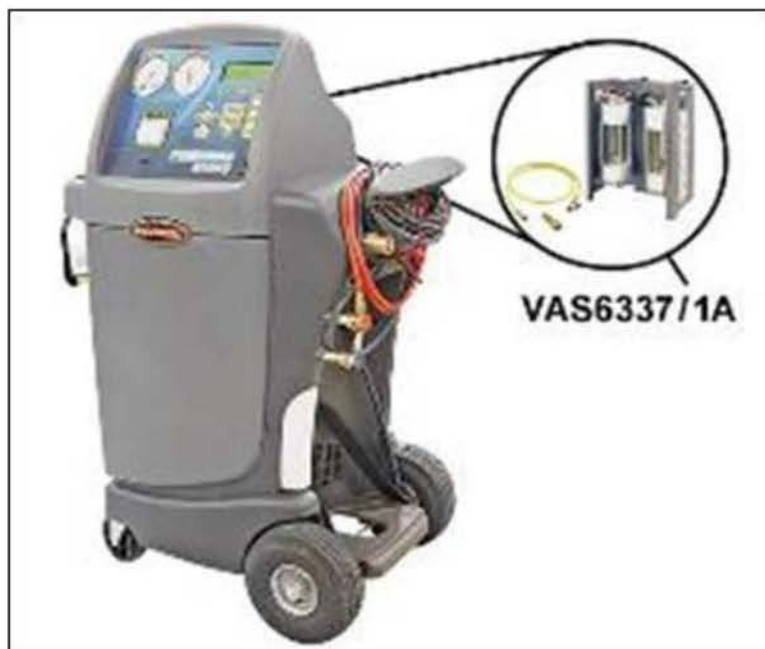
Figure 4. Robinair A/C Service Unit.

Connect both the refrigerant service station (Figure 4) and the diagnostic tester to the vehicle.

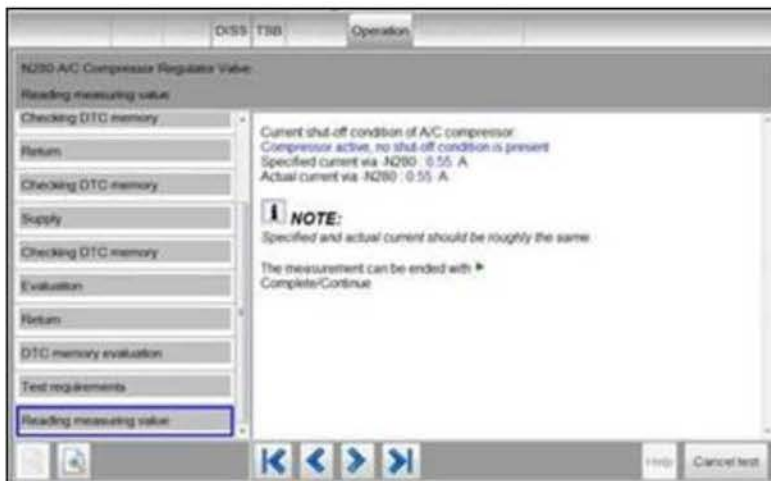
Figure 5. Checking N280 signal value Measuring Value Block.

Monitor the measuring value for the air conditioner compressor regulating valve N280 signal (Figure 5).

The actual and specified values will be plausible and will show a normal regulating range of current for cooling request (0.400 A – 0.820 A).

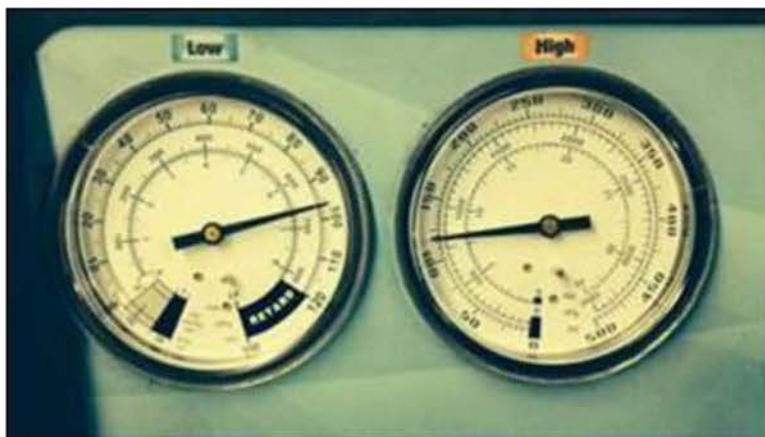
Figure 6. Equalized pressure condition. No pressure generated from compressor.

After verifying the compressor should be on and operating check the gauge readings on the Robinair® service station. If the gauges show no pressure generation from the compressor continue to the next step.

(Example of no pressure generation is when the pressure readings on the high and low sides are equalized in Figure 6).

! Note: If the gauge readings are showing normal compressor operation per the Elsa Repair Manual, this bulletin does not apply and further diagnosis is required.

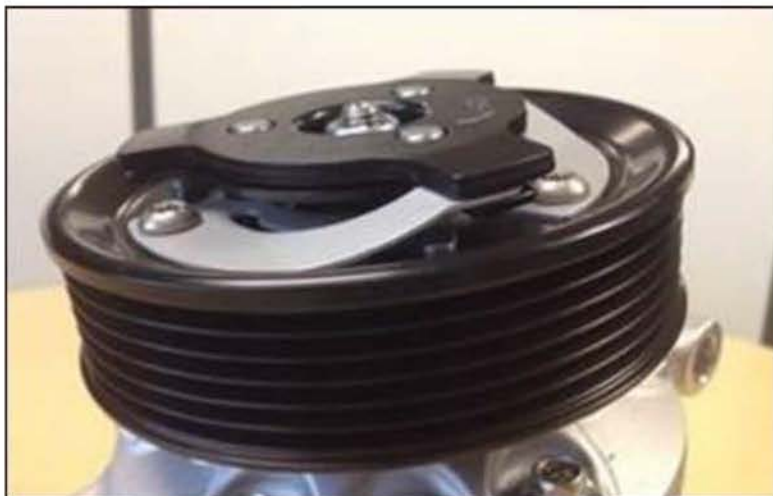
Figure 7b. Example of torque limiter over load protection still intact.

Check that the compressor torque limiter has not been activated (Figure 7b).

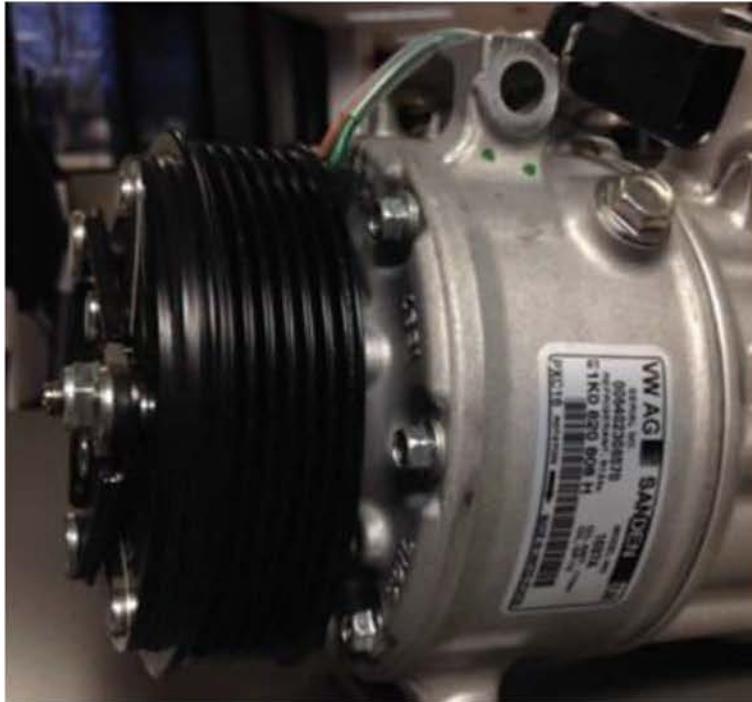
Figure 8. MY2016 AC compressor with clutch (Sanden)

For MY2016 vehicles with Sanden AC compressor 1K0820808H make sure the compressor clutch is engaged when the AC is switched on.

If clutch is not engaging perform diagnosis of the compressor clutch J44 test.

Check that adaptation channel 9 and is set at 1 for clutch enabled. (See TT 87-16-01).

! Note: If the AC compressor clutch is not engaging this bulletin does not apply.

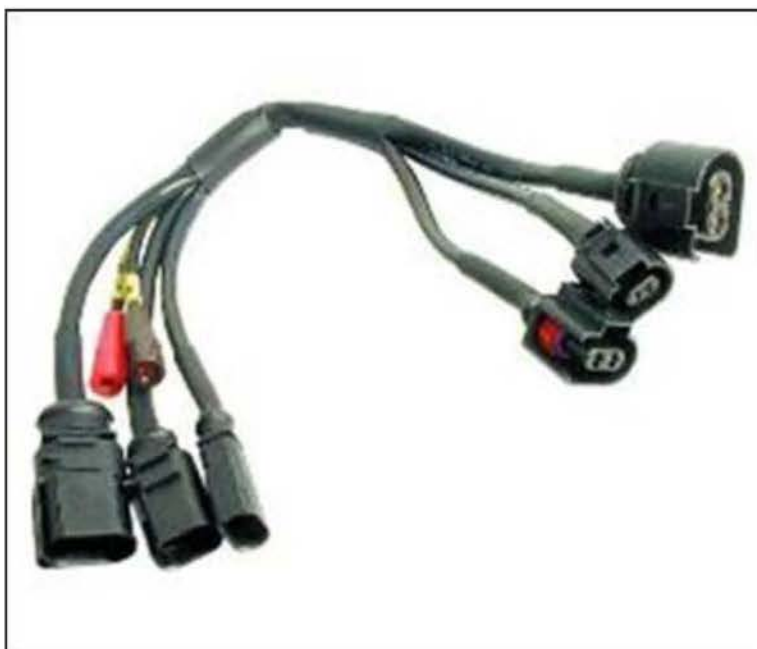
Figure 9. VAS 5256 breakout harness.

Shut off the engine. Connect the breakout harness VAS 5256 (Figure 9) between the N280 valve and its connector.

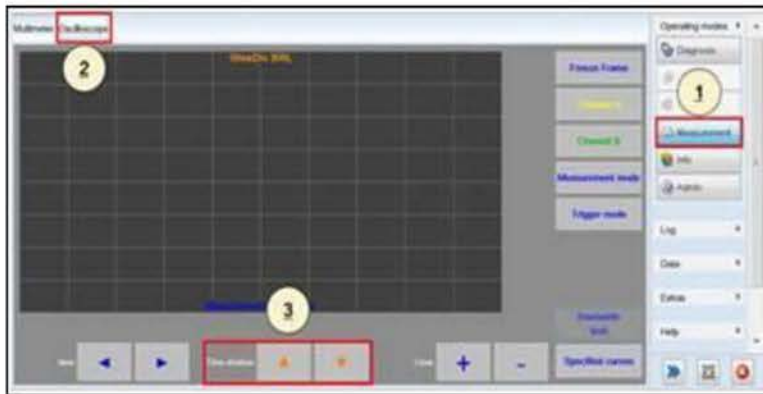
Figure 10. Select Measurements from operating mode menu”.

Go to Operating Mode “Measurements” to check the N280 signal from the control module.

Select Measurements.

Select oscilloscope.

Change time division to 2ms/Div (Figure 10).

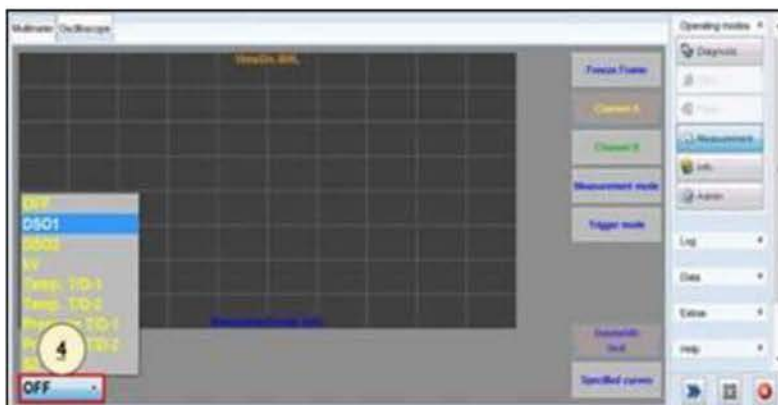
Figure 11. Setting up DSO channel”.

Select the correct DSO channel according the test leads hooked to the vehicle (Figure 10).

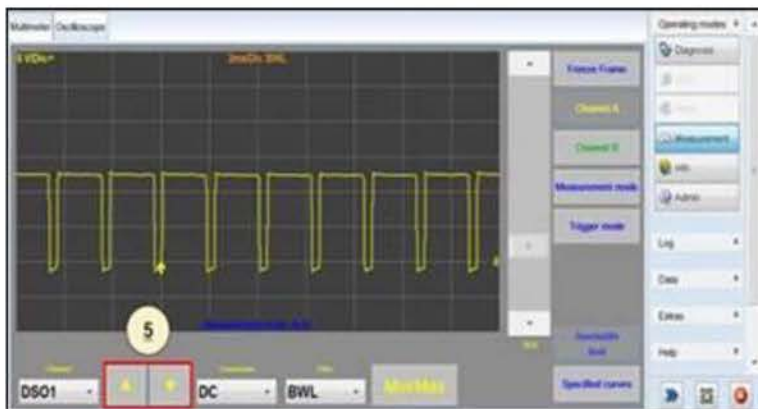
Figure 12. Checking the N280 signal wave form.

Change the voltage to 5VDiv.

Check the signal wave form (Figure 11). The square wave signal should be between 75% and 100%.

If the wave form signal is good, the mechanical integrity of the N280 valve needs to be inspected.

GO TO: Removing/Installing the N280 Regulating valve.

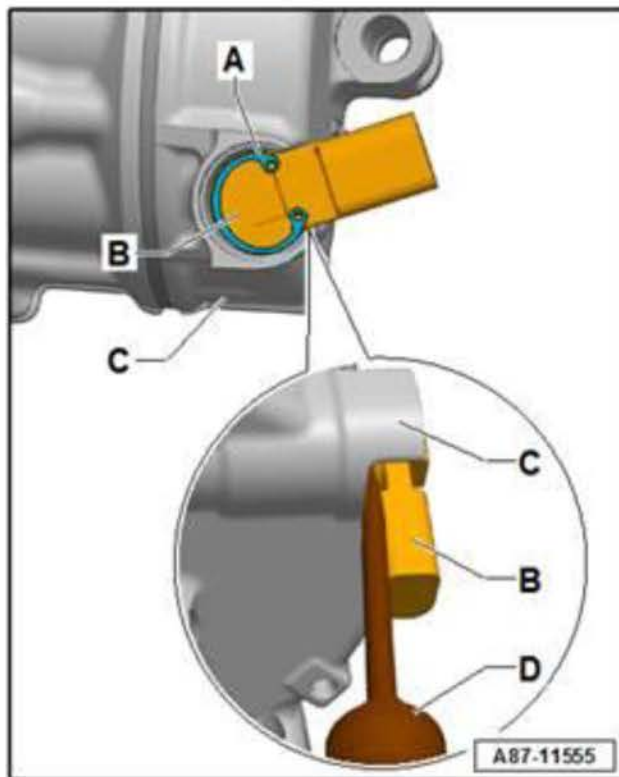
Figure 13. Circlip / N280 removal

1. Remove circlip-A- carefully.

2. Carefully remove the A/C Compressor Regulator Valve -N280- -B- from the A/C compressor mount -C-, using a suitable screwdriver -D-, for example (Figure 13).

Circlip must be reused.

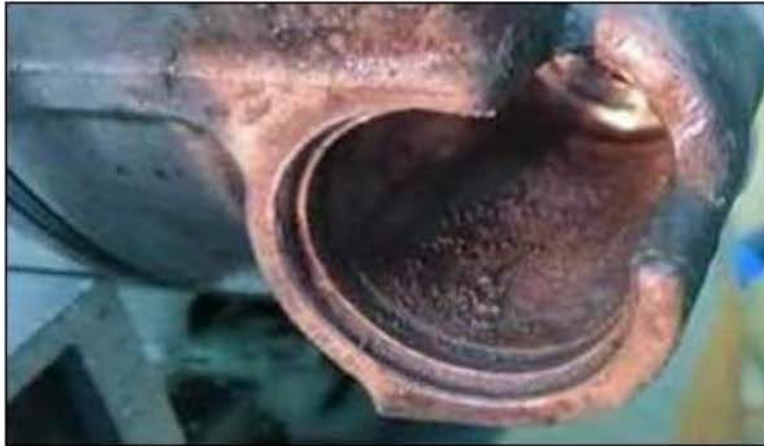
Figure 14. Corrosion in the N280 valve bore.

Assess the condition of the N280 valve bore and the valve filter screen (Figure 14). If severe contamination is found in valve bore there is a risk of damaging the replacement valve on installation. In these cases the A/C compressor must be replaced.

A slight amount of debris or corrosion does not present a risk and does not justify replacement of the AC compressor.

- If little or no corrosion or contamination is found perform Repair Procedure A: Replacing the N280 regulating valve.
- If corrosion and contamination is found, perform Repair Procedure B: A/C compressor replacement.
- Document the all workshop findings of this procedure on the repair order.

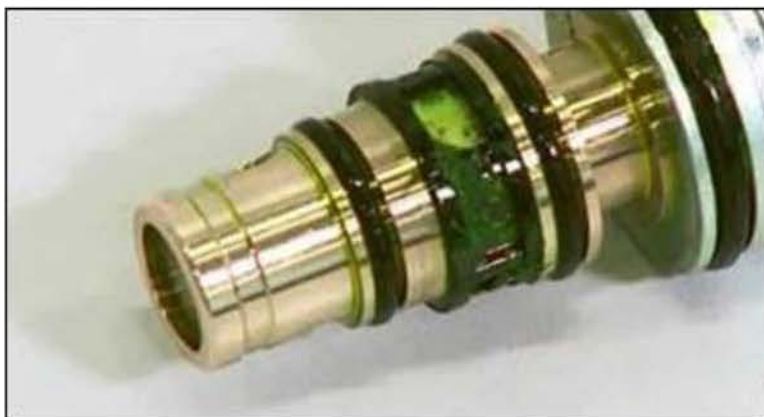
Figure 15: Severe contamination at the N280 valve filter screen.

Should severe contamination be found at the valve filter screen (Figure 15) and A/C compressor replacement becomes necessary, ensure that the refrigerant circuit is flushed in the course of repair.

Small random particles on the filter screen does not constitute "severe" contamination and does not justify replacement of the A/C compressor.

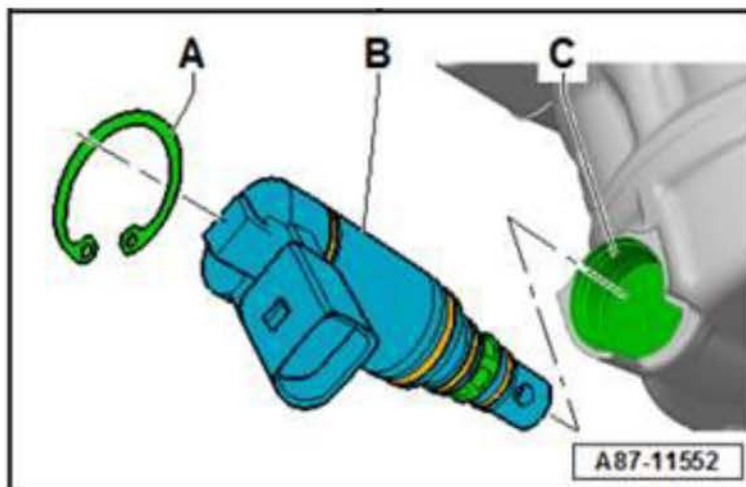
Figure 16: Prepare mount for N280 installation.

1. Check the A/C compressor mount -C- and the circlip groove for dirt, and if necessary, clean them carefully and thoroughly with a clean, lint-free cloth (Figure 16).

Risk of damaging another N280 Valve or compressor may result due to dirt contamination or damage to the sealing surfaces in the mount.

- If necessary, carefully clean the A/C compressor mount -C- using only a clean, lint-free cloth. **DO NOT** use compressed air.
- Make sure while cleaning the mount -C- that no dirt gets into the area underneath the O-ring sealing surface -F- or the existing channels and none of the mount sealing surfaces become damaged.

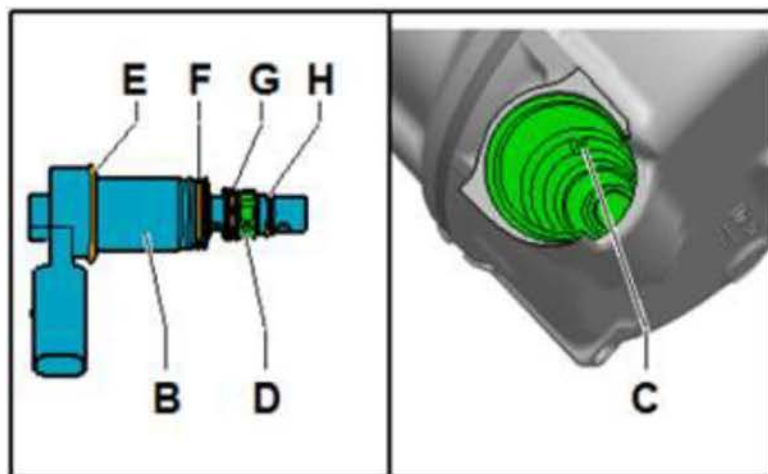
Figure 17. Check and prepare N280 o-rings

1. Check the O-rings -F-, -G-, -H- and -E- (if applicable) of the A/C Compressor Regulator Valve -N280- -B- for damage.
2. Coat the O-rings -F-, -G-, -H- and -E- (if applicable) of the A/C Compressor Regulator Valve -N280- -B- lightly with refrigerant oil and check for proper seating (Figure 17).

3. Insert the A/C Compressor Regulator Valve -N280- -B- until the stop in the A/C compressor mount -C-.
4. Re install circlip -A-.
5. Install the removed parts in the opposite order.
6. Evacuate and refill the refrigerant circuit.

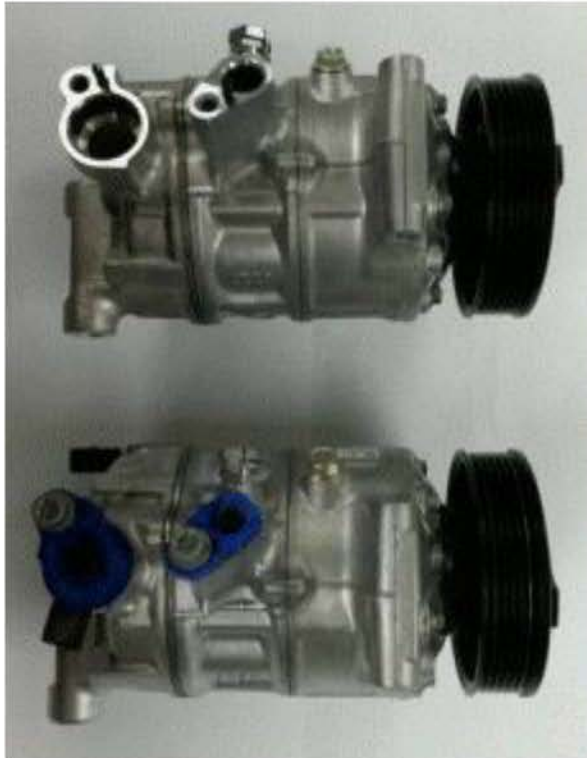
Figure 18

When installing a new compressor transfer the compressor shipping caps to the original compressor as shown in Fig 18.

All replaced compressors must have the shipping caps re-installed before being returned to the WPRC.

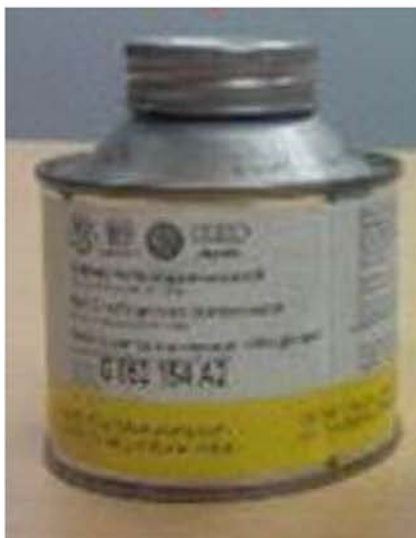
Figure 19: Sanden compressor manufacturer PAG oil G 052 154 A2.

The replacement Sanden compressor will come with the specified type of PAG oil G 052 154 A2 (Figure 19).

The compressor comes with a full charge of oil for the entire refrigerant circuit. However the amount of PAG oil supplied with the replacement compressor may not be the exact amount to replenish the refrigerant circuit. Drain and measure the PAG oil in the replacement compressor to determine the required amount. If the amount needs to be adjusted, do so using the correct type of PAG oil specified in ETKA. Refer to Elsa for the correct oil capacity for the compressor being installed.

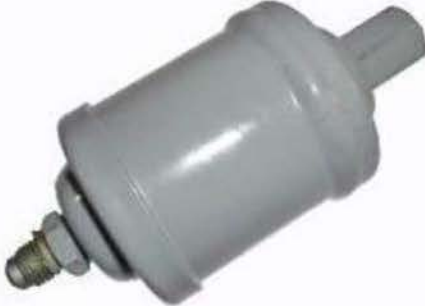
<p>Bosch – 17707-6</p>

OR	
<p>Air Conditioning System Flushing Device Filter</p>

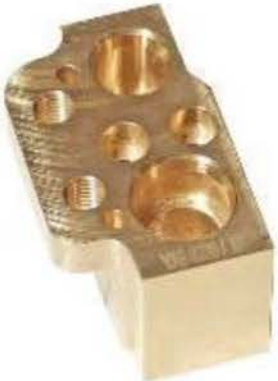
<p>Refrigerant Circuit Adapter 18</p>	<p>VAS 6338/18 (MY2013-2015)</p> <p>Note: For MY2016 the expansion valve must drilled out and used to flush the refrigerant circuit. A new expansion valve must be installed.</p>
---	---

The correct adapters can be found in Elsa at: Ventilation & Air Conditioning>>Refrigerant R134a Servicing >>00 General Technical Data>> Refrigerant circuit removing contaminates>>Refrigerant Circuit, Cleaning (Flushing), with Refrigerant R134a >>Adapter for Assembling Flushing Circuit.
