Tech Tips

TT 91-16-02

2016 Golf, GTI, eGolf, Sportswagen - MIB 2 Blue Emergency
Screen after 91N9 update

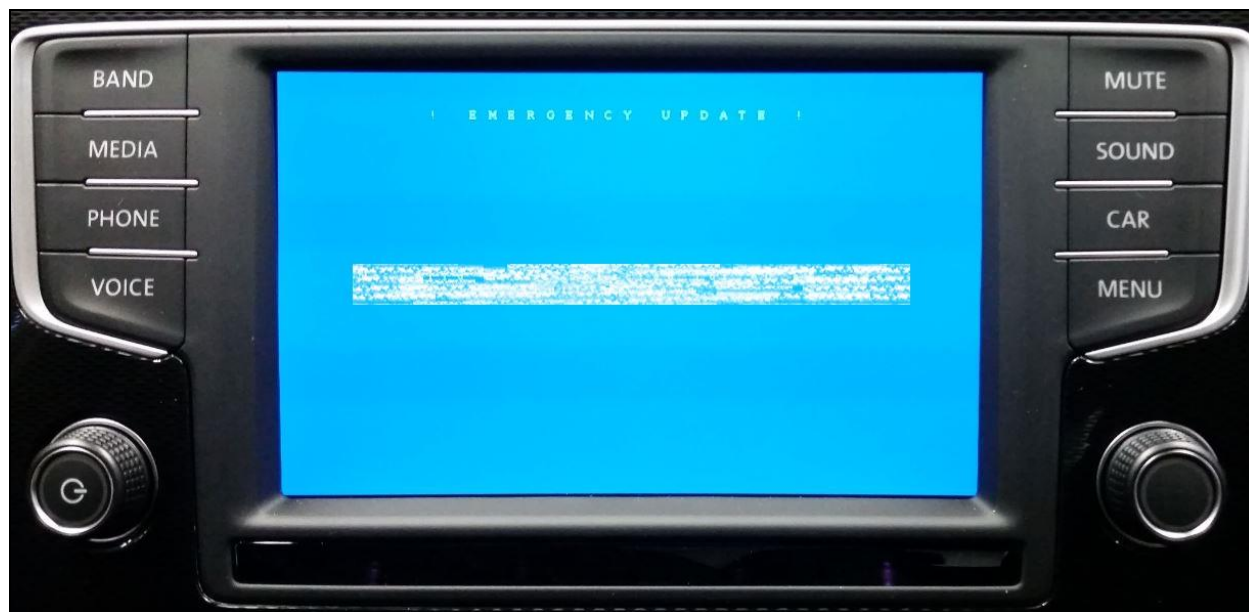
If the Blue “emergency” screen has appeared after the 91N9 update, the unit may be able to be recovered. There are 2 portions of the 91N9 update. The first update fixes any corrupt files that may already be in the radio. It’s possible that when the blue screen appears, a portion of the download did not fully complete.

Perform the following: Re-insert the SD card from the 91N9 Update, perform a hard reset of the radio by holding the power button down on the radio for 15 seconds and see if more files are written to the radio. **It may take up to 10 minutes for the files to start loading again.** After the update completes, reboot the radio again and perform the replacement test plan as outlined in the update.
