51970-01893 Version 6

Recall: Driver's Airbag Inflator May Produce Excessive Pressure After Long-Term Exposure to High Absolute Humidity

Supersedes 14-029, dated April 14, 2015, to revise the information highlighted in **yellow**

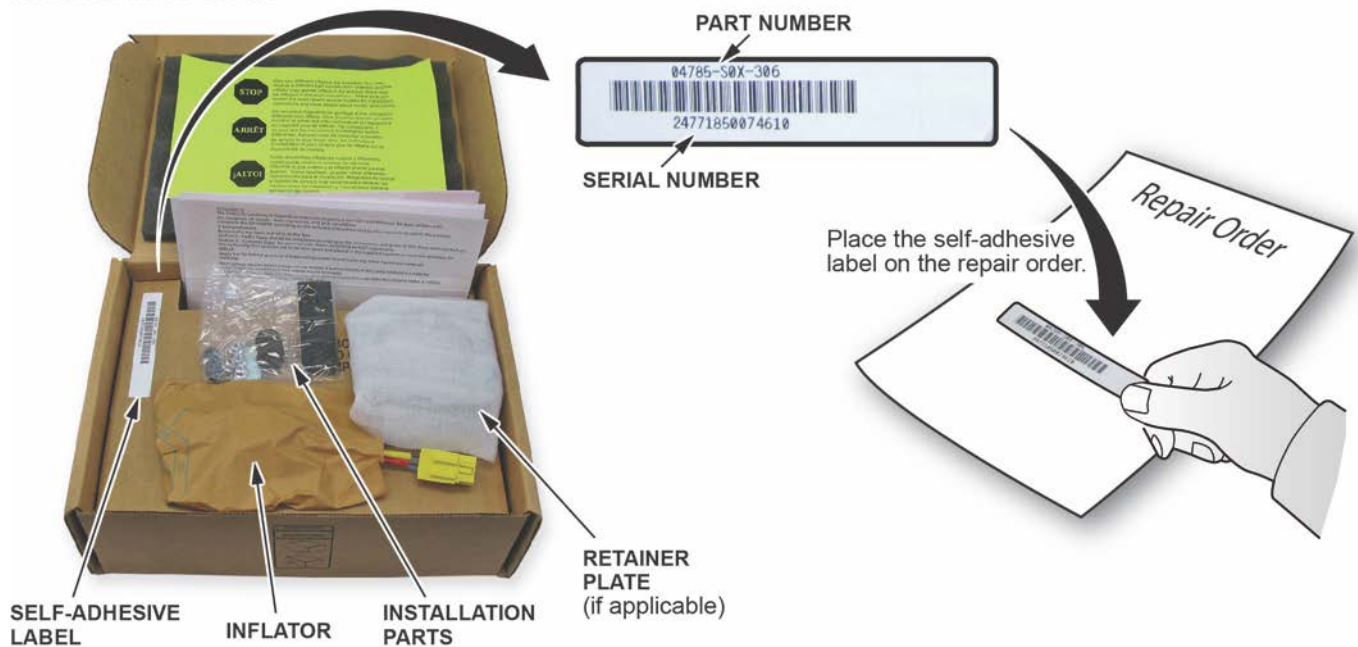
INFLATOR PARTS BOX

- The replacement part number is printed on the top part of the label and the serial number is printed on the bottom. **Make sure you attach the label to the R.O. and give it to the warranty clerk.**
- There may also be a colored sticker located in the kit, ignore it because it is not used.
- Not all inflator kits have a label included. In those cases, write the serial number and part number from the side of the inflator box on the R.O. The part number always starts with 047.

2. Peel the label located inside the inflator box from its backing and attach it to the R.O. For the warranty claim to be paid, the **replacement inflator part number that you received** must be on the warranty claim and your warranty clerk must enter the serial number in the Diagnostic Trouble Codes field.

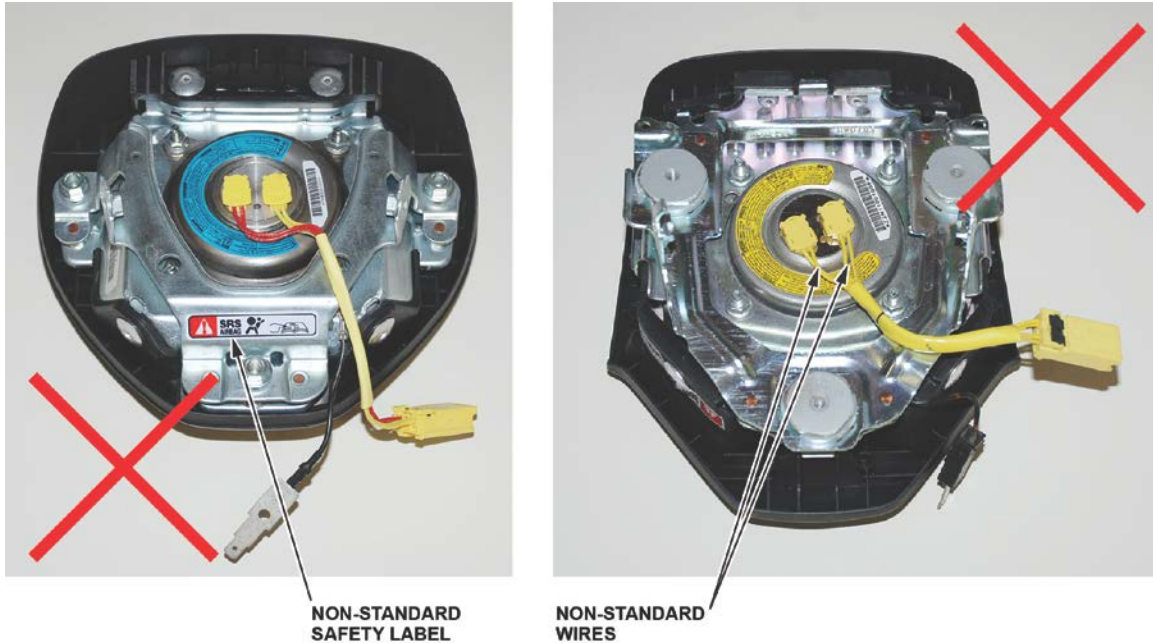
4. Visually inspect the airbag and the inflator for any unusual writing or markings.
 - If there is nothing unusual about the airbag or the inflator, go to step 5.
 - If there are any unusual markings, like an incorrect label or a model year written in marker, the airbag and inflator may not be the correct airbag and/or inflator for the vehicle or it may be a counterfeit part. For more information about counterfeit airbags, you can refer to safercar.gov, enter keywords **MANAGING COUNTERFEIT**, and select **Recommended Dealer Guidance for Managing Counterfeit Air Bags** from the list. **If you suspect that the airbag or inflator is counterfeit, do not continue this procedure.** Contact your DPSM for assistance.

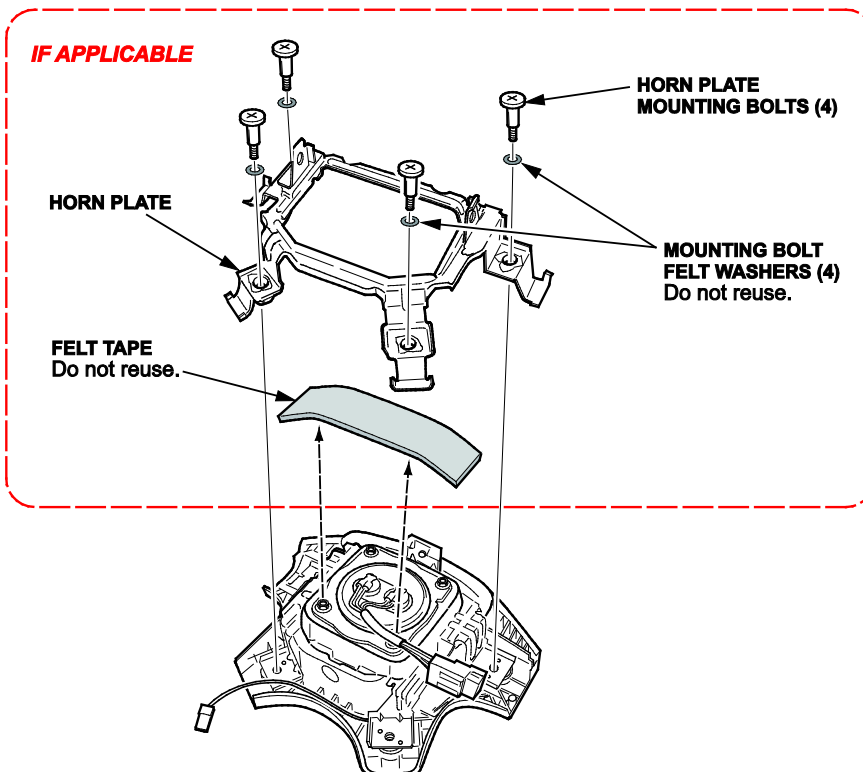
5. If there is no horn plate installed, go to step 7. If there is a horn plate installed, remove the four horn plate mounting bolts, the mounting bolt felt washers, the horn plate, and remove the felt tape covering the lower two inflator locknuts. The felt washers and felt tape will not be reused.

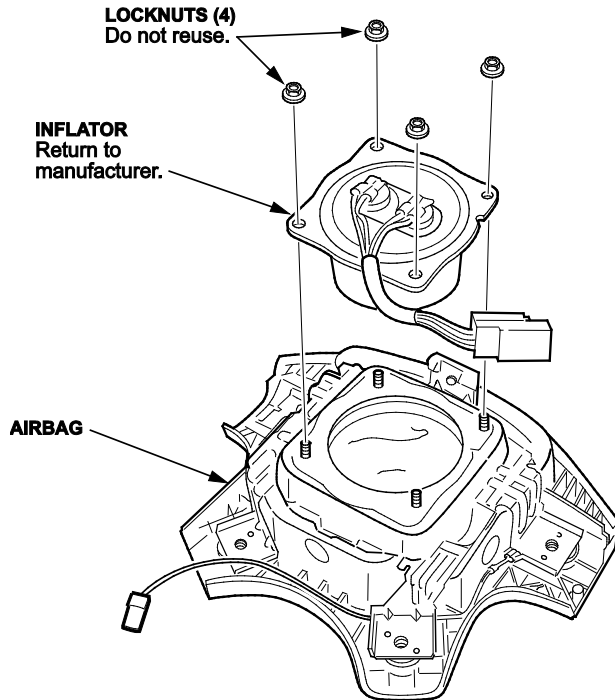
- Using needle-nose vise grips or a 3/8 in. 6-point socket, remove the four locknuts from the inflator. The locknuts will not be reused.

NOTE: Do not remove the inflator from the airbag until you complete step 7.

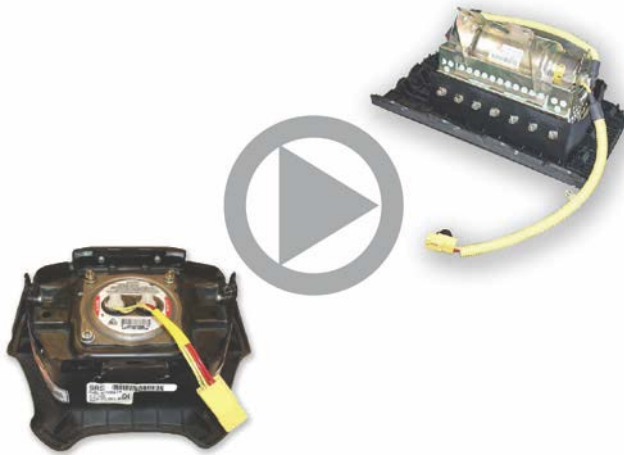
NOTE: There may be some minor surface rust or corrosion on the new inflator; this is OK.
Click on the image below for a short video about the different inflators.

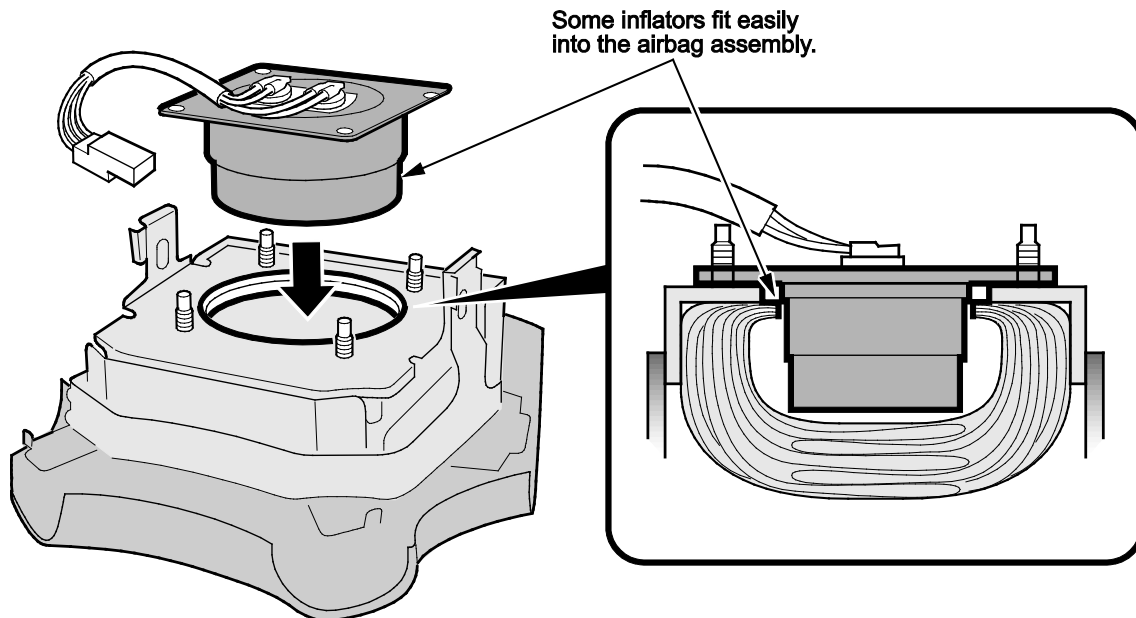
- Insert the inflator into the opening.

NOTE: Make sure the inflator wires are positioned toward the bottom of the airbag. If you install the inflator incorrectly, you may not be able to reconnect the SRS airbag harness.

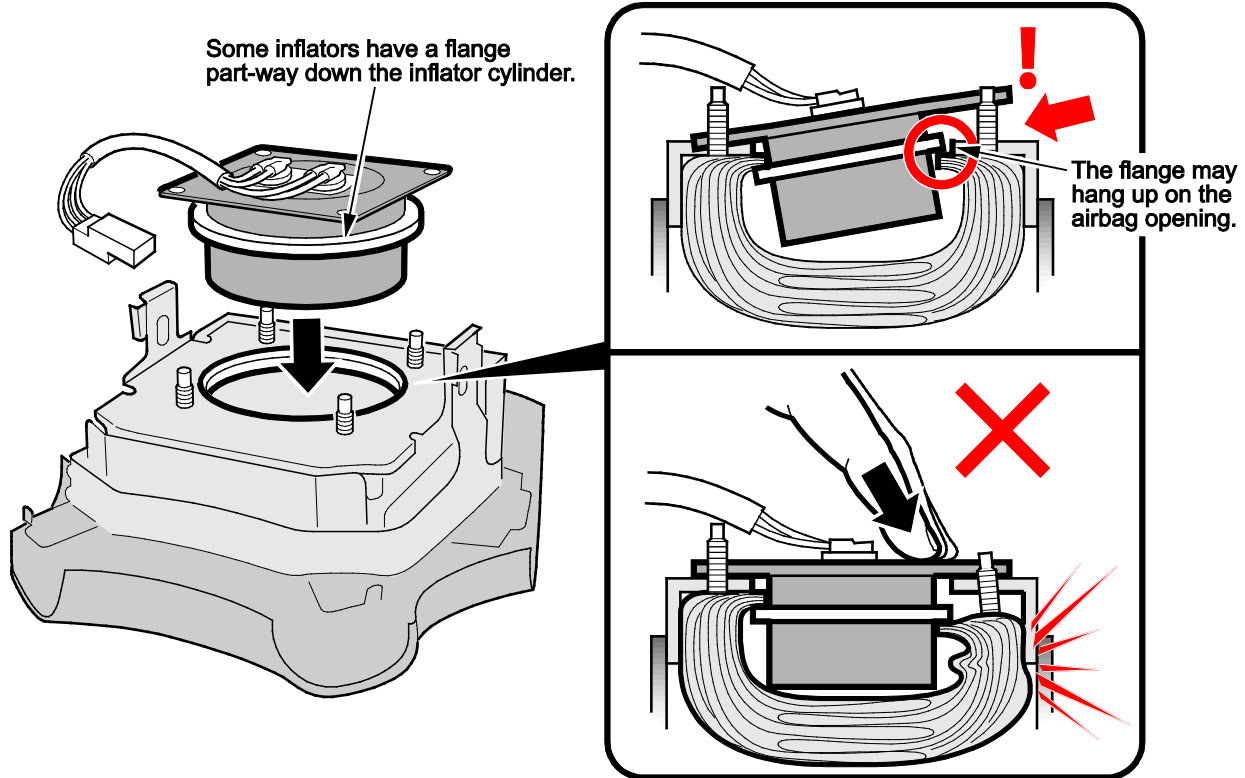
- Insert the inflator into the opening. Do not force it into the airbag module.

NOTE: Make sure the inflator wires are positioned toward the bottom of the airbag. If you install the inflator incorrectly, you may not be able to reconnect the SRS airbag harness.

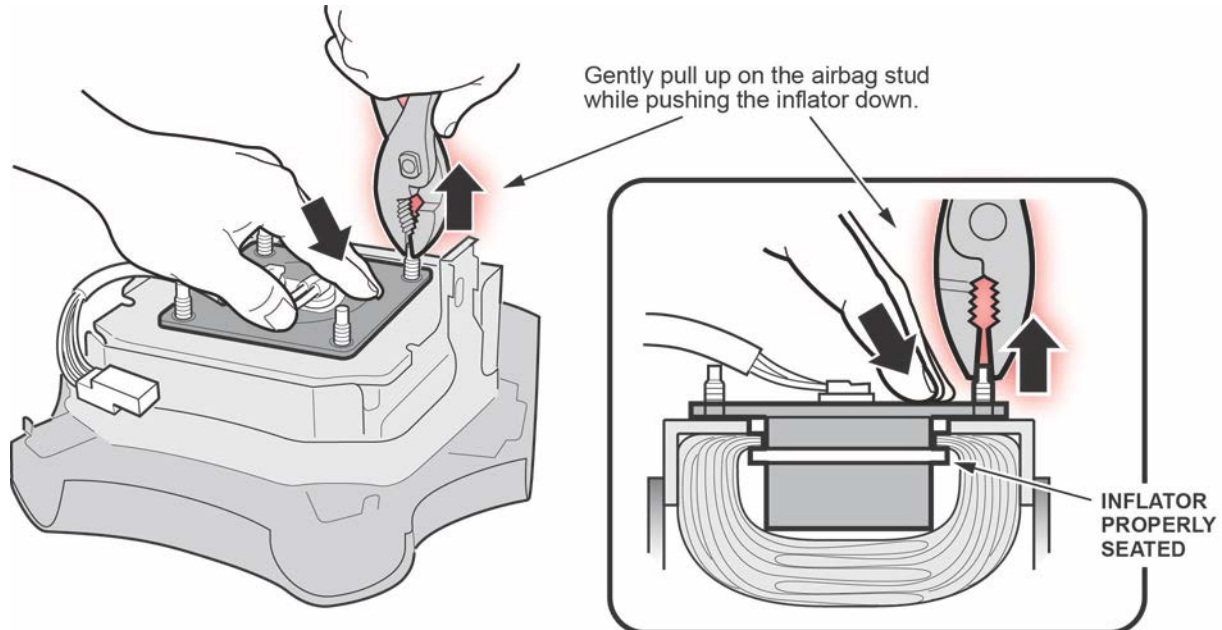
- Using a pair of pliers, gently pull up on each stud up while pushing the inflator module down until the airbag is properly seated within the airbag module.

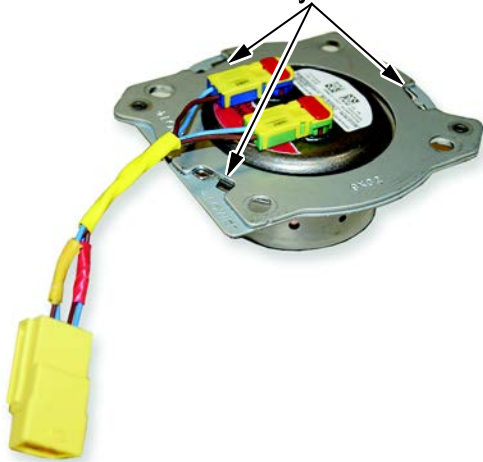
The inflator is held down by a directional retainer that is keyed to the inflator.

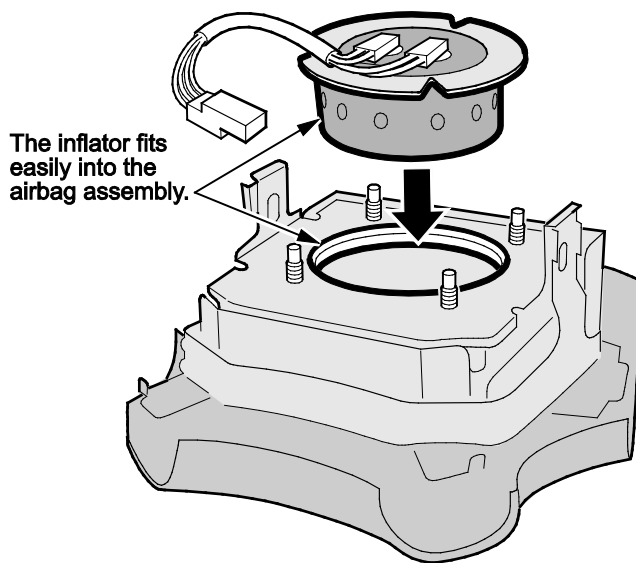
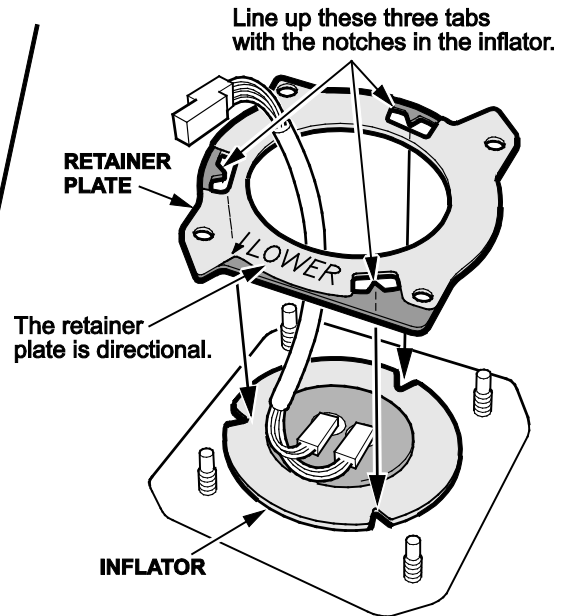
- Place the inflator into the opening with the inflator harness toward the bottom of the airbag.

- Install the bracket onto the studs with the stamp **LOWER** at the bottom of the airbag.
- Make sure the three tabs and notches are properly aligned.

- The tabs and notches are designed to align in one direction only. If the tabs and notches are not aligned, the inflator and bracket are not installed correctly.
- Make sure the harness comes out through the center opening. Do not install the bracket over the harness wires.
