May 1, 2015

51969-01908 Version 6

Recall: Front Passenger's Airbag Inflator May Produce Excessive Pressure After Long-Term Exposure To High Absolute Humidity

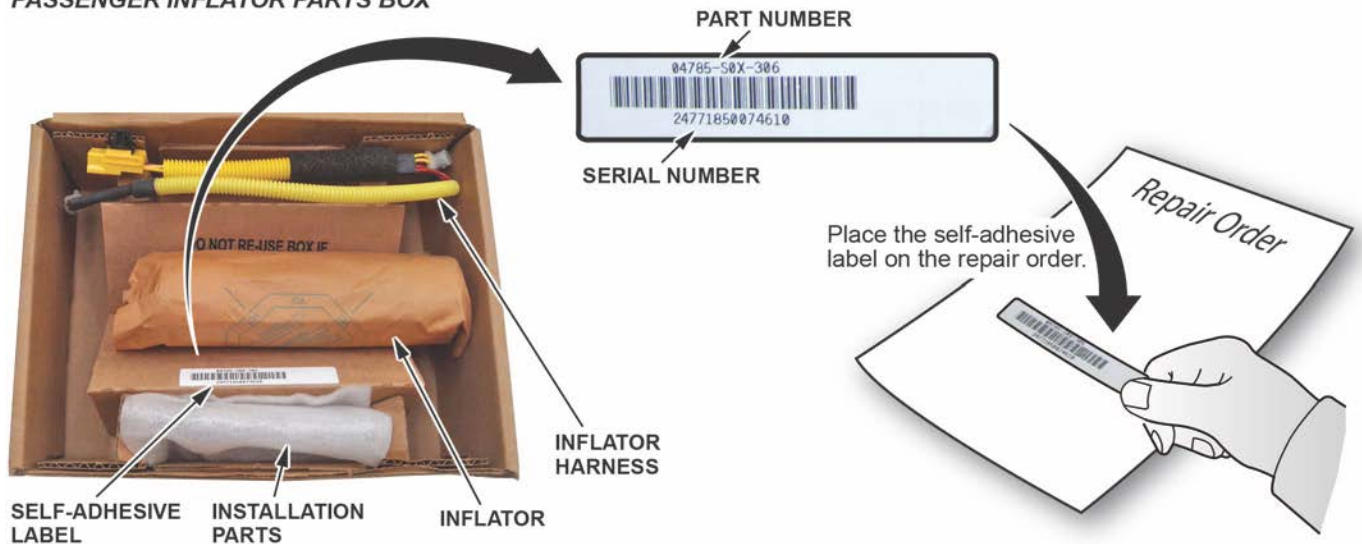
PASSENGER INFLATOR PARTS BOX

- The replacement part number is printed on the top part of the label and the serial number is printed on the bottom. **Make sure you attach the label to the R.O. and give it to the warranty clerk.**
- There may also be a colored sticker located in the kit, ignore it because it is not used.
- Not all inflator kits have a label included. In those cases, write the serial number and part number from the side of the inflator box on the R.O. The part number always starts with 047.

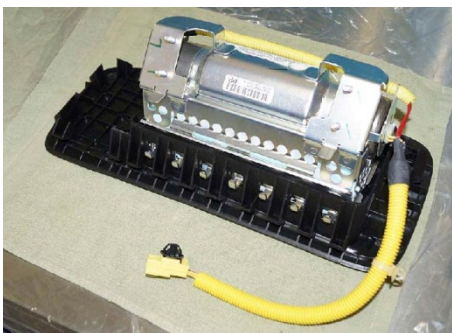
2. Remove the front passenger's airbag.
3. Place the airbag face-down on a clean shop towel as shown.

- The orientation of the airbag is critical because if the inflator is installed incorrectly, the harness will be too short when you reinstall the airbag.
- The brackets between the various models are similar but may differ from the example shown.

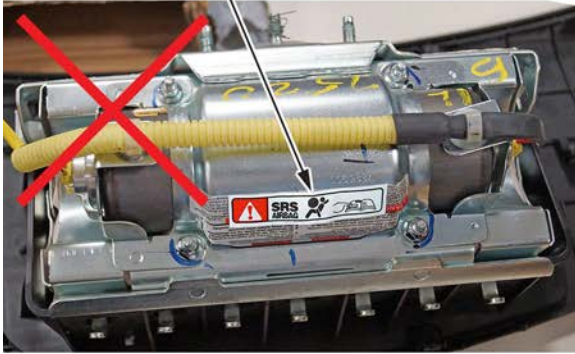
NON-STANDARD SAFETY LABEL

4. Visually inspect the airbag and the inflator for any unusual writing or markings.
 - If there is nothing unusual about the airbag or the inflator, go to step 5.
 - If there are any unusual markings, like an incorrect label or a model year written in marker, the airbag and inflator may not be the correct airbag and/or inflator for the vehicle or it may be a counterfeit part. For more information about counterfeit airbags, you can refer to safercar.gov, enter keywords **MANAGING COUNTERFEIT**, and select **Recommended Dealer Guidance for Managing Counterfeit Air Bags** from the list. **If you suspect that the airbag or inflator is counterfeit, do not continue this procedure.** Contact your DPSM for assistance.

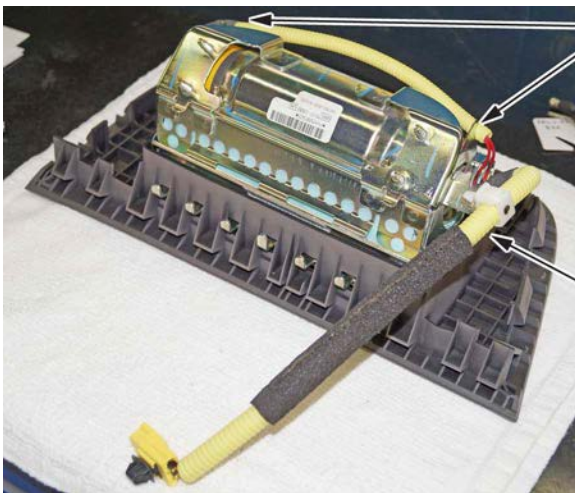
INFLATOR BRACKETS

5. Remove the harness from both ends of the inflator bracket.

Disconnect and remove the harness clip if applicable.

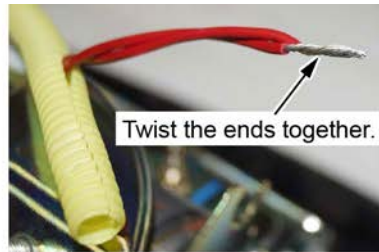
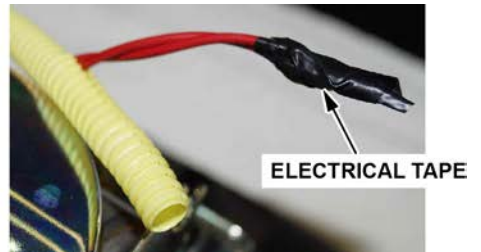
- Strip away about 1 inch of the wire insulation, then twist the wires together.

- Tape the twisted ends with electrical tape.

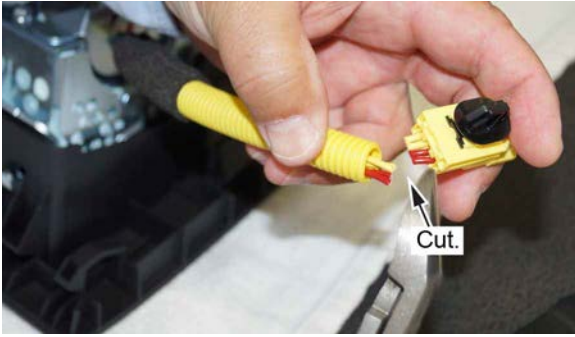
7. Cut off the connector and short the yellow wires.

You must cut and short the wires as indicated to prevent accidental deployment.

- Cut all four wires to remove the connector.

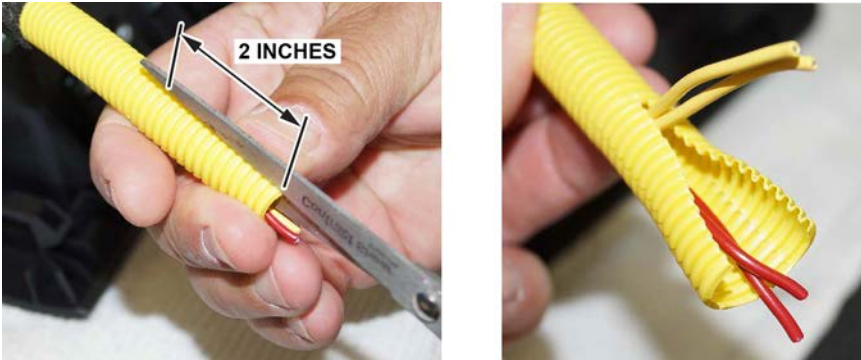
- Cut about 2 inches of the corrugated tube, then pull out the yellow wires.

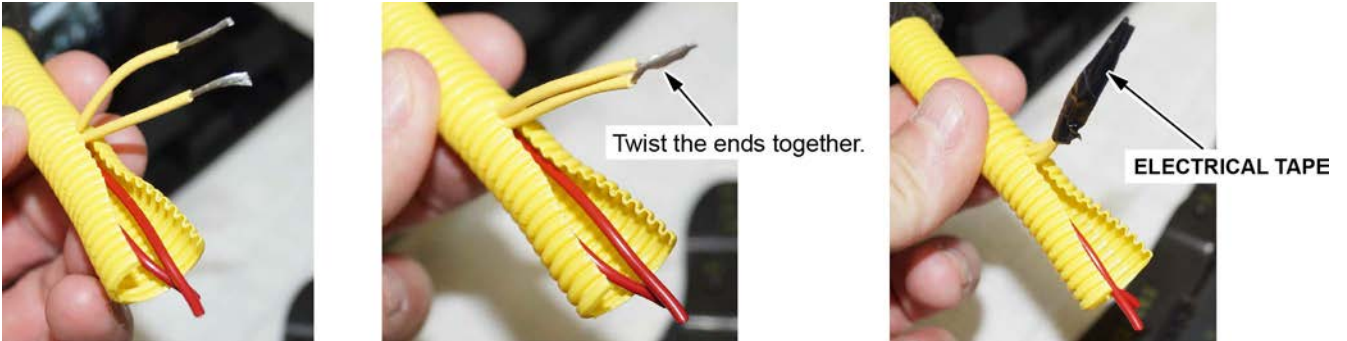
- Strip away about an inch of the wire insulation, then twist the wires together.

- Tape the twisted ends with electrical tape.

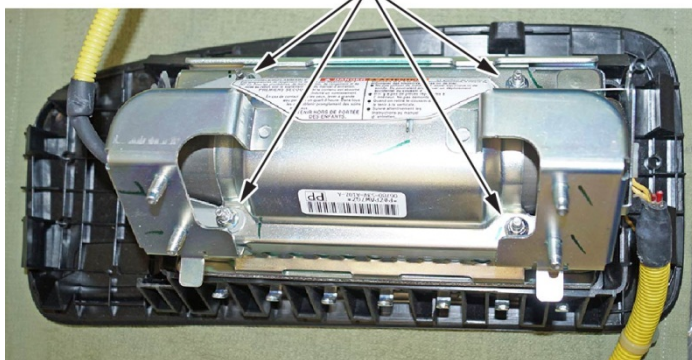
INFLATOR NUTS

8. Remove the four inflator nuts.

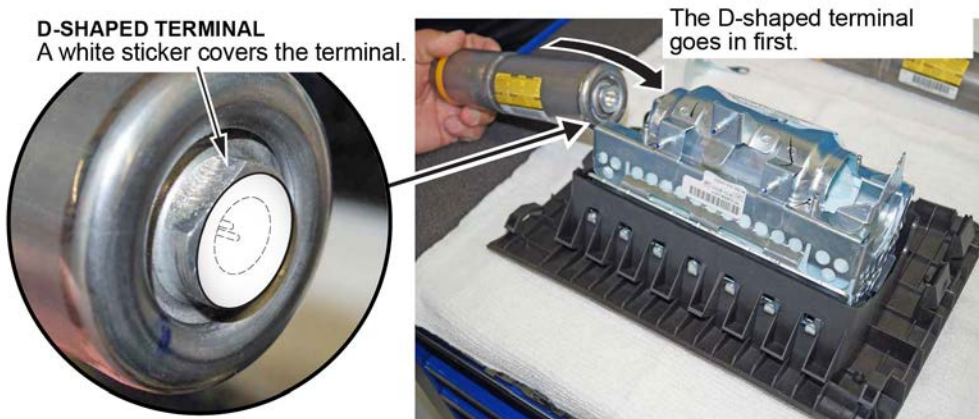
11. Install the new inflator.

- One connector looks like a “D” whereas the other connector is a circle. Make sure you insert the “D” connector into the airbag first.

NOTE: There is a yellow band marking on the circle side.
