Service Bulletin

Applies To: **2014–15 RLX** – ALL

P-AWS RTC Actuators Moan When Making Small Turns

(Supersedes 13-041, dated March 14, 2015, to revise the information marked by the black bars)

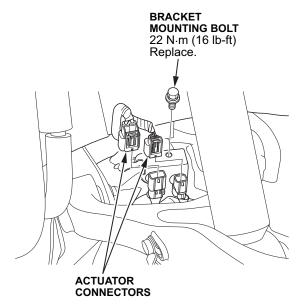
- 1. Raise the vehicle on a lift, and make sure it is securely supported.
- 2. Remove both rear wheels.
- 3. Disconnect the RTC actuator connectors.
- 4. Remove the RTC actuator harness bracket bolt.

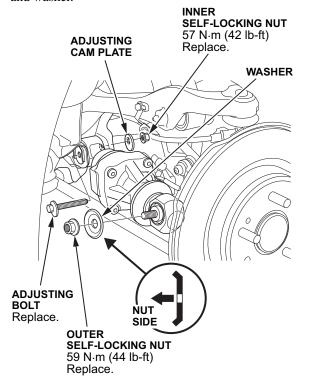
- 5. Note and mark the position of the adjusting cam plate and adjusting bolt in reference to the frame.
- Remove the RTC actuator outer self-locking nut and washer.

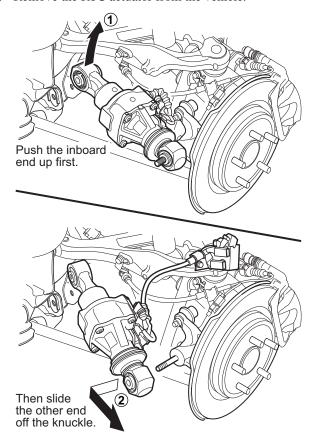
- 7. Remove the inner self-locking nut, the adjusting cam plate, and the adjusting bolt.
- 8. Pry on the RTC actuator to remove it from the inner mount.

NOTE: Do not loosen or remove the lower arm bolts.

9. Remove the RTC actuator from the vehicle.

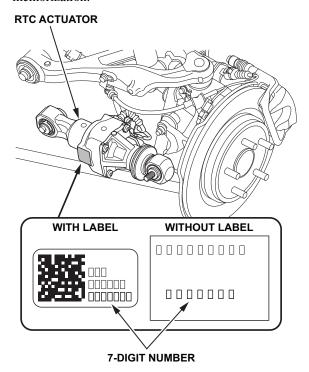
Write down the seven-digit number ID of each new RTC actuator for the neutral position wheel memorization.

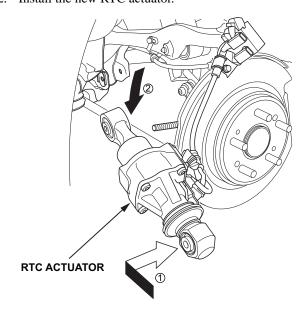
2. Install the new RTC actuator.

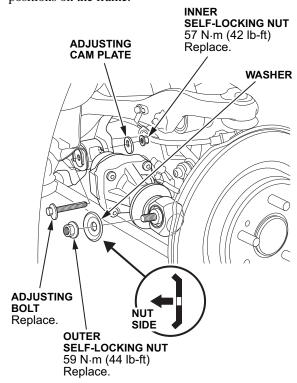
3. Loosely reinstall the original adjusting cam plate using a new inner self-locking nut, and a new adjusting bolt.

NOTE: Align the cam positions of the new adjusting bolt and the adjusting cam plate with the marked positions on the frame.

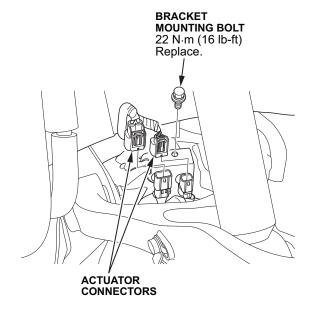
- 4. Loosely install the new outer self-locking nut and the original washer.
- 5. Install the new actuator harness bracket mounting bolt and torque it to 22 N•m (16 lb-ft), then connect the connectors.
