April 14, 2015

ATB 51971-01676 Version 7

Recall: Driver's Airbag Inflator May Produce Excessive Pressure After Long-Term Exposure to High Absolute Humidity

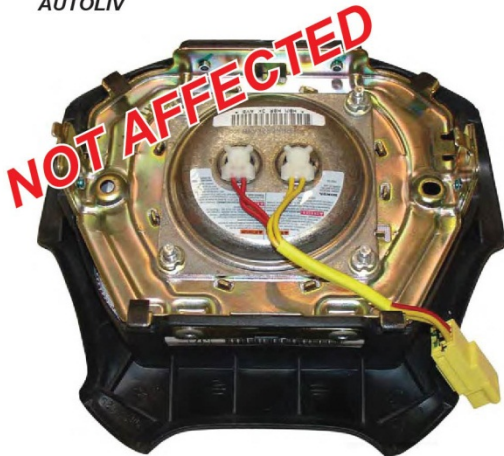
AUTOLIV

NOTE: The Autoliv serial number label is different from the Takata label; the Autoliv has 11 characters, the Takata has 9.

- If the airbag is made by Autoliv, the airbag is OK. Reinstall the airbag using new Torx bolts. Torque the bolts to **9.8 N·m (7.2 lb-ft)**. If you already received a replacement inflator, return the unopened kit to American Honda.
- If the airbag is made by Takata, go to step 6.
