AT15-007q

March 31, 2017

2013 JX35 AND 2014 – 2017 QX60; CVT JUDDER AND DTC P17F0 OR P17F1 STORED

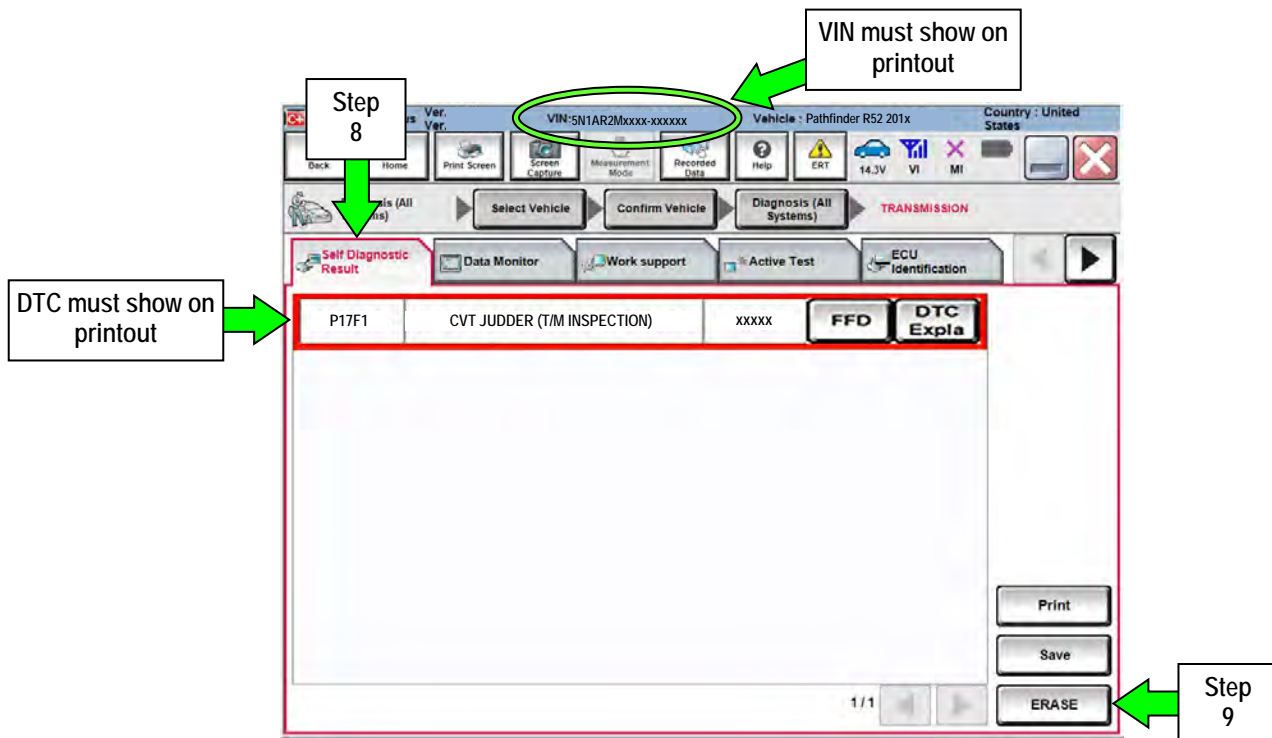
Figure 3

8. Select the **Self Diagnostic Result** tab, print the screen showing the VIN and DTC, and then attach the printout to the repair order.

9. Print a screen shot.

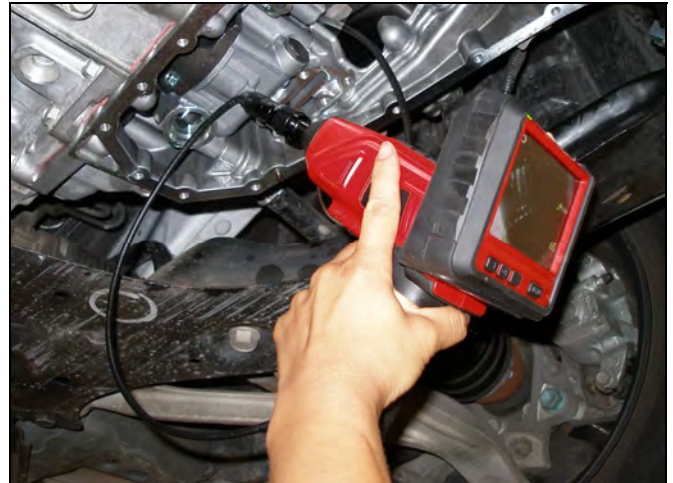
Figure 11

- Holding the borescope with one hand allows for turning the tire with the other hand (see Figure 11).

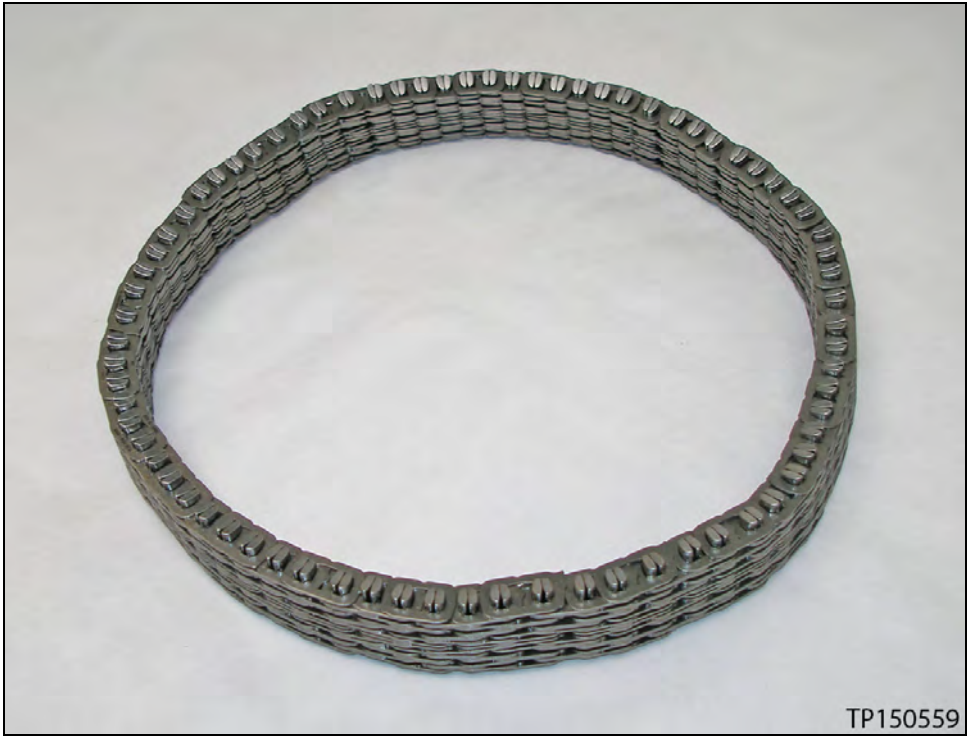
TP150559

Figure 14: CVT chain

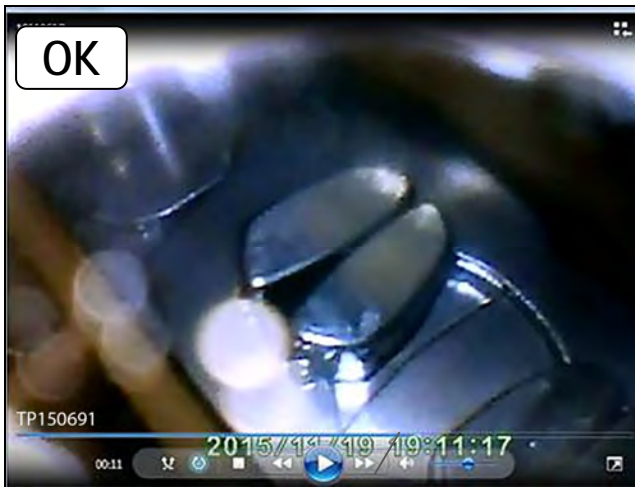
Pictures in Figure 16 and 17 were taken with borescope J-51951.

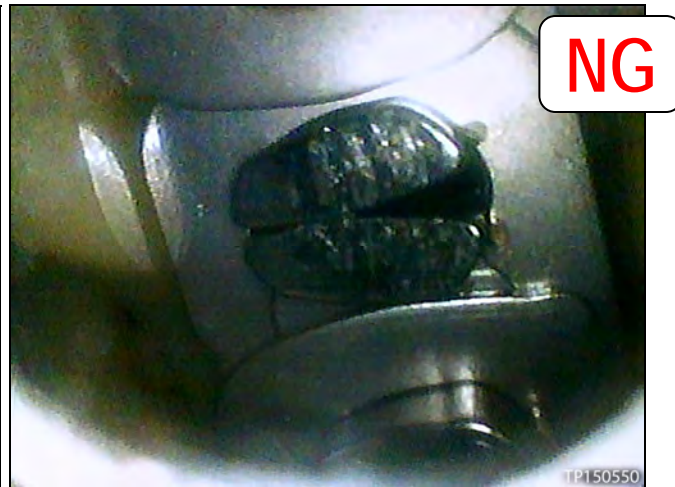
Pictures in Figure 20-21 were taken with borescope J-51951.
