ITB16-048a

VOLUNTARY SERVICE CAMPAIGN 2013 JX35 AND 2014 QX60; CVT

CAMPAIGN ID #: PC501**APPLIED VEHICLE:** 2013 JX (L50)
2014 QX60 (L50)**Check Service COMM to confirm campaign eligibility.**

Infiniti is conducting this voluntary service campaign on certain specific 2013 JX35 and 2014 QX60 vehicles to reprogram the TCM and, if needed, inspect and replace the CVT or CVT control valve. This service will be performed at no charge to the customer for parts or labor.

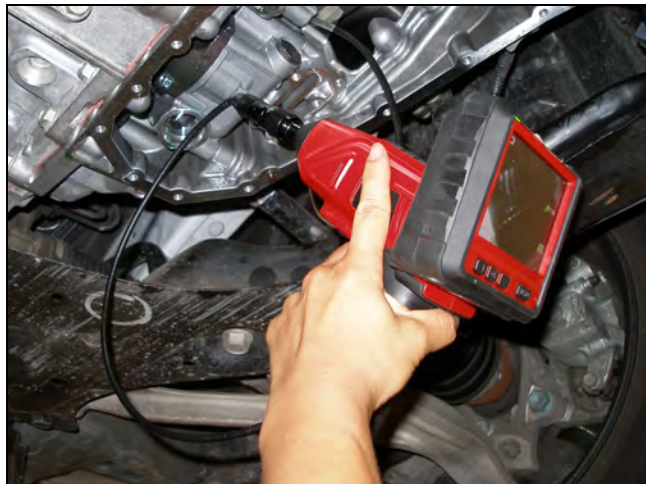
Figure 2C

CAUTION: If the tire is rotated in the rearward rotation, the camera lens may get caught between the chain and pulley.

- Holding the borescope with one hand allows for turning the tire with the other hand (see Figure 2C).

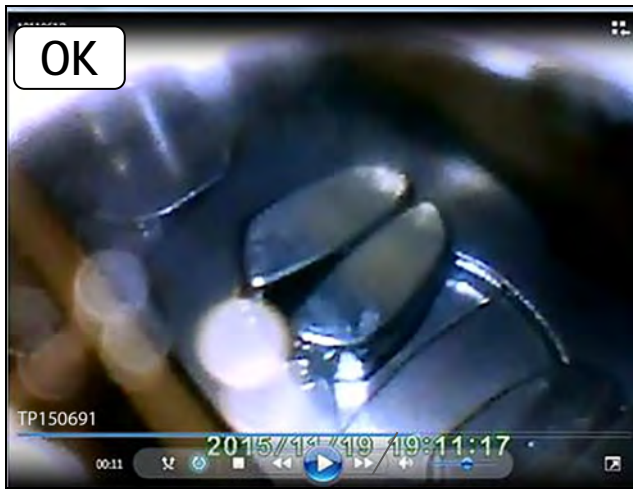
NOTE: Reference the photos on pages 22 – 24 for examples of chain slippage and for comparison to the vehicle you are working on.

Photos in Figure 12C and 13C were taken with borescope J-51951.

- If no evidence of chain slippage is found on both sides of the chain; go to VALVE BODY REPLACEMENT on page 26.
- If any evidence of chain slippage is found, go to step 5 below.

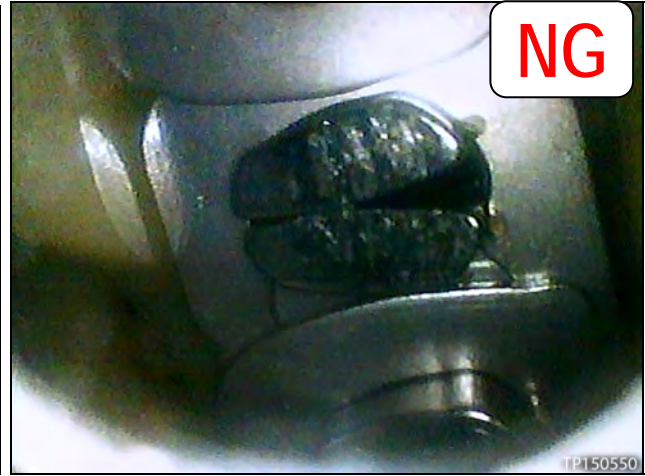
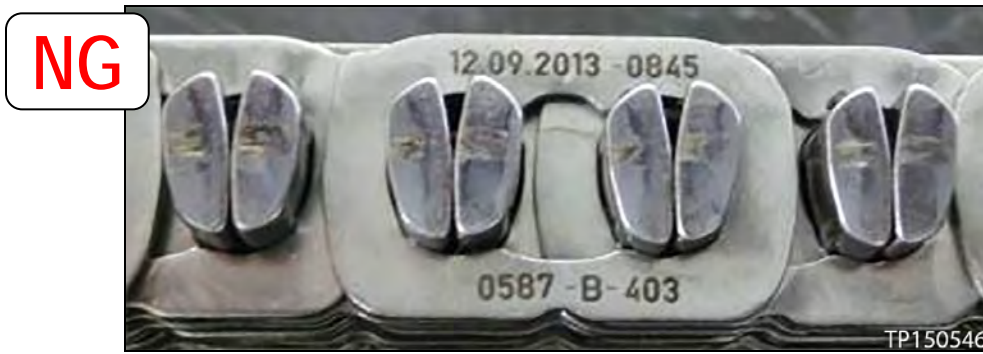
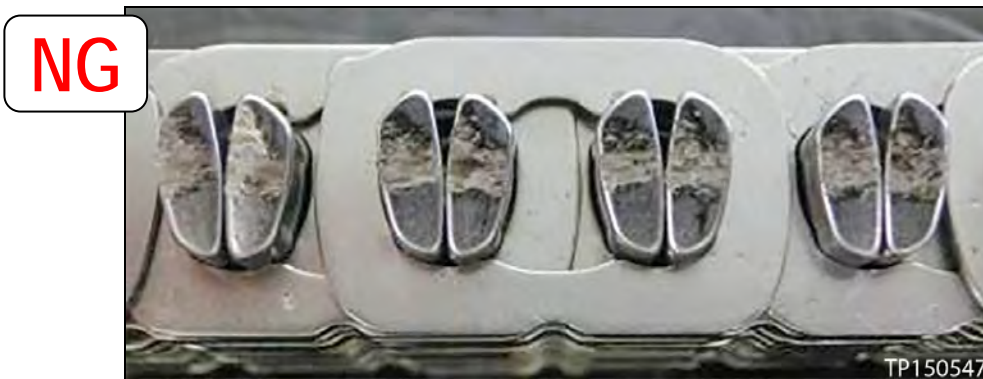
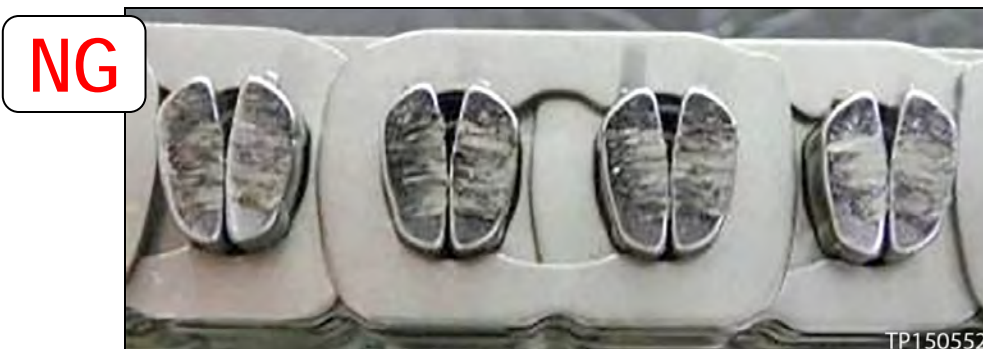
Pictures in Figure 16C – 20C were taken with borescope J-51951.
