ITB16-048b

## VOLUNTARY SERVICE CAMPAIGN 2013 JX35 AND 2014 QX60; CVT

**CAMPAIGN ID #:** PC501  
**APPLIED VEHICLE:** 2013 JX (L50)  
2014 QX60 (L50)

Infiniti is conducting this voluntary service campaign on certain specific 2013 JX35 and 2014 QX60 vehicles to reprogram the TCM and, if needed, inspect and replace the CVT or CVT control valve. This service will be performed at no charge to the customer for parts or labor.

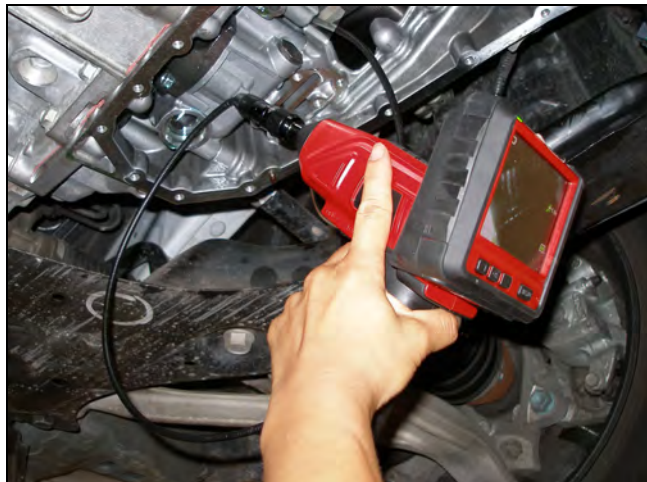
Figure 2C

**CAUTION:** If the tire is rotated in the rearward rotation, the camera lens may get caught between the chain and pulley.

- Holding the borescope with one hand allows for turning the tire with the other hand (see Figure 2C).

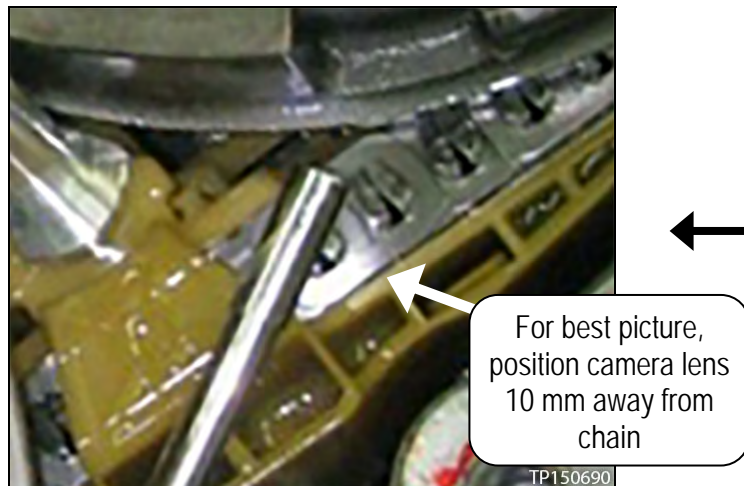
Figure 7C

- Figures 7C and 8C show the routing and location of the camera.

**NOTE:** The CVT's side cover was removed for easier viewing of camera location. The side cover is not to be removed at any time during this procedure.

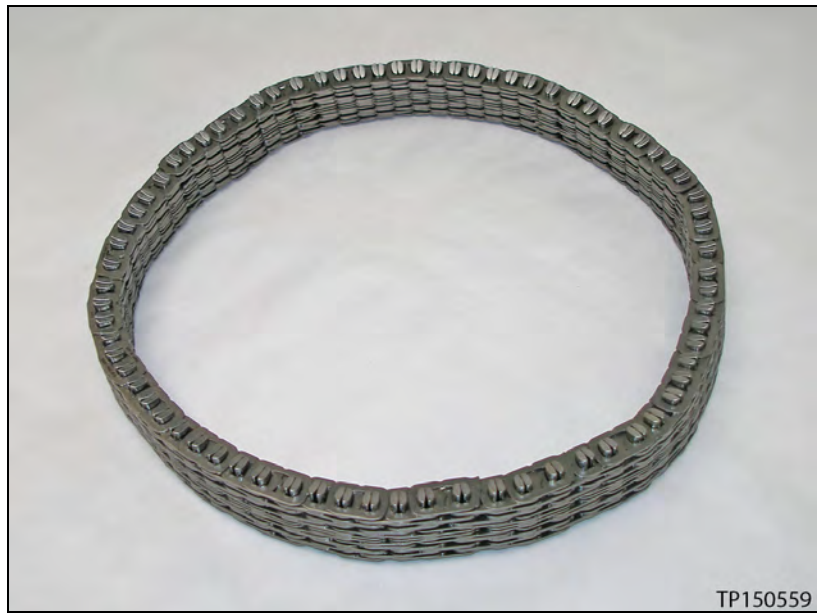
Figure 9C: CVT chain

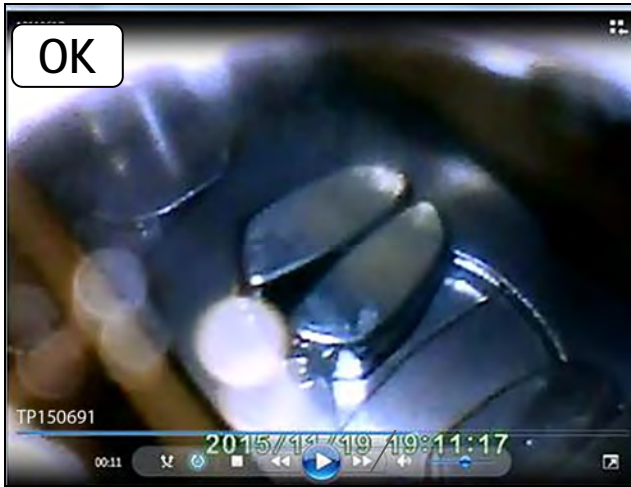
**NOTE:** Reference the photos on pages 22 – 24 for examples of chain slippage and for comparison to the vehicle you are working on.

Photos in Figure 12C and 13C were taken with borescope J-51951.

- If no evidence of chain slippage is found on both sides of the chain; go to VALVE BODY REPLACEMENT on page 26.
- If any evidence of chain slippage is found, go to step 5 below.

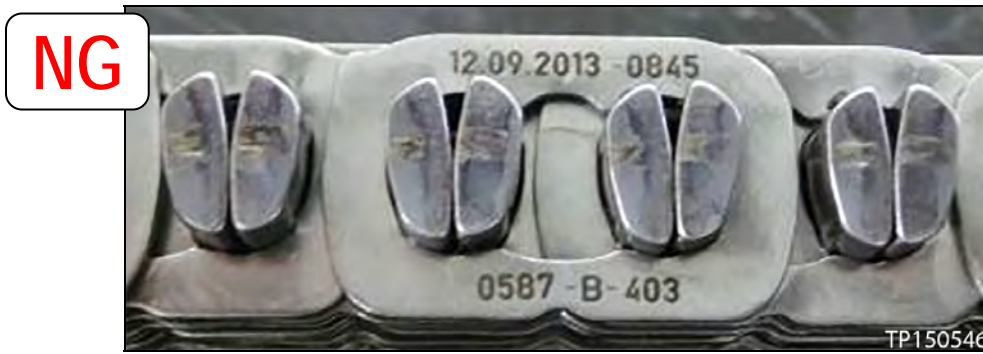
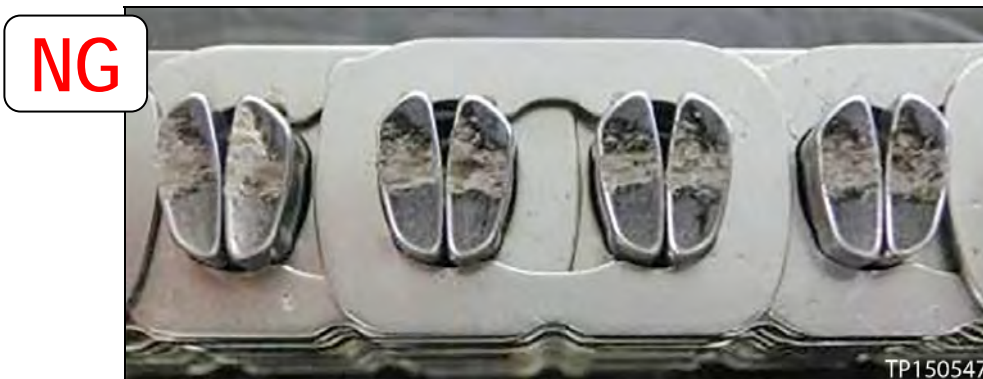
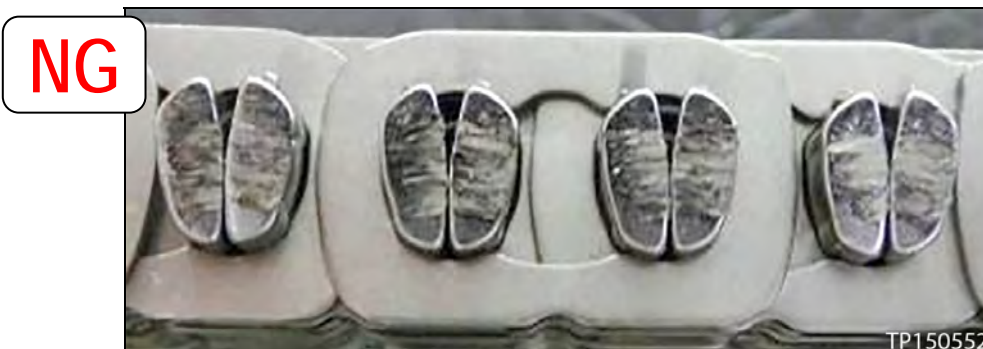
Pictures in Figure 16C – 20C were taken with borescope J-51951.

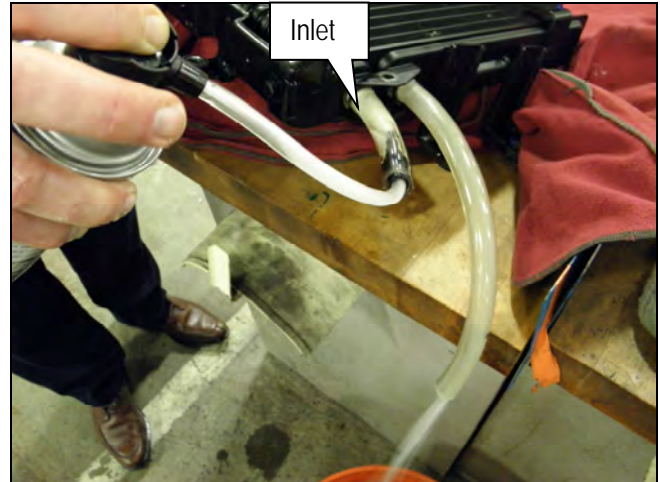
Figure 7E

- Flush from the inlet side of the auxiliary fluid cooler through to the outlet.

27. Allow the remaining fluid in the auxiliary fluid cooler to drain into the catch container.

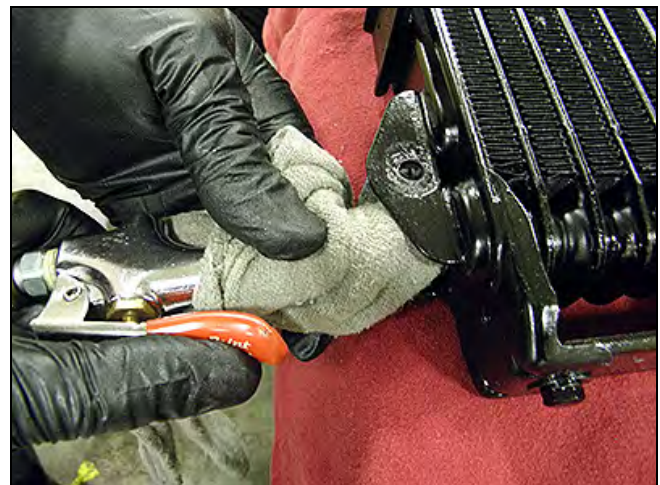
Figure 8E

28. To complete the flush, insert the tip of an air gun again into the end of the fluid cooler inlet (Figure 8E).
29. Wrap a shop rag around the air gun tip and end of the cooler inlet (Figure 8E).
30. Blow compressed air, regulated to 5-9 kg/cm<sup>2</sup> (70 – 130 PSI), through the inlet of the auxiliary fluid cooler for 10 seconds to force out any remaining CVT fluid.
31. Reassemble the auxiliary fluid cooler and CVT fluid cooler bypass valve in the reverse order of disassembly with new O-rings.
  - New O-rings are listed in the **PARTS INFORMATION**.
  - If needed, refer to the ESM, section **TM – Transaxle & Transmission** for correct hose assembly and alignment.
