Classification:  
EM16-009aReference:  
ITB17-002aCOPYRIGHT© NISSAN NORTH AMERICA, INC.  
Date:  
April 11, 2017

## INFINITI; OIL LEAKING AROUND VALVE TIMING CONTROL SOLENOID VALVE

**APPLIED VEHICLES:** 2017 Q60 (V37)  
2016-2017 Q50 (V37)  
2013 JX35 (L50)  
2014-2017 QX60 (L50)  
2017 QX80 (Z62)

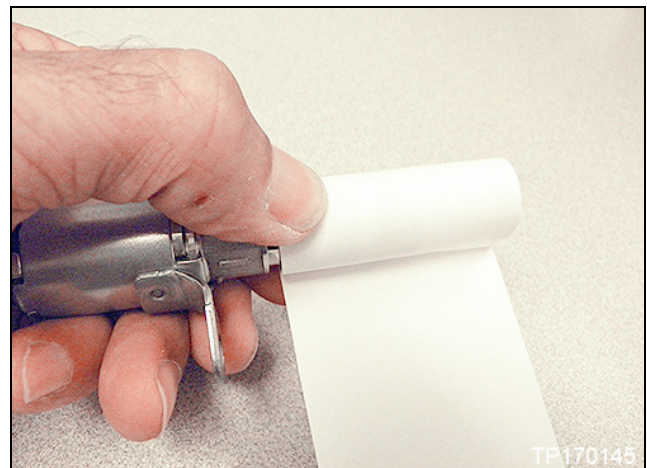
Figure 4

- c. Roll the VTC solenoid valve with the sheet of paper cut in step 5b (Figure 4).
