SERVICE BULLETIN

Classification: AT15-005h	Reference: NTB15-015h	Date: April 27, 2017
------------------------------	--------------------------	-------------------------

PATHFINDER, QUEST, MURANO, MAXIMA, ALTIMA V6; CVT JUDDER AND DTC P17F0 OR P17F1 STORED

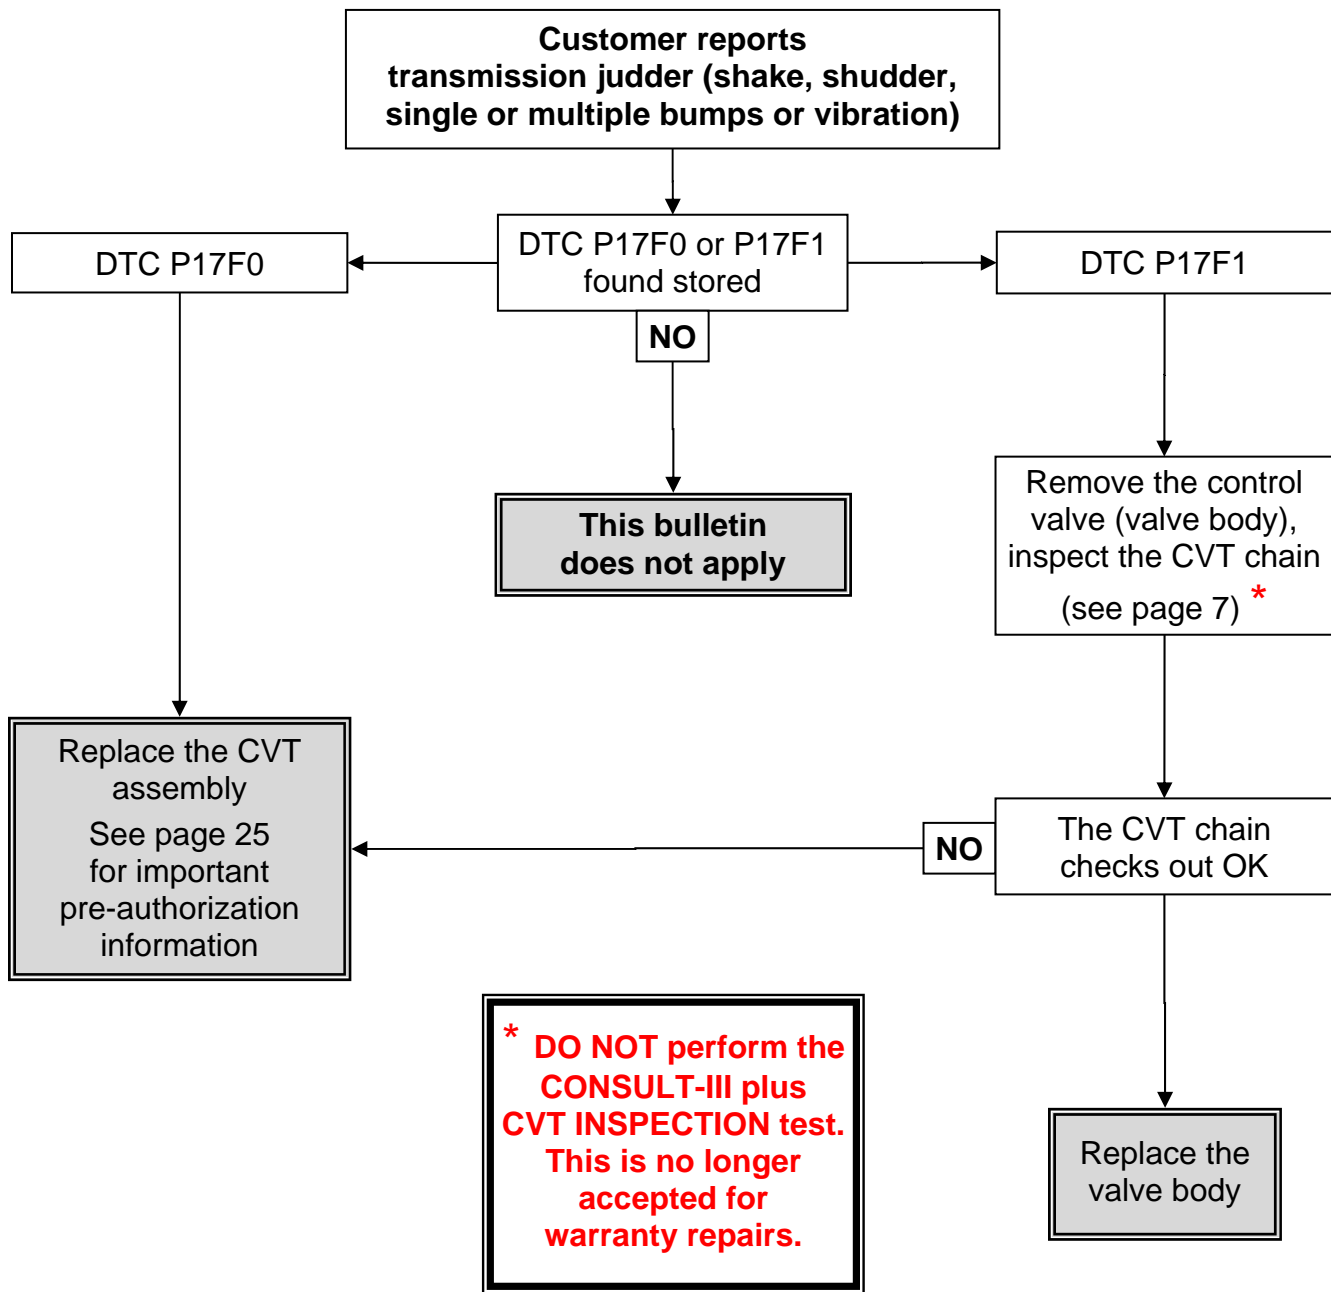
Repair Flow Chart

- Review the **Repair Flow Chart** on this page.

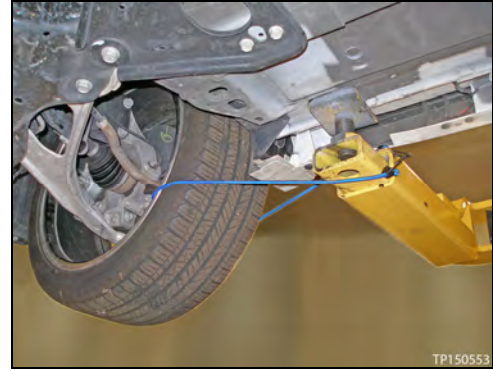
Figure 5

2. Secure the right front tire with a suitable strap.
 - This will assist in making the chain turn.
3. Mark the left front tire with a suitable marking.
 - This will assure all 360° of the chain is inspected.

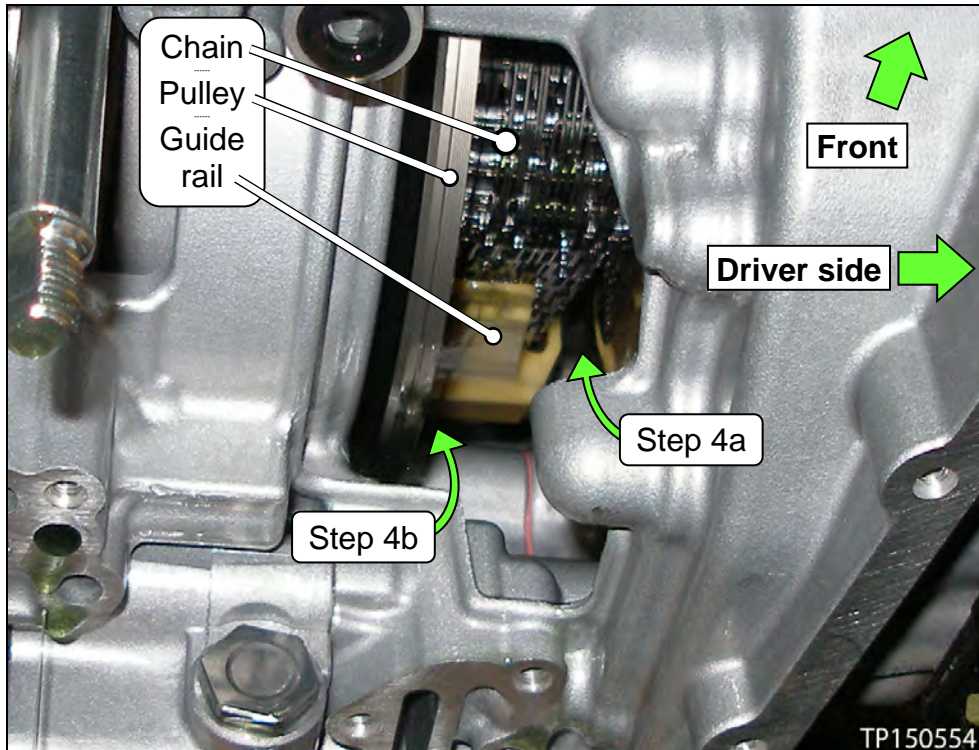
- Insert the camera lens behind the pulley between the guide rail and the pulley where shown in Figure 6 (also see page 9-10, Figure 7-10).
- Insert the lens approximately 8-9 inches, and then view the side of the chain that contacts the pulley.

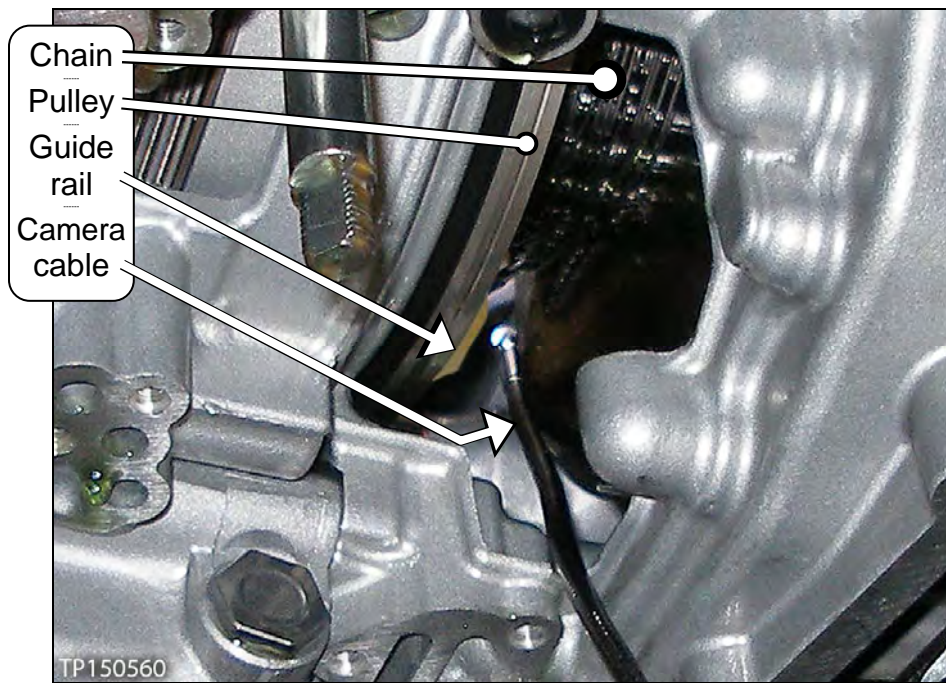
Figure 7

- Figure 8 shows where to insert the camera lens on the driver side of the chain.

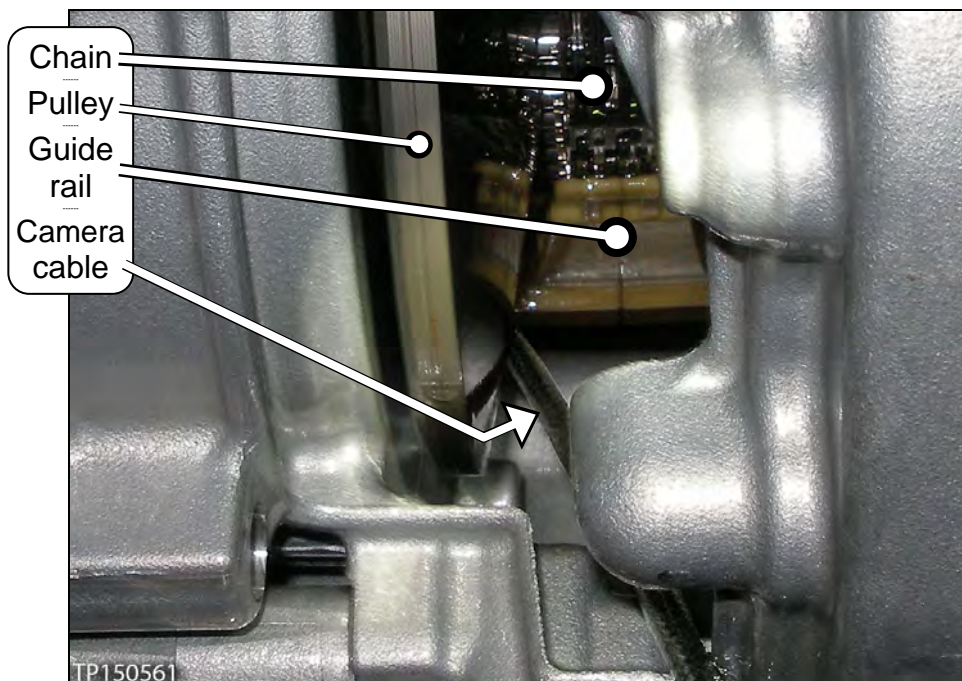
Figure 8

- Figure 9 shows where to insert the camera lens on the passenger side of the chain.

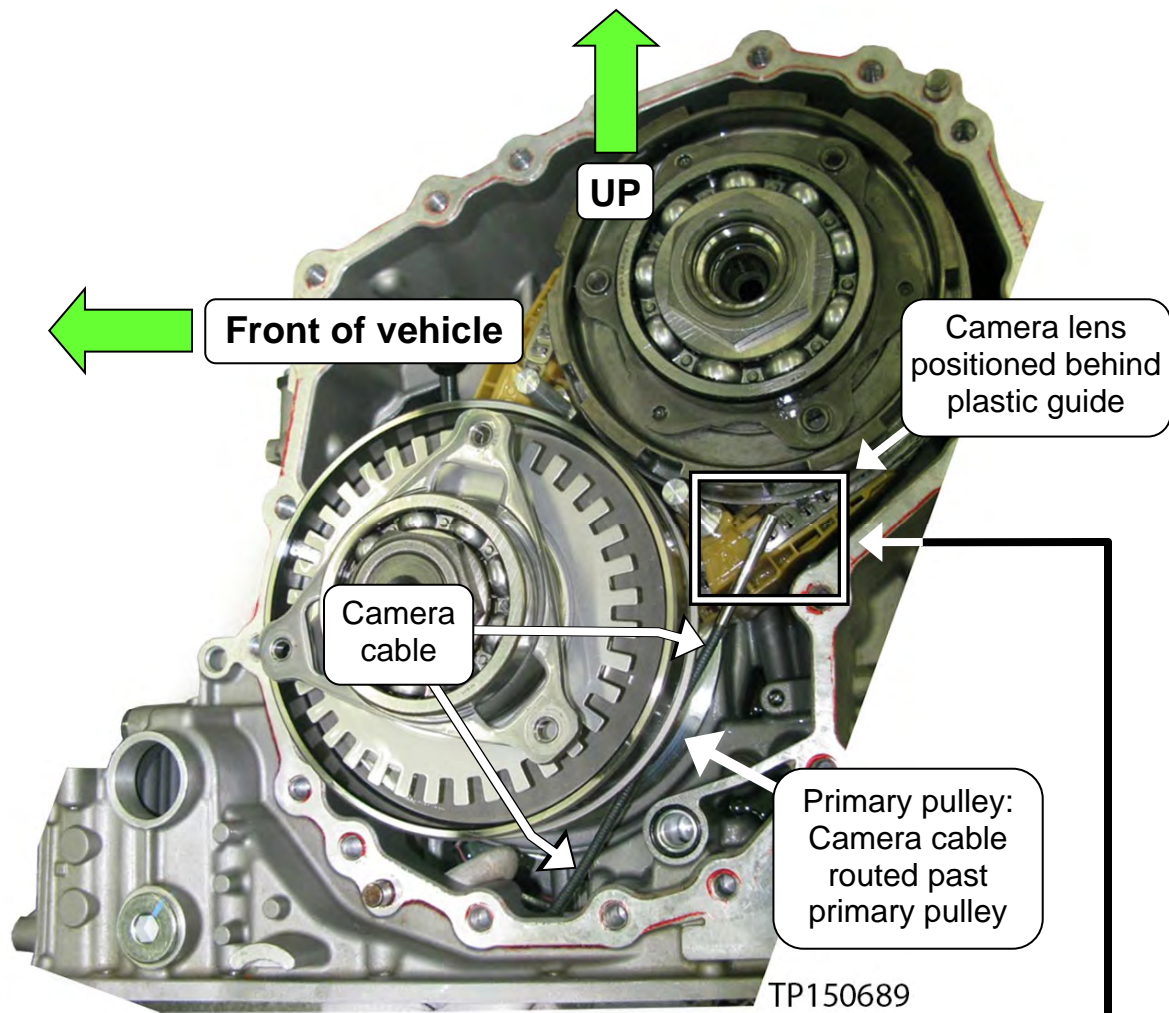
- Figures 9 and 10 shows the routing and location of the camera.

NOTE: The CVT's side cover was removed for easier viewing of camera location. The side cover is not to be removed at any time during this procedure.

4. Using borescope J-51951 with mirror attachment, visually inspect the side of the chain that comes in contact with the pulley:
 - a. First inspect the entirety (360°) of the driver side of the chain that comes in contact with the pulley (see page 10, Figure 9 and 10, and page 12, Figure 13).
 - b. If the inspection result is OK on all 360°, inspect all 360° of the passenger side of the chain.

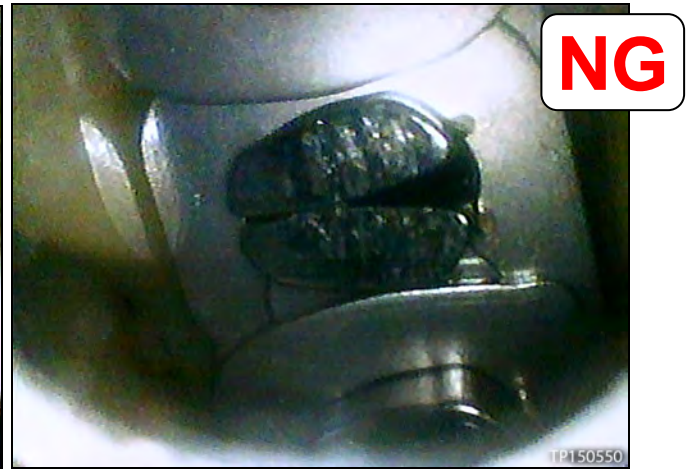
Figure 20

Pictures in Figure 20-21 were taken with borescope J-51951.

NOTE: Reference the pictures on page 13-15 for comparison.

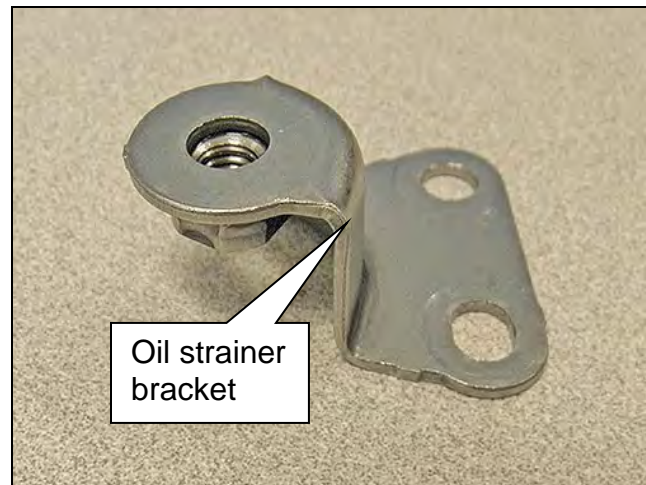
Figure 25

1. Discard the oil strainer bracket (Figure 25).

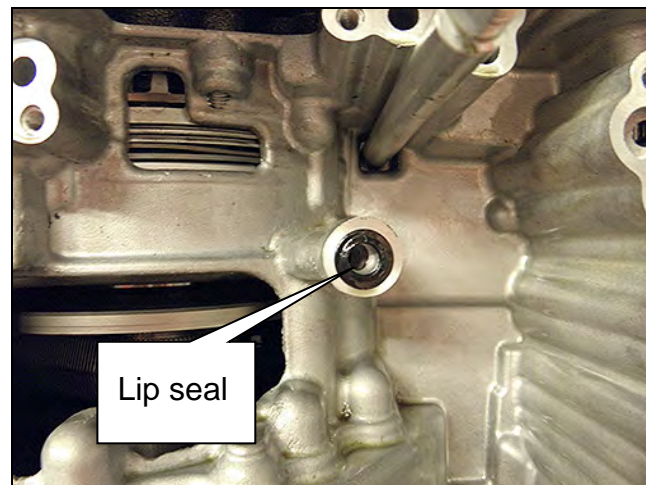
Figure 26

2. Install a new lip seal. Do **NOT** reuse the old lip seal (Figure 26).

NOTE: Apply a small amount of petroleum jelly to the lip seal to keep it in place on the CVT.

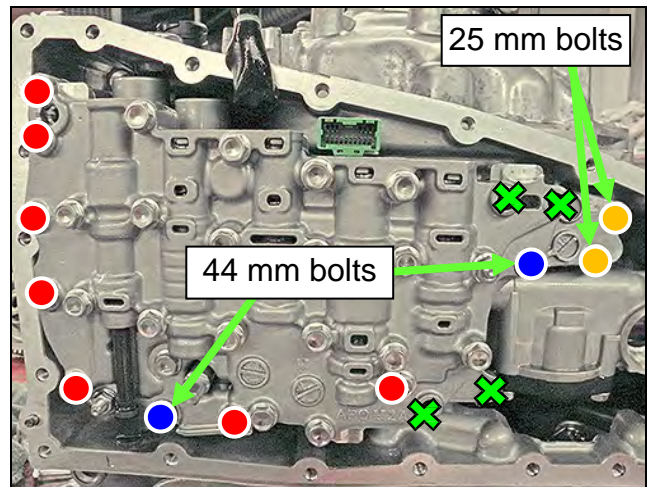
Figure 27

3. Install the Control Valve with eleven (11) mounting bolts (Figure 27).

IMPORTANT: Leave Four (4) ✘ bolt holes blank at this step.

- 54 mm long bolt ● – 7 pieces
- 44 mm long bolt ● – 2 piece
- 25 mm long bolt ● – 2 piece

CAUTION: The two 25 mm bolts are installed WITHOUT the strainer bracket.

- Bolt torque: 7.9 N•m (0.81 kg-m, 70 in-lb.)

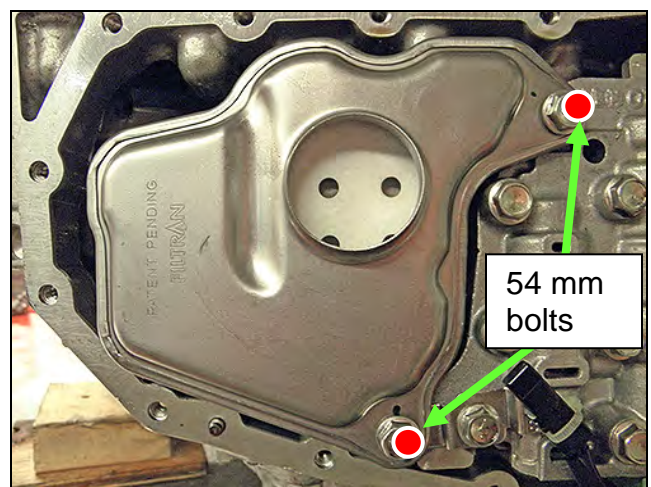
Figure 33

7. Install the new oil strainer with its new O-ring seal with two (2) bolts (Figure 33).

NOTE: replacement strainer maybe a different shape.

- Bolt torque: 7.9 N•m (0.81 kg-m, **70 in-lb.**)
- 54 mm long bolt

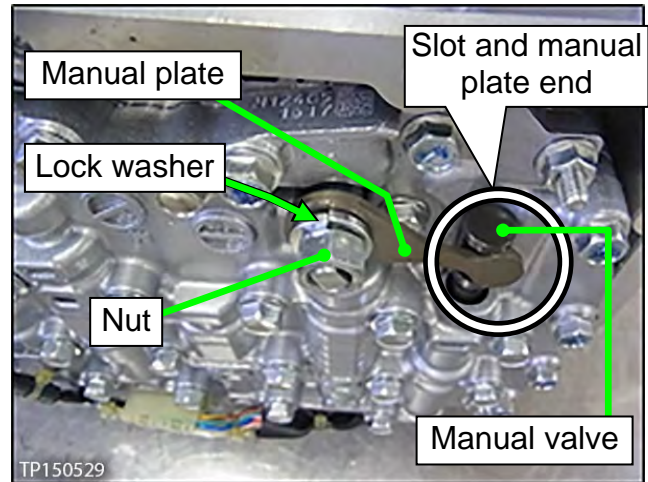
Figure 34

8. Install the manual plate, lock washer, and nut (Figure 34).

NOTE: Make sure the manual plate fits into the slot of the manual valve before applying torque to the nut.

- Reuse the existing manual plate, lock washer, and nut.
- Nut torque: 22.1 N•m (2.3 Kg-m, **16 ft-lb.**)

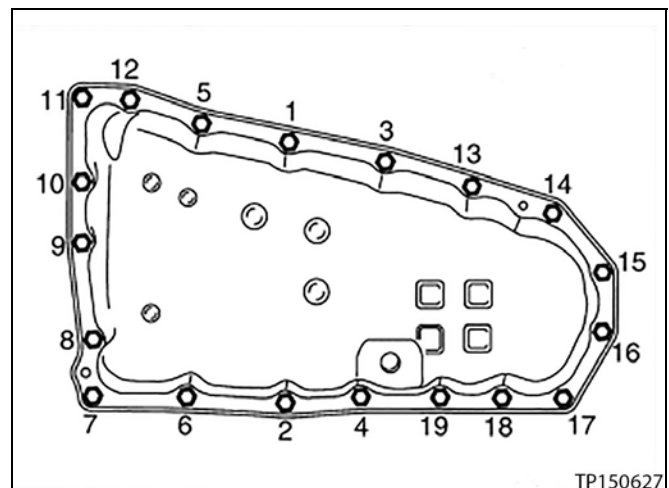
Figure 35

12. Install the oil pan bolts (see Figure 35).

- Reuse the existing pan bolts.
 - Oil pan bolts torque: 7.9 N•m (0.81 kg-m, **70 in-lb.**)
