Thump Noise from Rear as Suspension Returns to Rest Position

Service
Category Brake

Section Brake (rear)

YEAR(S)	MODEL(S)	ADDITIONAL INFORMATION
2010 – 2015	RX350

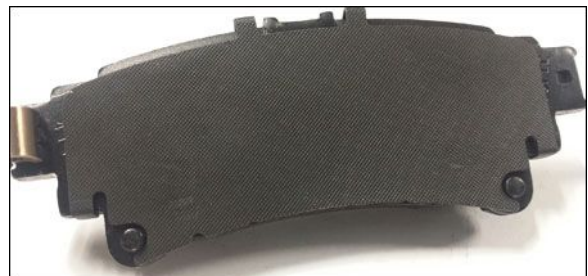
Figure 1. NEW 1-Piece Rear Brake Shim

3. Install the NEW service part Rear Disc Brake Anti-Squeal Shim Kit, Disc Brake Pad Fitting Kit, and Disc Brake Cylinder Mounting Brackets, No. 1 and No. 2 Slide Pins, No. 2 Slide Pin Bushing, and boots for No. 1 and No. 2 Slide Pins and rear brake pads (if need to be replaced).

- When installing the NEW rear brake shims to rear brake pads, do NOT apply disc brake grease to shims or disc brake pad backing plate.
- If reinstalling the USED pads, remove all shim grease from the backing plates BEFORE installing shims.
- *Assemble these parts dry.*

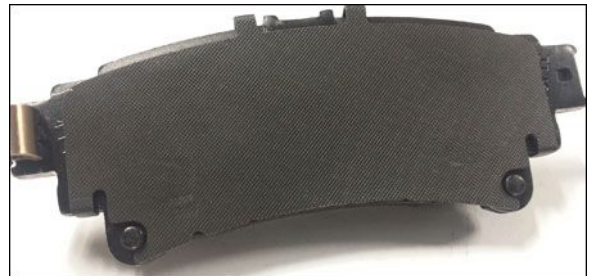
Figure 3. NEW 1-Piece Rear Brake Shim

- [2010 \(12/2008 – 08/2009\)](#) / [2010 \(08/2009 –\)](#) / [2011](#) / [2012](#) / [2013](#) / [2014](#) / [2015](#) RX 350: *Brake – Brake (rear) – “Brake (rear): Rear Brake: Inspection”*
3. Install the NEW service part Rear Disc Brake Anti-Squeal Shim Kit, Disc Brake Pad Fitting Kit, and Disc Brake Cylinder Mounting Brackets.

- When installing the NEW rear brake shims to rear brake pads, do NOT apply disc brake grease to shims or disc brake pad backing plate.
- If reinstalling the USED pads, remove all shim grease from the backing plates BEFORE installing shims.
- *Assemble these parts dry.*
