GROUP	MODEL
СНА	Multiple Models (see table below)
NUMBER	DATE
044 (Rev 1, 06/11/2014)	May 2014

TECHNICAL SERVICE BULLETIN

MDPS FLEXIBLE COUPLING REPLACEMENT

This bulletin provides information related to the replacement of the flexible coupling in the MDPS motor of some of vehicles, which may experience a "clicking" noise emanating from the MDPS when turning the steering wheel left or right, while stopped. This condition may be caused by premature wear of the flexible coupling in the MDPS. To correct this concern, replace the flexible coupling as outlined in this TSB. Refer to the table below for production dates and a breakdown of replacement procedures by model.

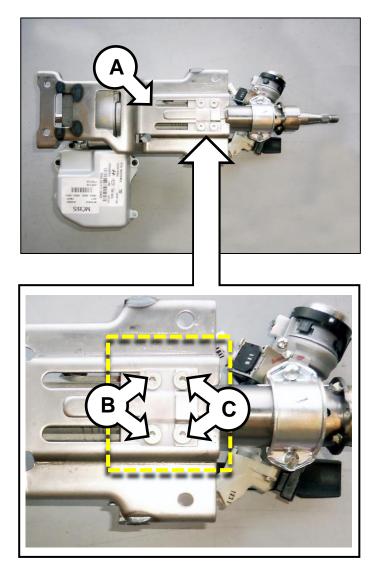
Locate the steering column guide bracket (A) and remove four (4) Torx[®] head screws (B/C) securing it to the steering column.

> Tightening torque: B: 3.6 lb-ft (4.9 Nm) C: 2.2 lb-ft (2.9 Nm)

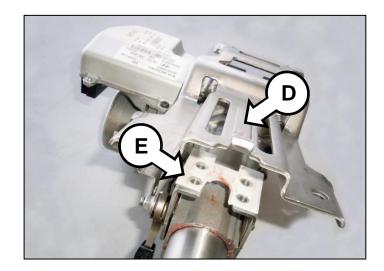
Lift the steering column guide bracket (D) and remove the plastic spacer (E). Retain all parts as they will be reused.

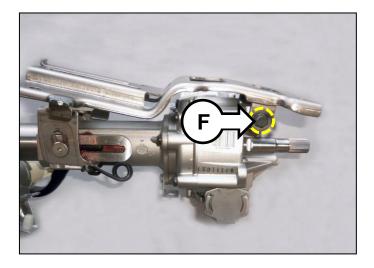
4. Remove the steering column guide bracket hinge bolt (F).

Tightening torque: 13~14.5lb-ft (17.7~19.6 Nm)

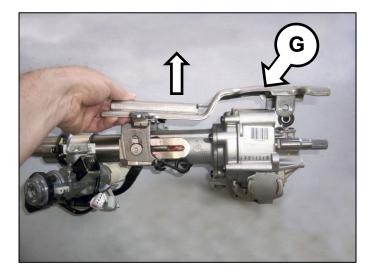
5. Remove the steering column guide bracket (G) from the steering column.

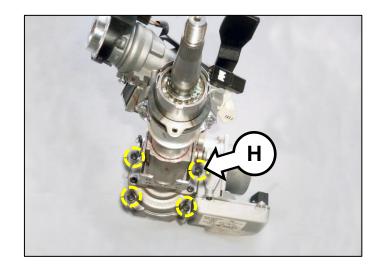
Hold the MDPS upright and loosen four Torx[®] head screws (H) securing the column to the motor housing.

> Tightening torque: 6.5~9.4lb-ft (8.8~12.7 Nm)

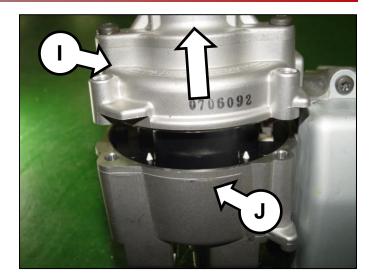
7. Separate the upper half (I) of the motor housing from the lower half (J).

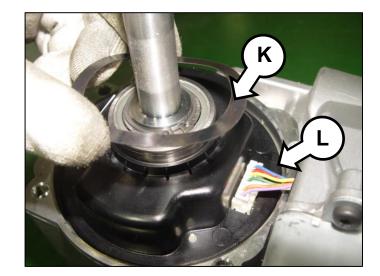
8. Remove the washer-gasket (K) and connector (L) from lower portion of the MDPS.

To avoid damage, use caution when removing the connector.

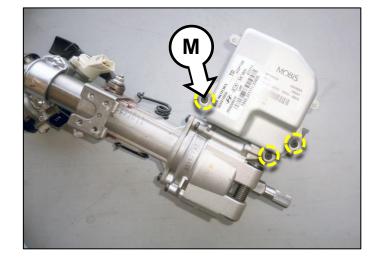
Remove three (3) Torx[®] head screws (M) securing the MDPS ECU cover.

Tightening torque: 3.6~5.1lb-ft (4.9~6.9Nm)

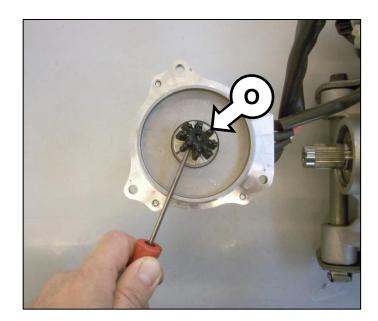
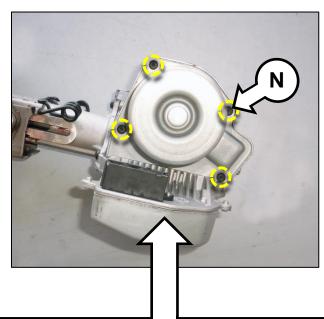
10. Remove four (4) Torx[®] head screws (N) securing the MDPS motor cover.

Tightening torque: 3.6~5.1lb-ft (4.9~6.9Nm)

11. Remove the MDPS motor cover.

Remove the original flexible coupling (O) from the housing. In addition, use an air gun to remove any foreign matter from the motor and/or the housing.

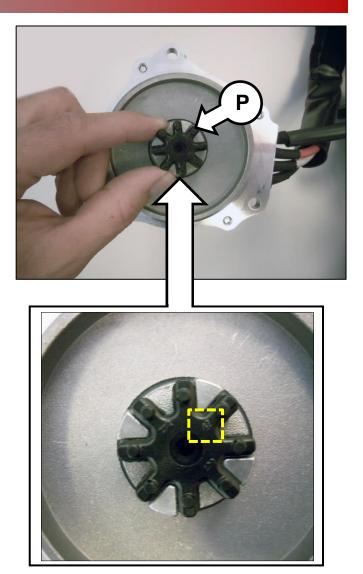
Replace the original flexible coupling with the new part (P). Refer to the graphic below to properly align the flexible coupling with the motor housing.

Before installing the new part, make sure it has "4P" embossed on the surface.

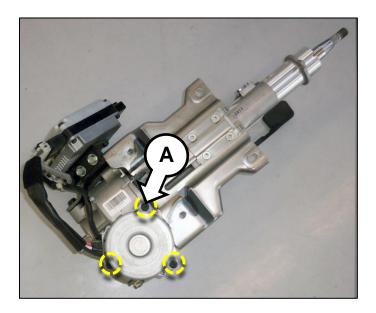
- 1. Remove the MDPS unit by referring to the applicable procedure on KGIS.
- 2. Remove 3 bolts (A) securing the MDPS motor to the housing.

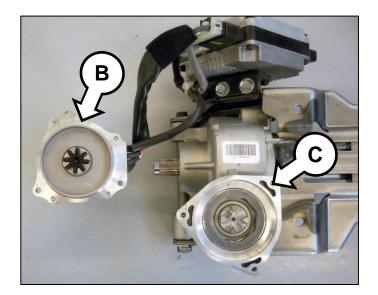
3. Separate the MDPS motor (B) from the housing (C), as shown.

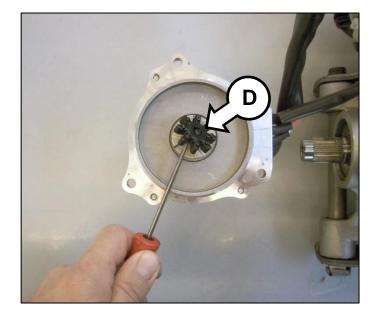
Remove the original flexible coupling (D) from the motor. In addition, use an air gun to remove any foreign matter from the motor and/or the housing.

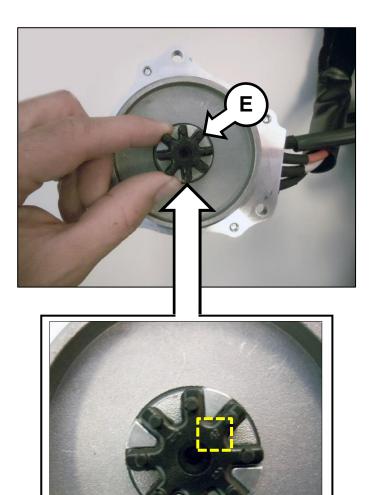
5. Install the new flexible coupling (E) onto the MDPS motor, as shown.

Before installing the new flexible coupling, make sure it has "4P" embossed on the surface.

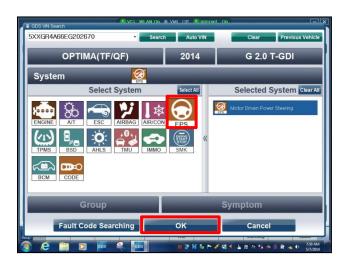
- 1. Connect the power supply cable to the GDS.
- 2. Connect the USB cable between the VCI and the GDS.
- 3. Connect the Main 16-pin DLC cable (GHDM 241000) to the VCI.
- 4. Connect the Main 16-pin DLC cable (GHDM 241000) to the OBD-II connector, located under the driver's side of the instrument panel.
- 5. Select **EPS** and click on **OK**.

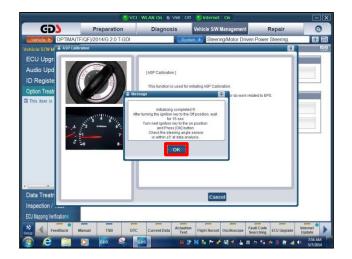
10. Turn the ignition **OFF** and wait 15 seconds. Then, turn the ignition **ON** and click on **OK**.
