TSB160017

New Lubricating Oil Filter Bypass Valve

Product Affected

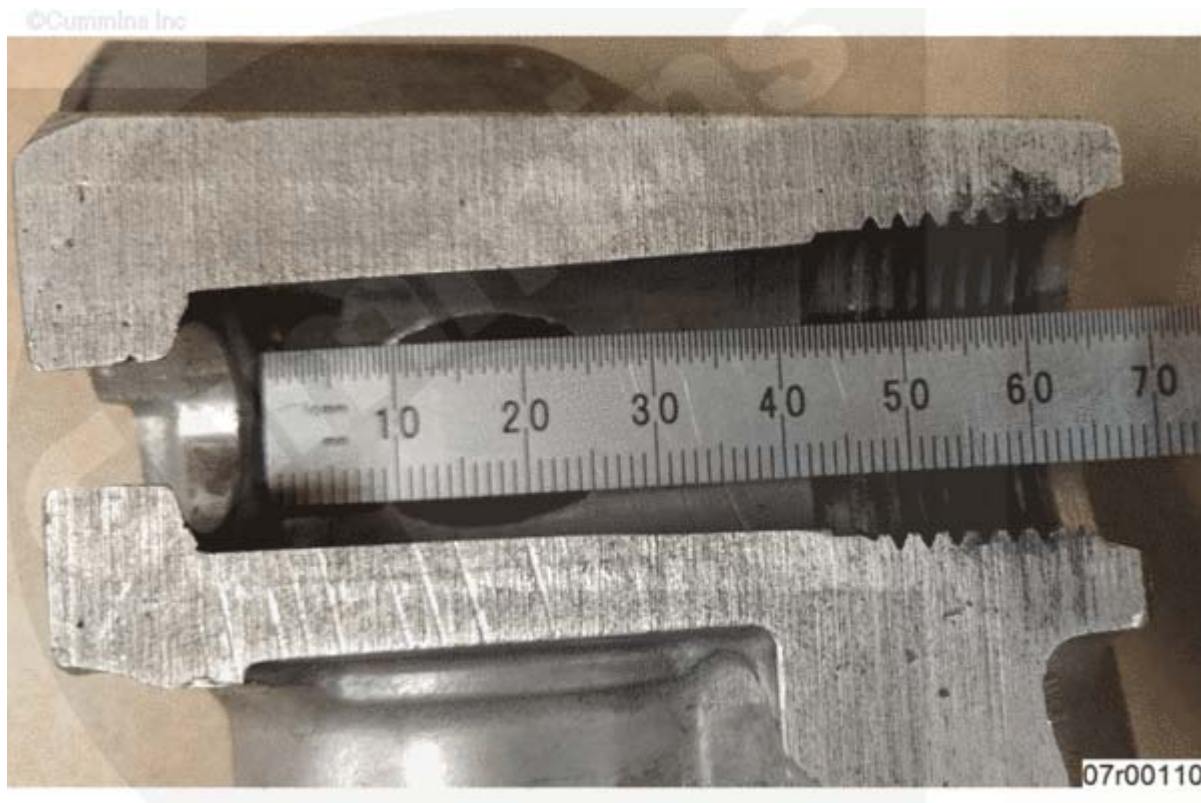
Figure 1, Measurement of Lubricating Oil Filter Head Bore.

- The threaded plug, which secures the lubricating oil filter bypass valve, varies depending on which lubricating oil filter head is installed on the engine.
- To properly secure the lubricating oil filter bypass valve, the correct threaded plug part number **must** be used.
- To determine correct lubricating oil filter bypass valve threaded plug selection:
 - Use a small ruler or scale to measure depth of lubricating oil cooler head bore. Measure depth from top of countersink to outside edge of lubricating oil filter head bypass valve bore. See Figure 1 below.
 - Measure length of threaded plug from underside of threaded plug head to end of threaded plug. See Figure 2 below.
- Use results of bore depth measurement to determine correct lubricating oil filter bypass valve threaded plug part number. Reference Table 2 below.

Table 2, Lubricating Oil Filter Head Threaded Plug Selection: ISX/QSX (All Versions)				
Engine Build Date (Reference Only)	Bypass Valve Bore Depth	Original Plug Part Number	Required Plug Part Number	Plug Length (Measured From Under Head to End)
Before 10 May 2000	68 mm [2.68in]	3679770	4059434	19.5 mm [0.77in]
2000-2006		4059434		19.5 mm [0.77in]
After 2006	64.5 mm [2.54in]	4952760	4952760	16 mm [0.63in]
If Unknown	68 mm [2.68in]	If Unknown	4059434	19.5 mm [0.77in]
If Unknown	64.5 mm [2.54in]	If Unknown	4952760	16 mm [0.63in]

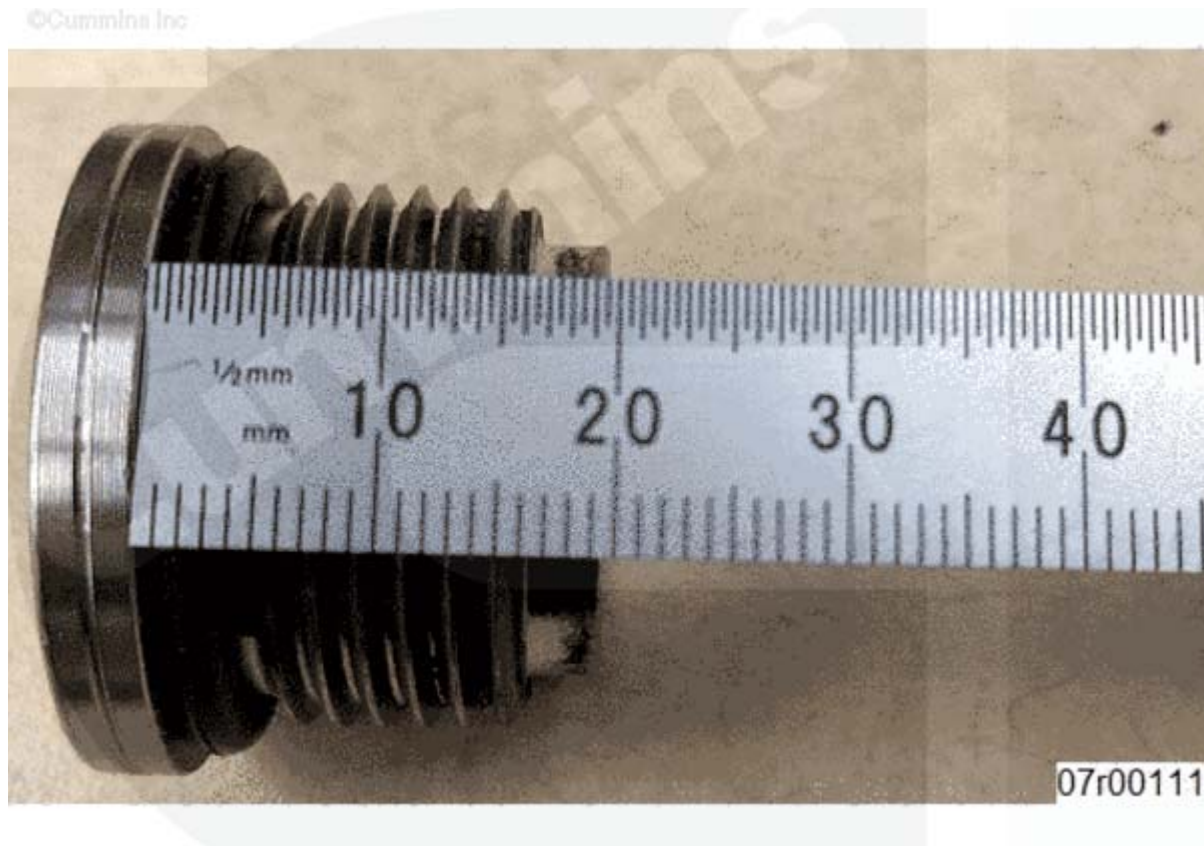
Figure 2, Measurement of Lubricating Oil Filter Head Threaded Plug.

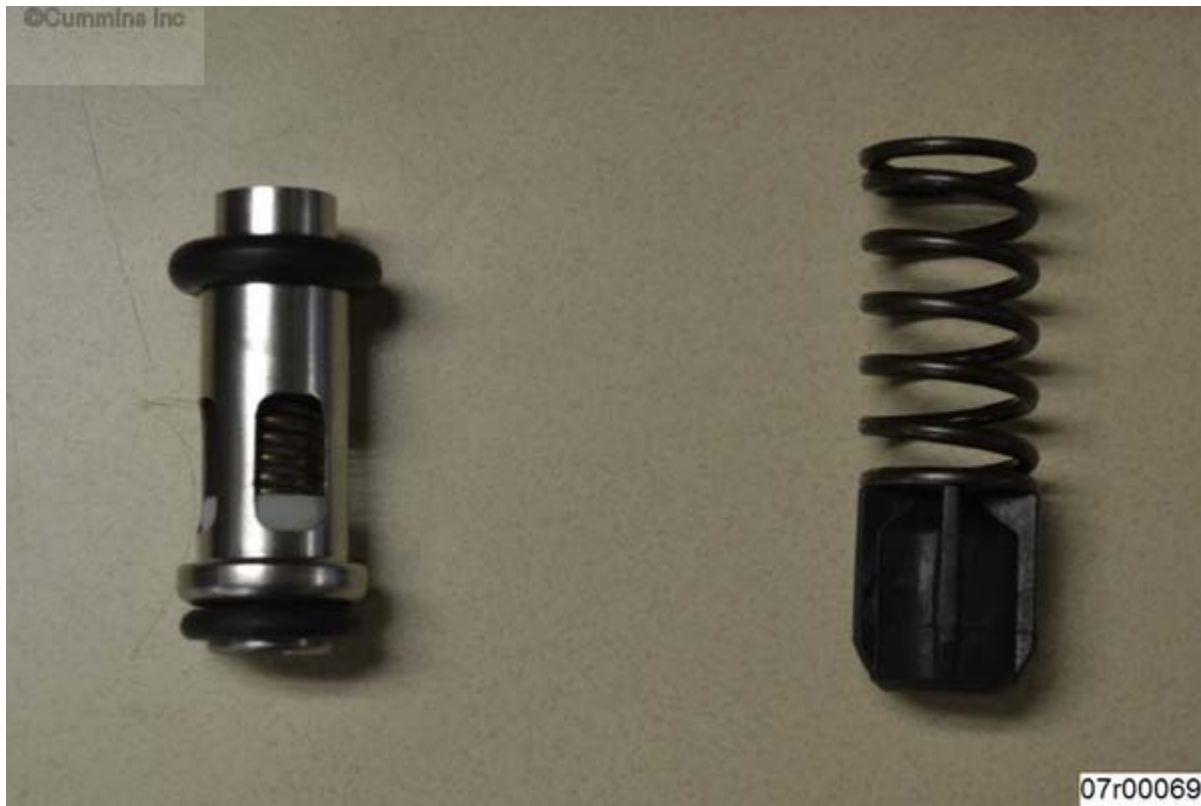
Figure 3, Left: New Single Piece Cartridge Style Bypass Valve. Right: Obsolete Spring and Bypass Valve.

A new single piece cartridge style lubricating oil filter bypass valve has been released to address this issue. Both the bypass valve plunger and spring have been replaced by the new single piece cartridge style lubricating oil filter bypass valve that uses an o-ring to seal the cartridge to the bore. The cartridge contains a bypass valve plunger which seals against a machined seat surface internal to the cartridge, which addresses the sealing issues of the old design. See Table 1 below for service parts information.

Part Description	Existing Part Number	Obsolete	Superseded	New Part Description	New Part Number	Product
Bypass Valve	3820320	Yes	No	Single Piece Cartridge Style Bypass Valve	4357177	ISX12/11.9, ISX12/11.9G, ISX15, QSX11.9, QSX15 (All Versions)
				Bypass Valve	4386023	ISM and QSM11 (All Versions)

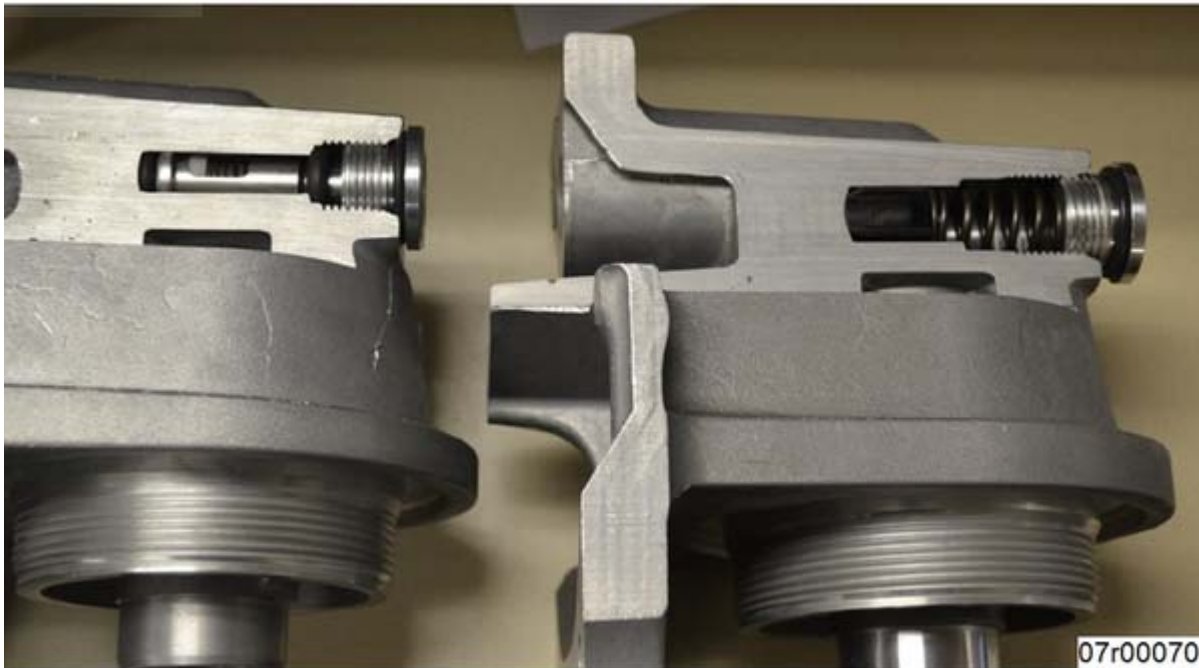
Figure 4, Left: New Single Piece Bypass Valve Installed. Right: Obsolete Spring and Bypass Valve Installed.

The existing lubricating oil filter bypass valve plunger **must** seat on a machined surface within the lubricating oil filter head. As the result of variation in machining and casting tolerance, the lubricating oil filter bypass valve plunger may **not** fully seat and allow debris to enter the engine.
