TSB160066

Lubricating Oil Leaks at Rocker Lever Cover

- ISX12 G CM2180 EJ

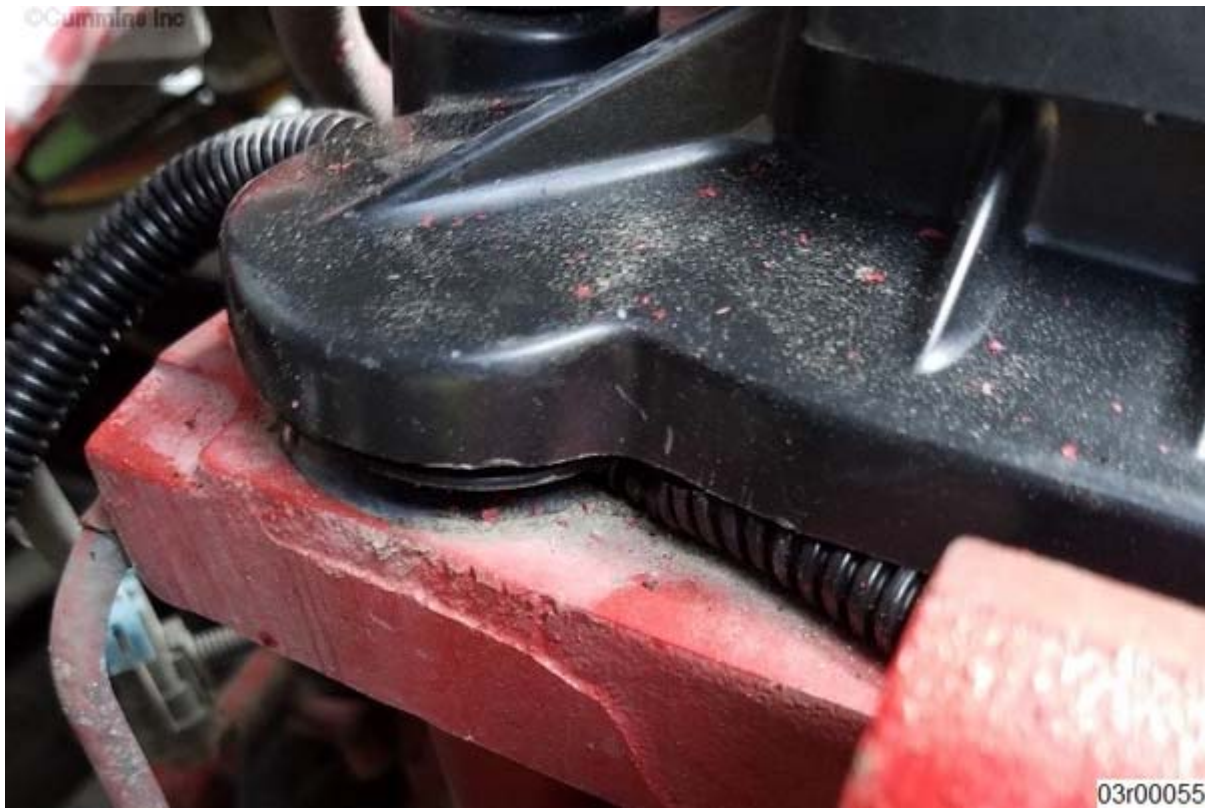
- Oxygen sensor branch of wiring harness is pinched between rocker lever cover and rocker housing during removal and installation of rocker lever cover. See Figure 1 below.
- Capscrew 11 and/or 14 is/are still installed when attempting to remove rocker lever cover. See Figure 3 below for rocker lever capscrew position.

Figure 1, Example of Pinched Wiring Harness.

- During removal and installation of rocker lever cover, secure oxygen sensor branch of wiring harness away from rocker lever cover to prevent wiring harness pinching between rocker lever cover and rocker lever housing.
- When removing rocker lever cover, do **not** use a pry bar to break seal between rocker lever cover and rock lever housing. A pry bar will cause damage to rocker lever housing and rocker lever cover gasket
- A flat head screw driver can be used to assist in removal of rocker lever cover. Insert screwdriver underneath rocker lever cover and twist, but do **not** pry or lift rocker lever cover with screw driver.

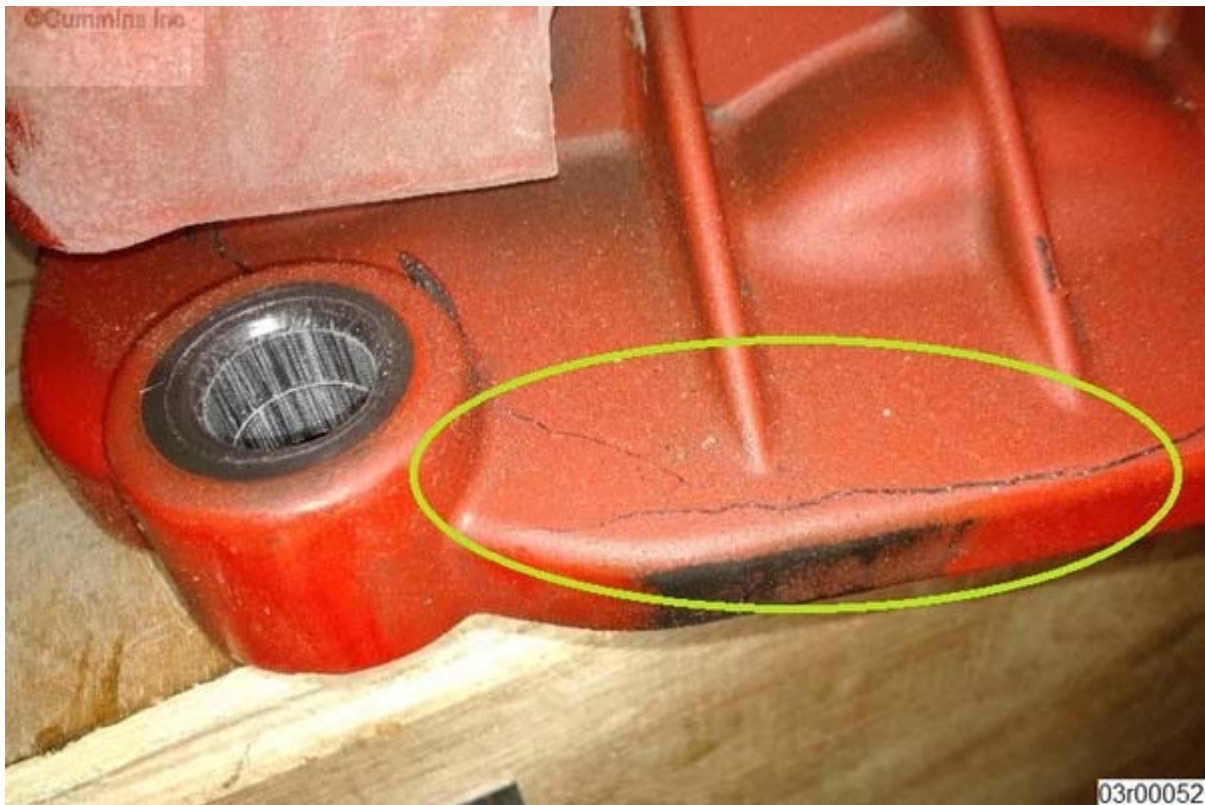
- External oil leaks originating from a cracked rocker lever cover.

Figure 2, Example of Rocker Lever Cover Cracking.

- Verify all rocker lever cover capscrews are removed before attempting to remove rocker lever cover from engine.
- Replace rocker lever cover if cracked. See ISX12 G CM2180 EJ Service Manual, Bulletin 4310682. Refer to Procedure 003-011 in Section 3.
- See Service Instructions section below.

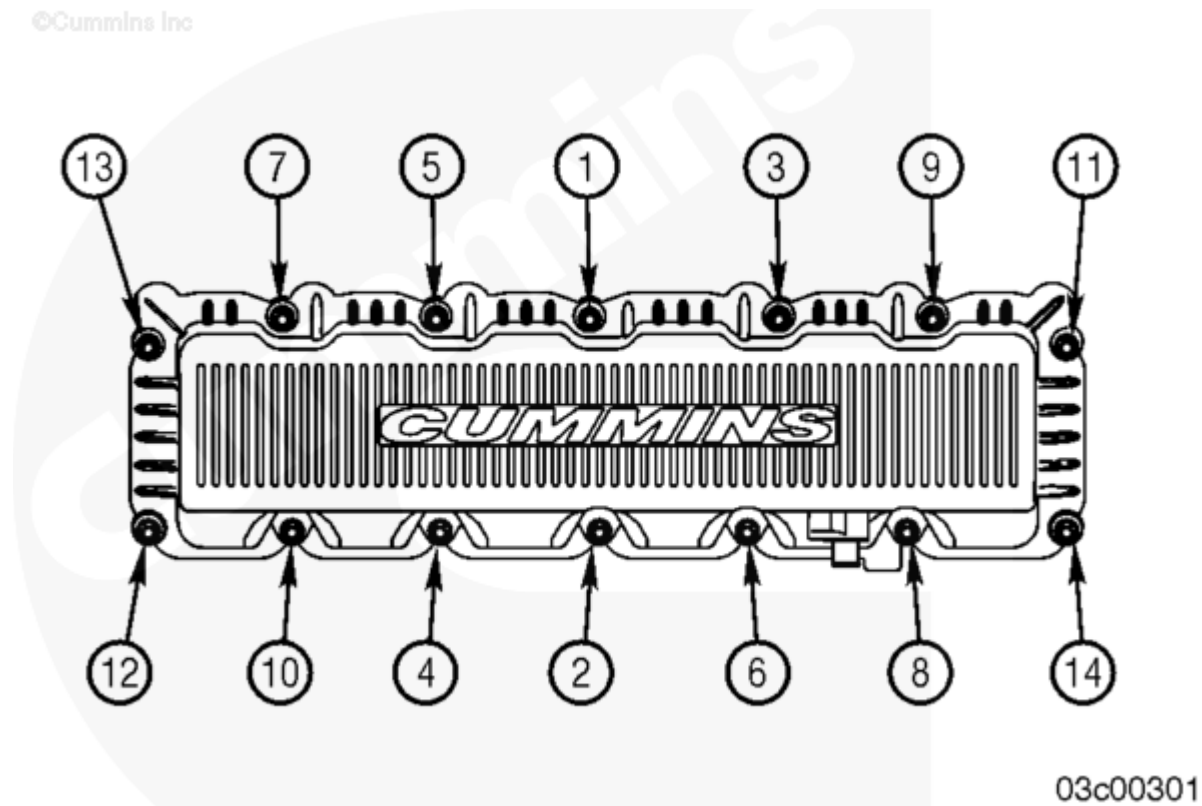
Figure 3, Rocker Lever Cover Capscrew Position.
