Bulletin Type.....: Field Fix (M)
Bulletin No.....: TS-M119
Bulletin Name.....: Hydraulic Hoses Of Ras System
Bulletin Ref No.....: 700003210
NHTSA.....:
Release Date.....: 20.06.2017
Expiry Date.....: 20.06.2018
Vehicle Model.....: TS45
Fiat Rate Code.....: TSM119
Flat Rate Time.....: 180'

Subject: TS45 Tag Axle RAS system hydraulic hose replacement

Summary: This technical service bulletin gives instruction about how to replace the hydraulic hoses of TS45 tag axle RAS system

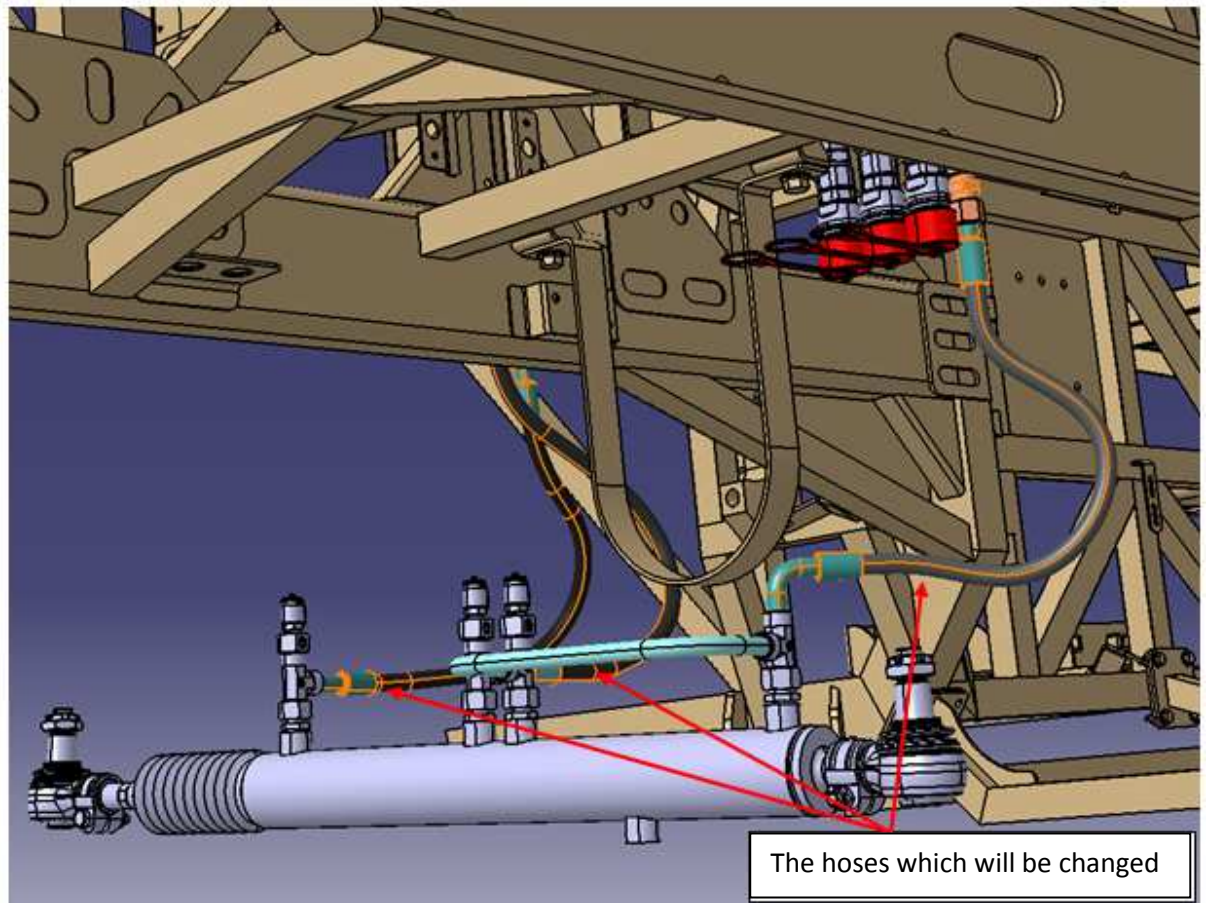
- 1- Pull the vehicle to the pit or lift.
- 2- Figure-1 shows the working area and hoses with the red arrows which will be changed with the new ones.

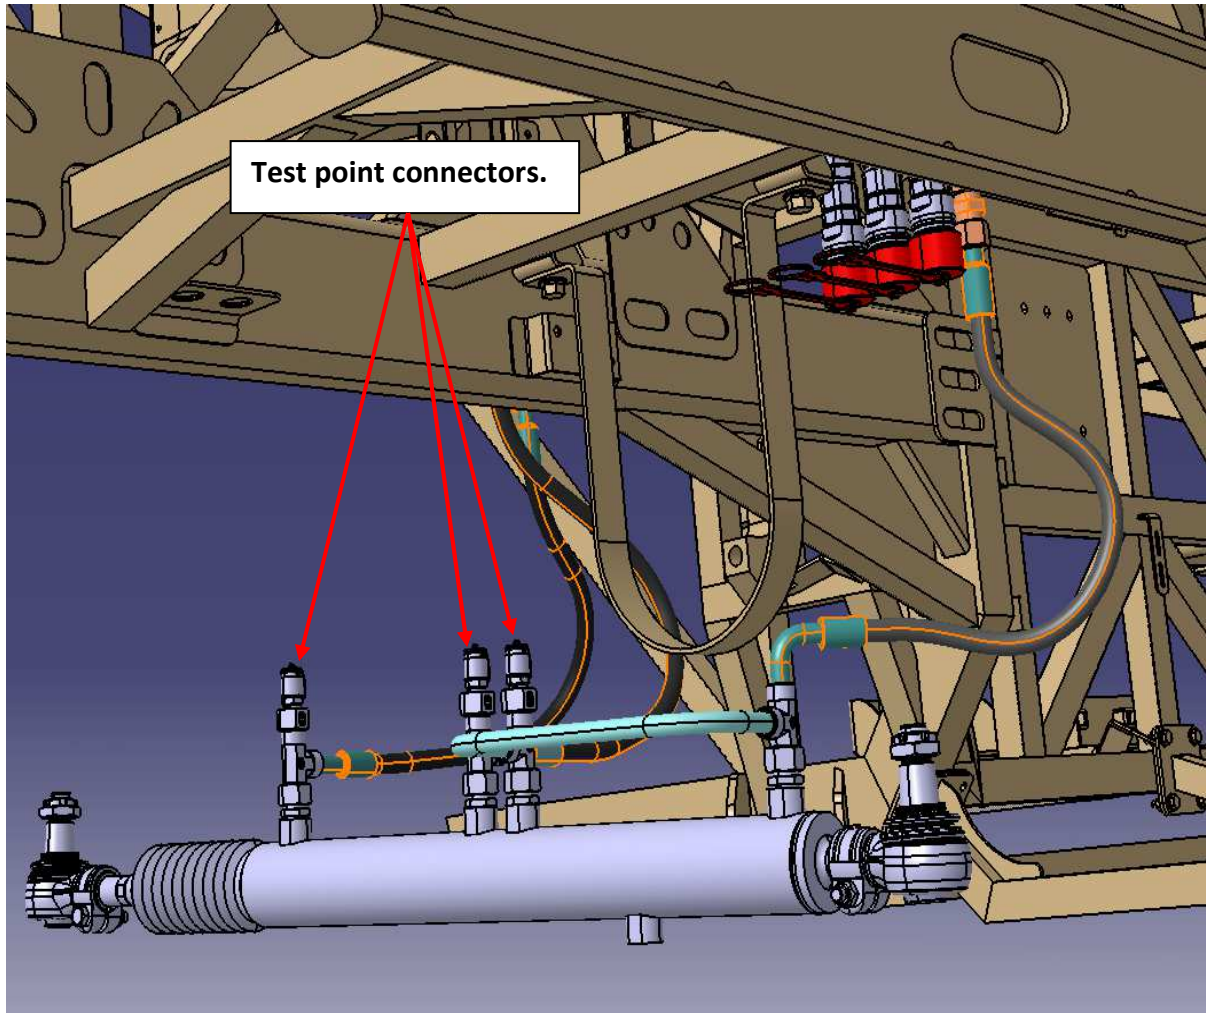
Figure-2

NOTE: The RAS System hydraulic line pressure is approximately 18 bar (261 Psi). In this regard, be careful when you work on the RAS system hydraulic line. Before starting the disassembly process, decrease the system pressure by using test point connectors which is marked with red arrows on Figure-2.

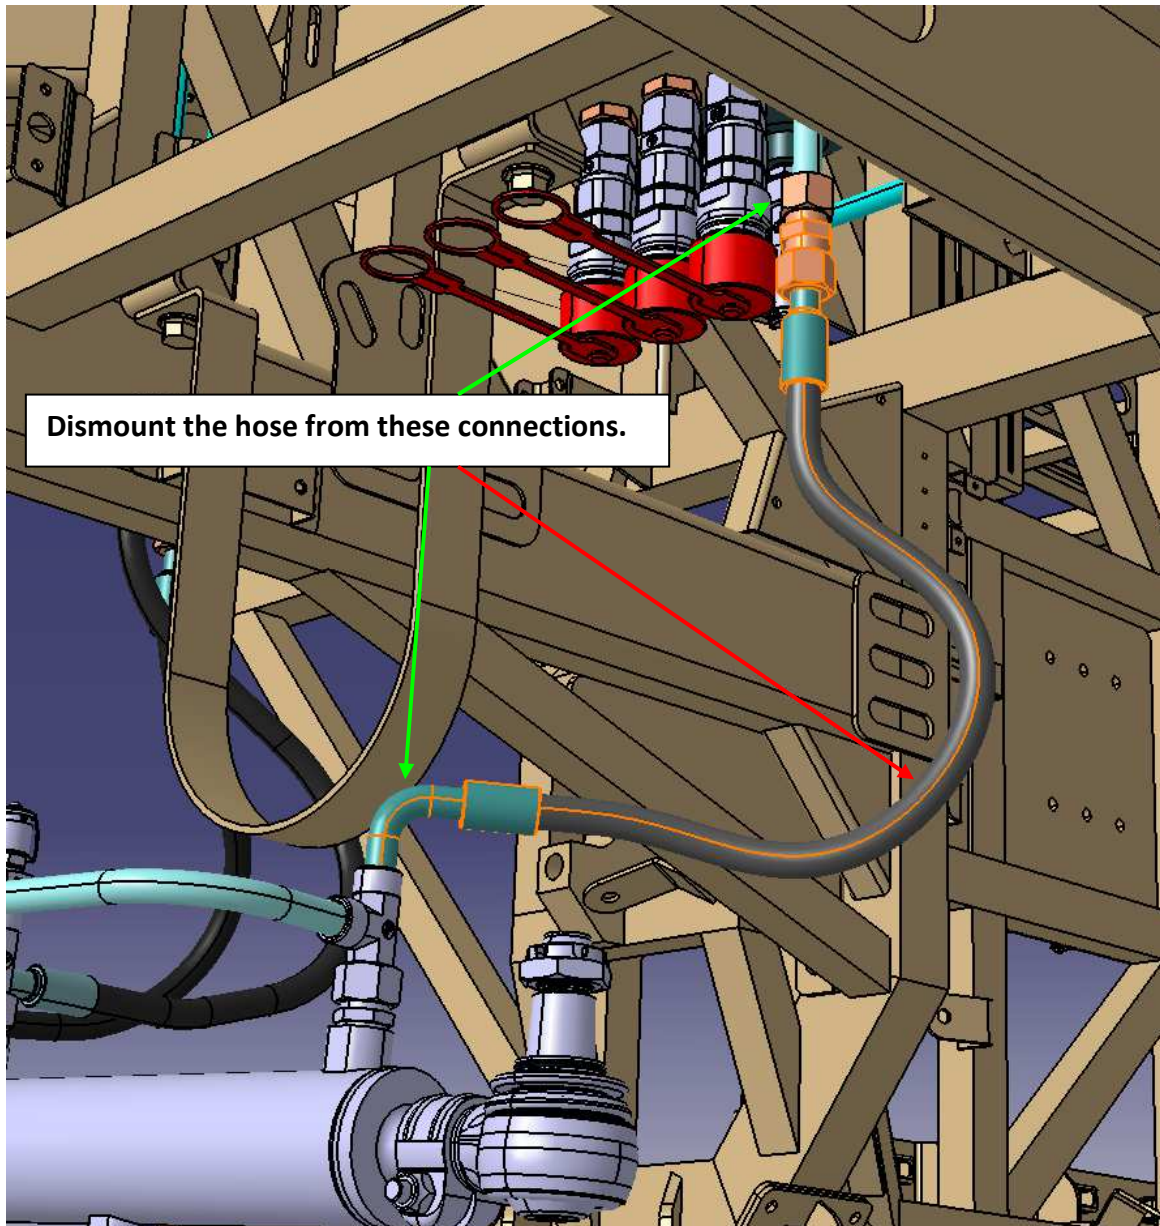
Figure-3

3. Dismount the 9630-06Y hose and 61102-90000-25 straight union then mount the 9630-34Y hose as replacement of these parts (see the Figure-3).

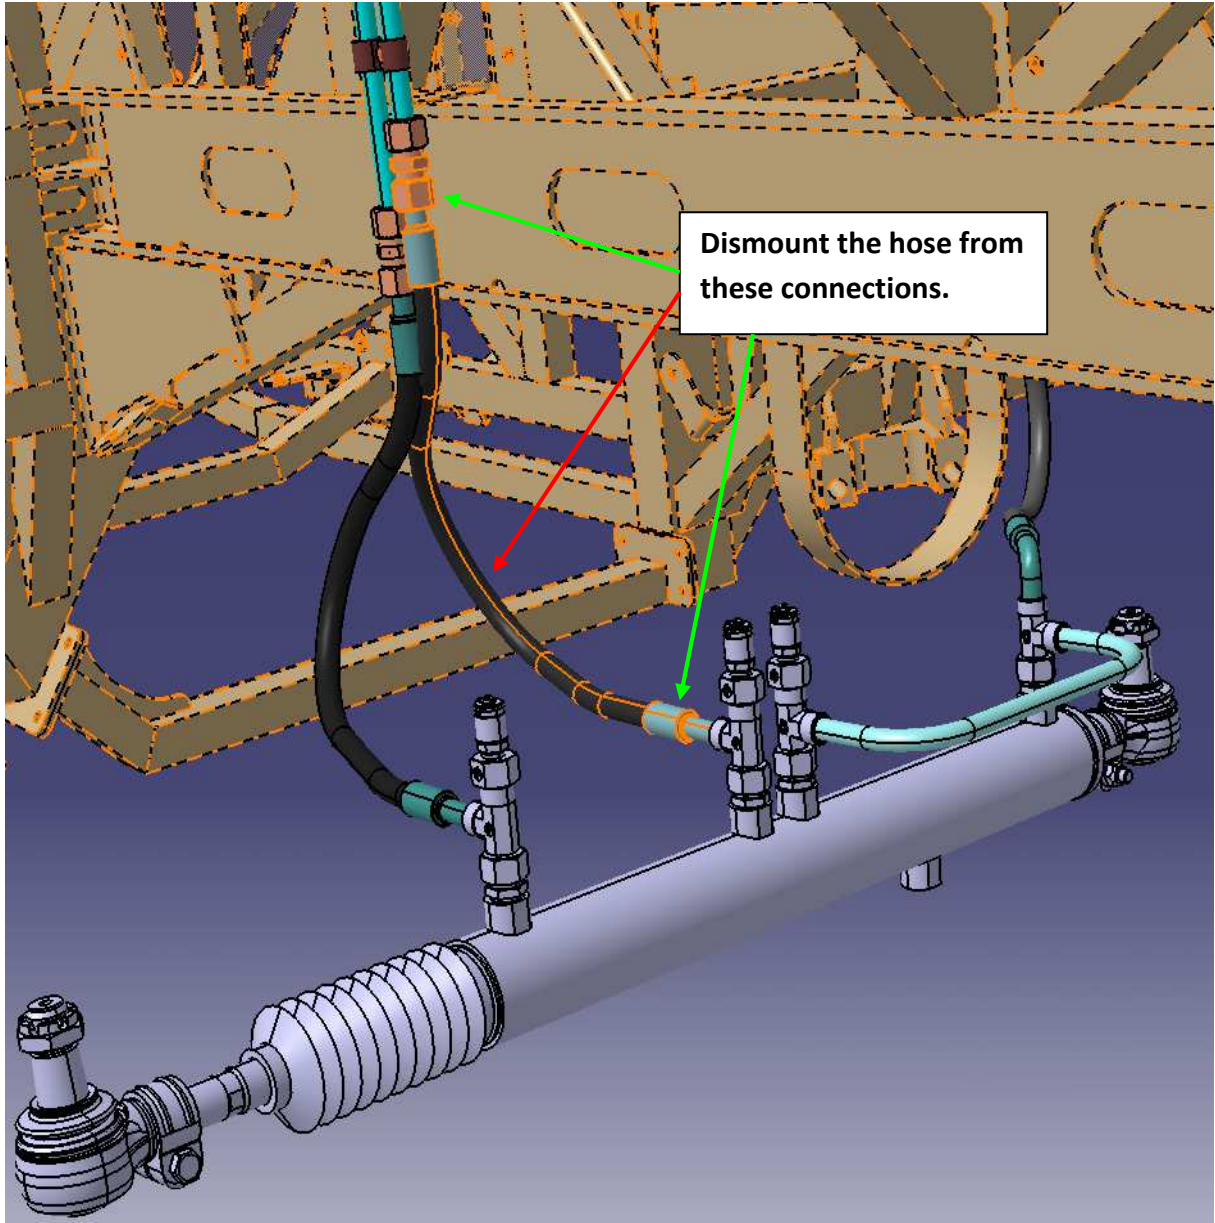
Figure-4

4. Dismount the 9630-04Y hose and 61102-90000-25 straight union then mount the 9630-32Y hose as replacement of these parts. (see the Figure-4)

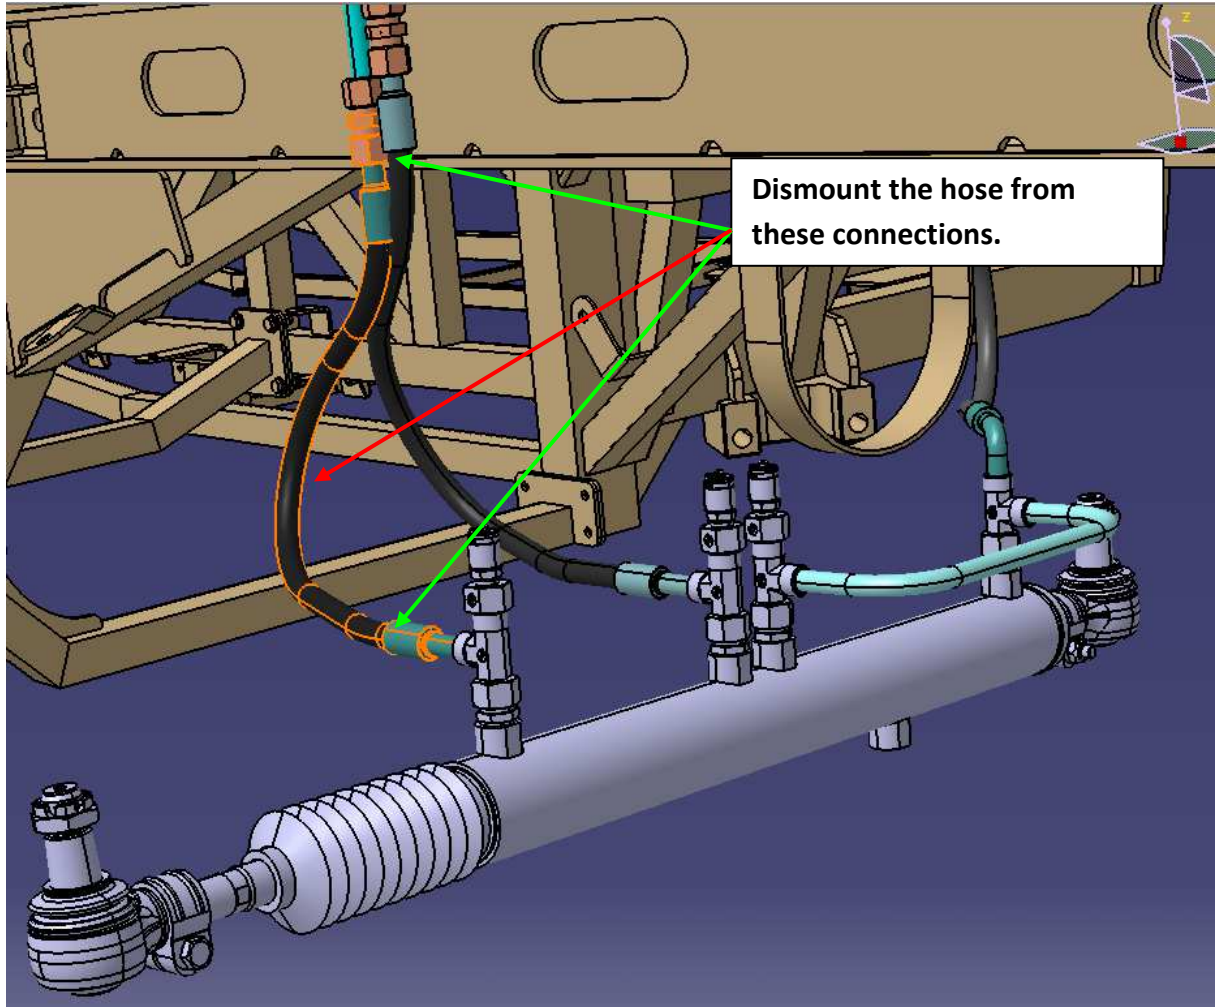
Figure-5

5. Dismount the 9630-05Y hose and 61102-90000-25 straight union then mount the 9630-33Y hose as replacement of these parts.(see the Figure-5)
