# Power Back Door Does Not Close Properly

YEAR(S)	MODEL(S)	ADDITIONAL INFORMATION
2008 – 2013	Highlander, Highlander HV

The information contained in this bulletin supersedes SB No. T-SB-0091-12.

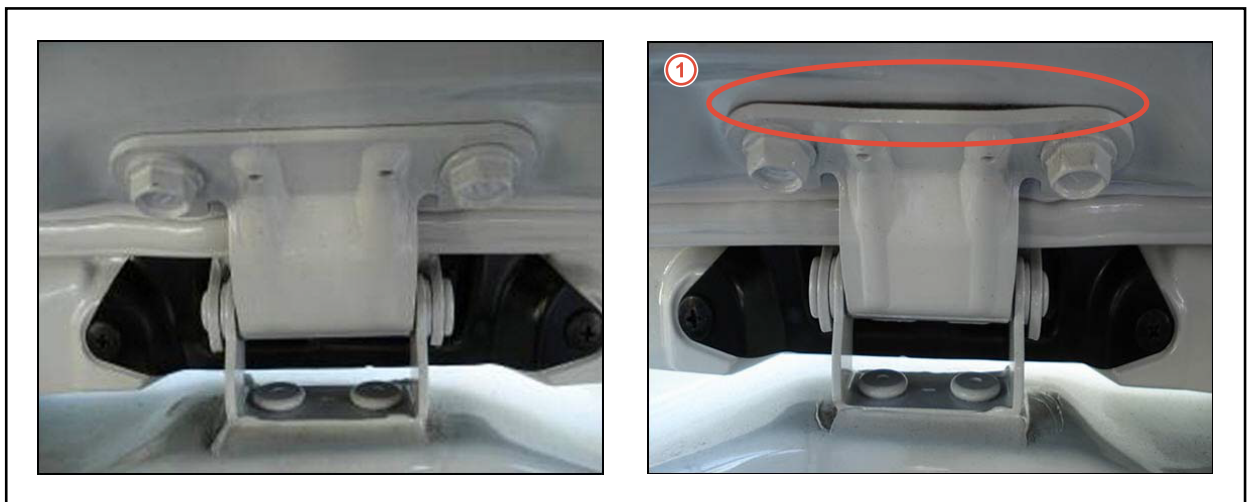
**Figure 1.**

1. Inspect the upper hinges for any gaps present by placing a 0.05 mm (0.002 in.) or greater feeler gauge between the 2 bolts mounted to the back door as shown in Figure 1. If a gap exists, replacement of both Back Door Hinges AND the Back Door Panel Sub-assembly is required. Proceed to step 2.

<b>1</b>	<b>Gap Location</b>
----------	---------------------

If a gap is not found, **STOP** – this bulletin does NOT apply.

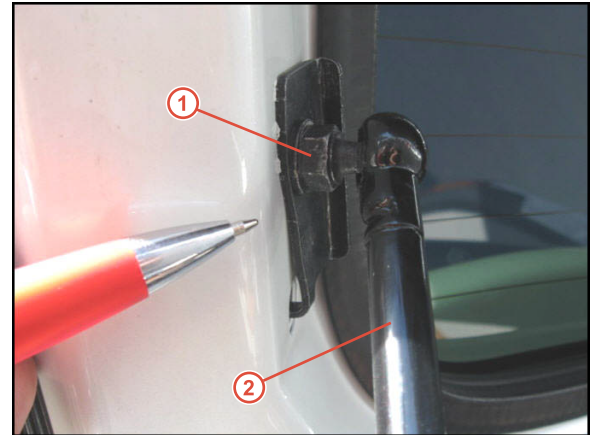
**Figure 2.**

2. Visually inspect the Back Door Upper Rod and Lift Arm Stud for bends or damage. If the Back Door Upper Rod and Lift Arm Stud are damaged, then replace as necessary.

<b>1</b>	Lift Arm Stud
<b>2</b>	Back Door Upper Rod

**NOTE**  
 The Back Door Upper Rod and Lift Arm Stud are available as separate service parts from the Back Door Motor Unit if found damaged or bent.

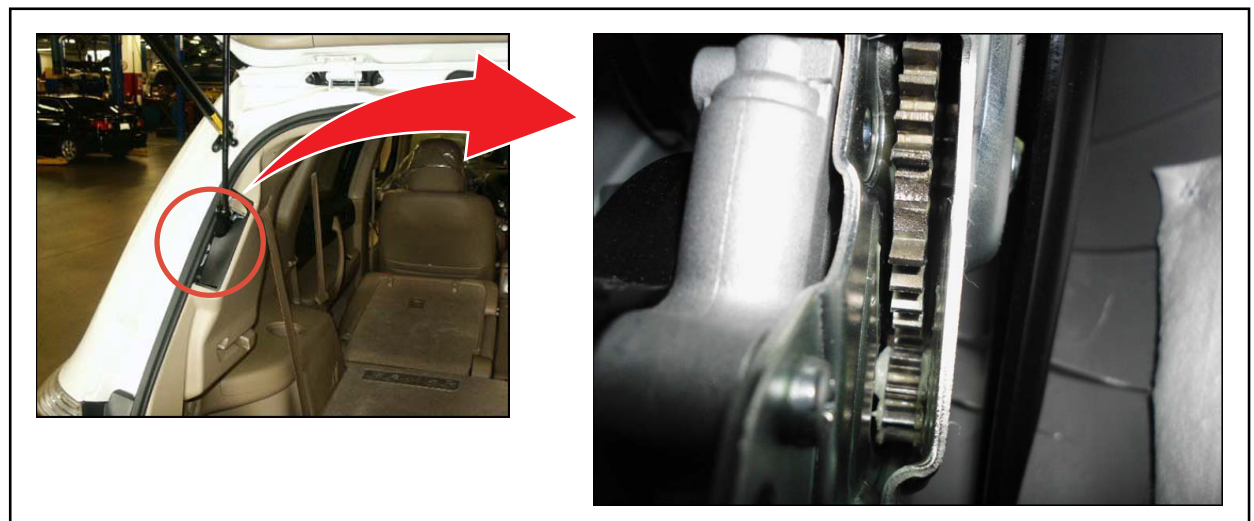
**Figure 3.**

3. Visually inspect the back door motor teeth for damage by opening the back door and manually moving the door towards the half-closed position while observing the large gear teeth for damage, as shown in Figure 3. If damage is found, replacement of the Back Door Motor Unit and Back Door Stay Plate is required.

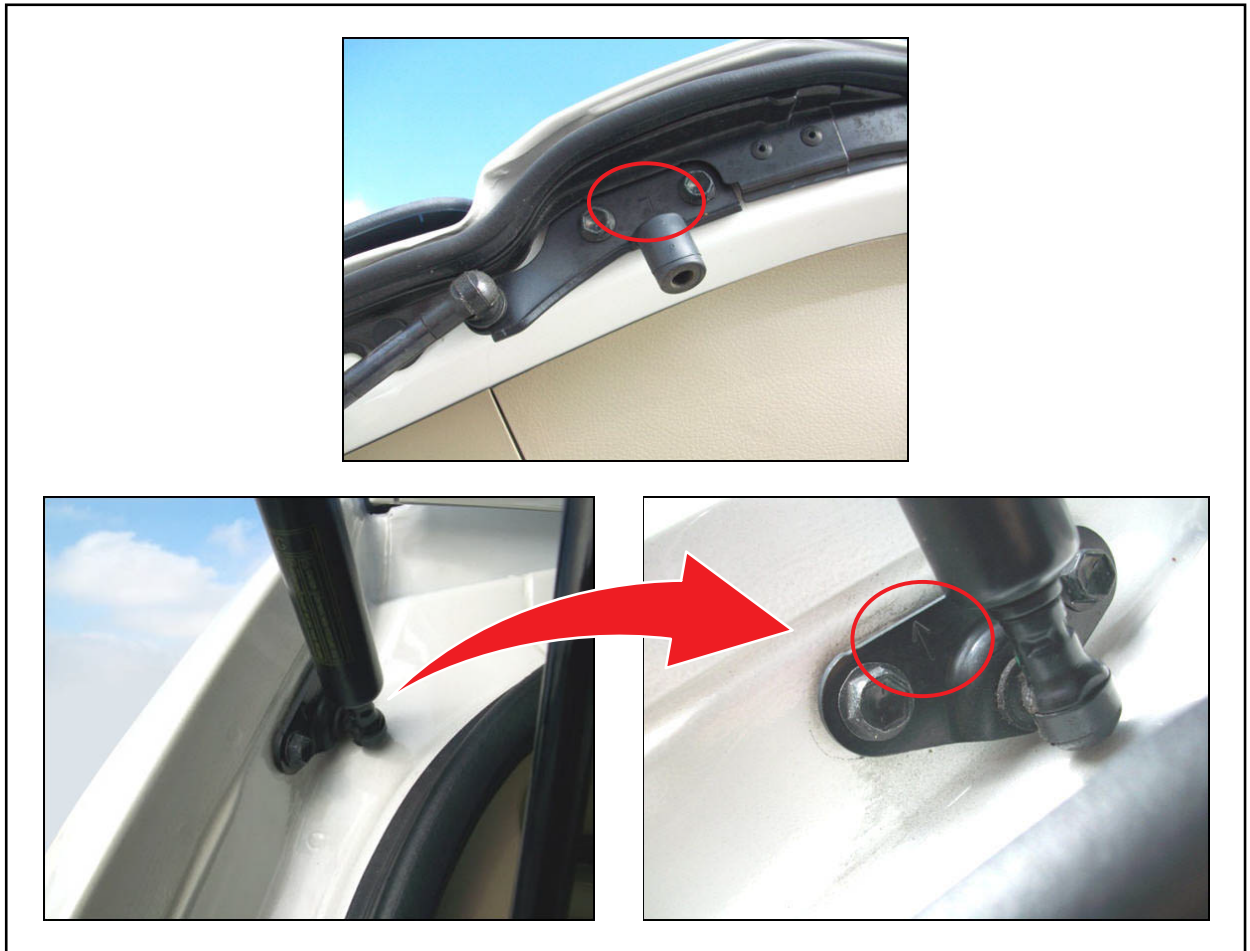
Figure 4.

To ensure correct installation of the back door struts, note the markings on the assembly (Figure 4). The markings indicate on which side of the car the strut should be installed, and the direction of the braces on the strut.
