Upper B-Pillar Trim Installation Procedure

Service Category Vehicle Interior

Section Interior Panels/Trim

YEAR(S)	MODEL(S)	ADDITIONAL INFORMATION
2008 – 2015	Sequoia	
2007 – 2015	Tundra	Body Type(s): Double Cab, Crew Max, Double Cab Long Bed

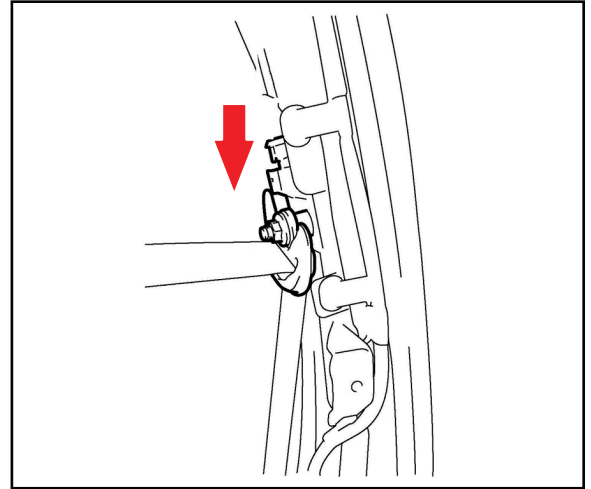
Figure 1.

1. Move the seat belt adjuster to the lowest position (passenger side shown).

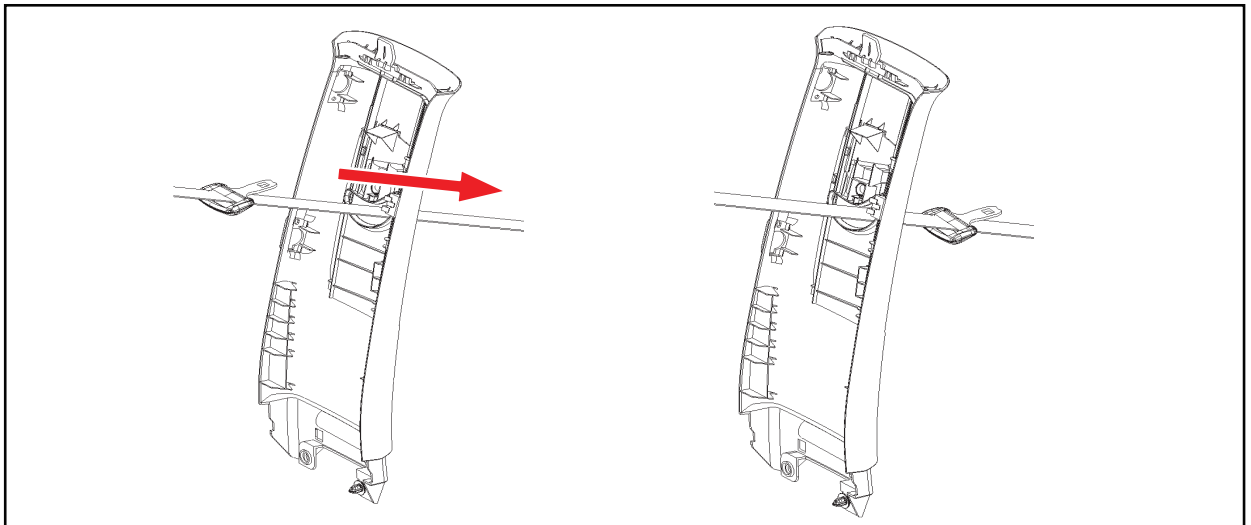
Figure 2.

2. Pass the front seat outer belt through the hole of the Center Pillar Garnish.

Buckle must be located on inboard side of garnish.

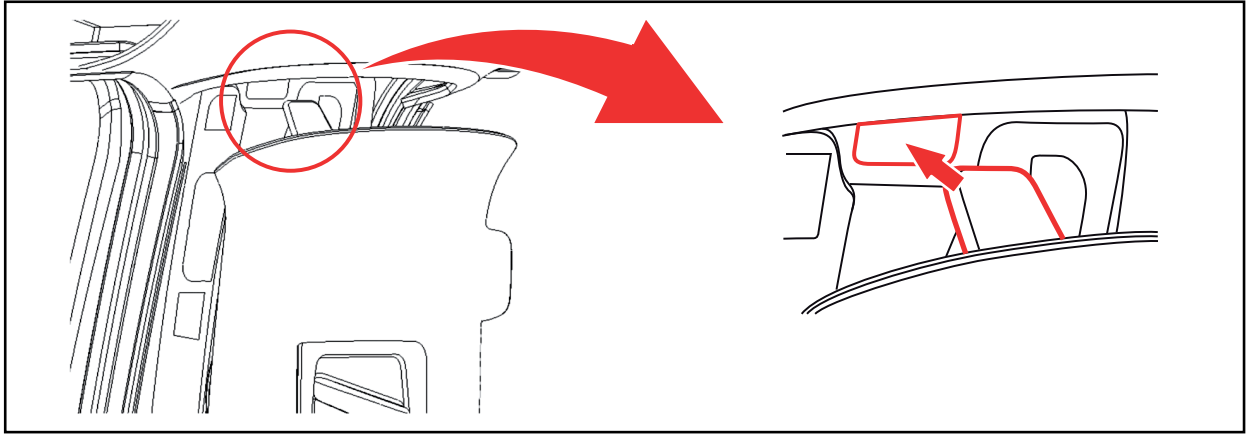
Figure 3.

- Slide the positioning tab on top of garnish into body hole.

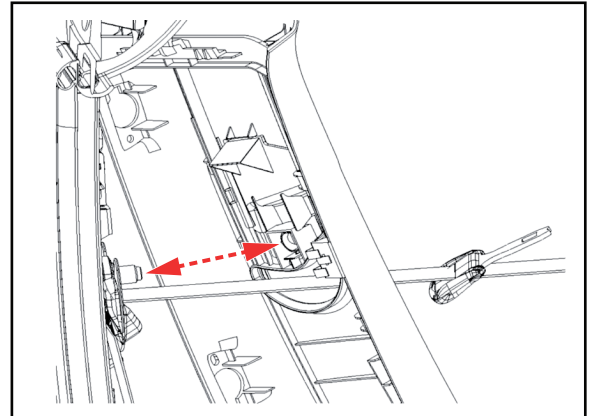
Figure 4.

- Visually line up cavity on Center Pillar Garnish with nut on seatbelt height adjustor.

Nut must be inside cavity on seatbelt height adjustor after garnish is installed.

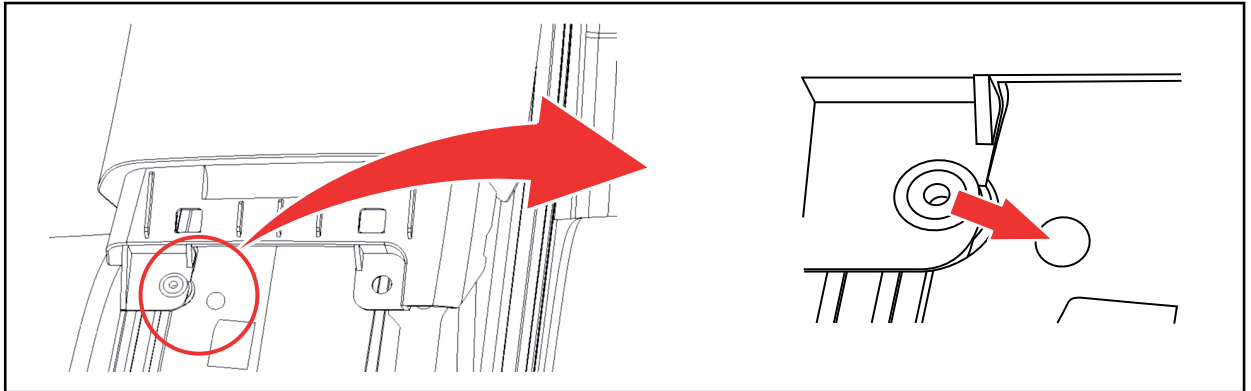
Figure 5.

5. Insert the clip into the hole in body.

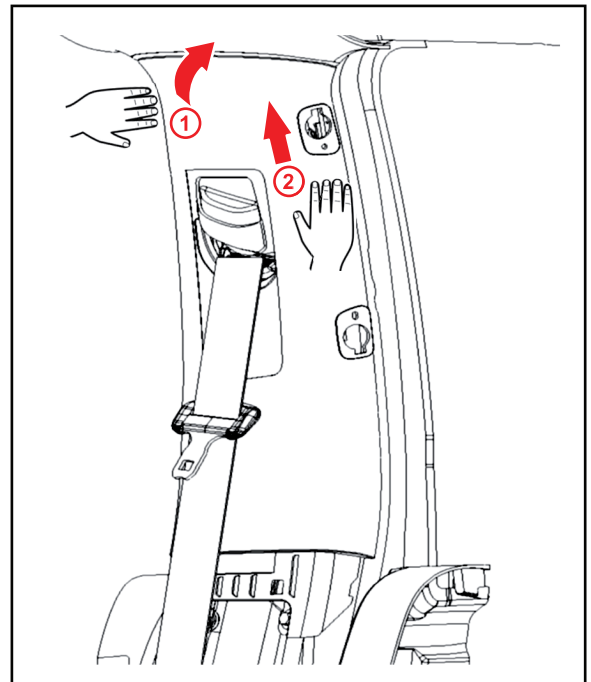
Figure 6.

6. Push top of garnish in an upward and outboard direction to securely attach the alignment tab to the body.

Push locations and directions shown by hands and arrows.

1	Push Outboard
2	Push Upward

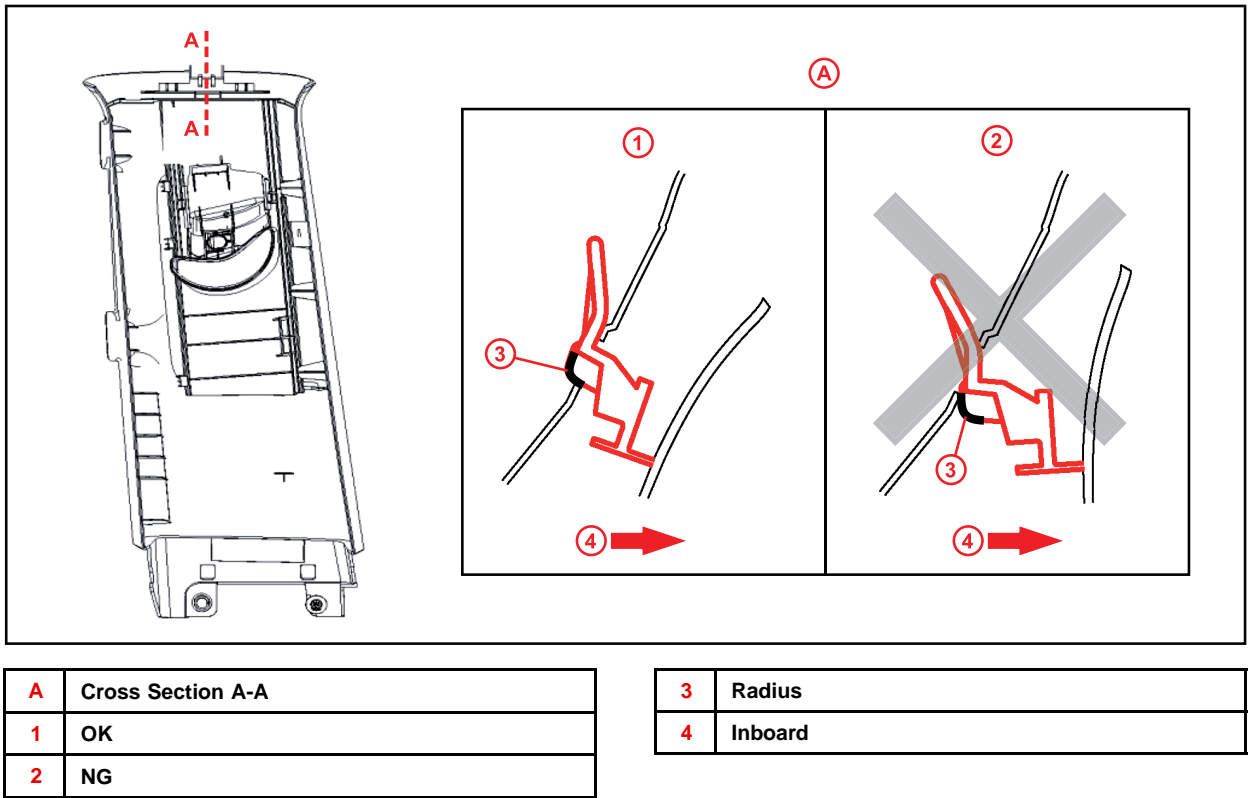
Figure 7.

7. Confirm correct installation of the positioning tab.

Radius on bottom rib of positioning tab must NOT be visible from inboard side after installation as shown.

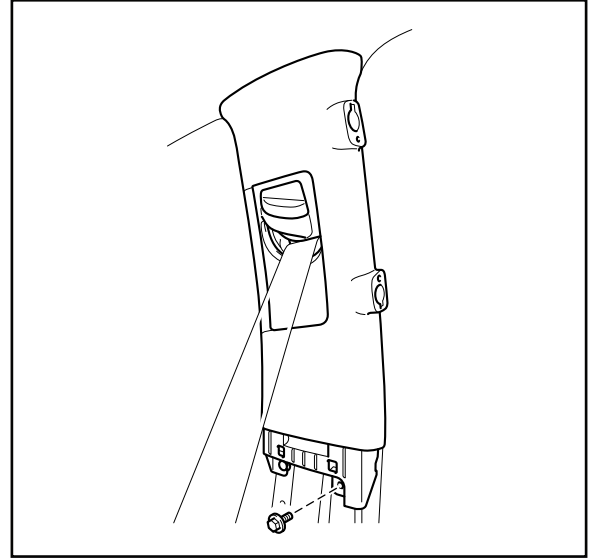
Figure 8.

8. Install the bolt.

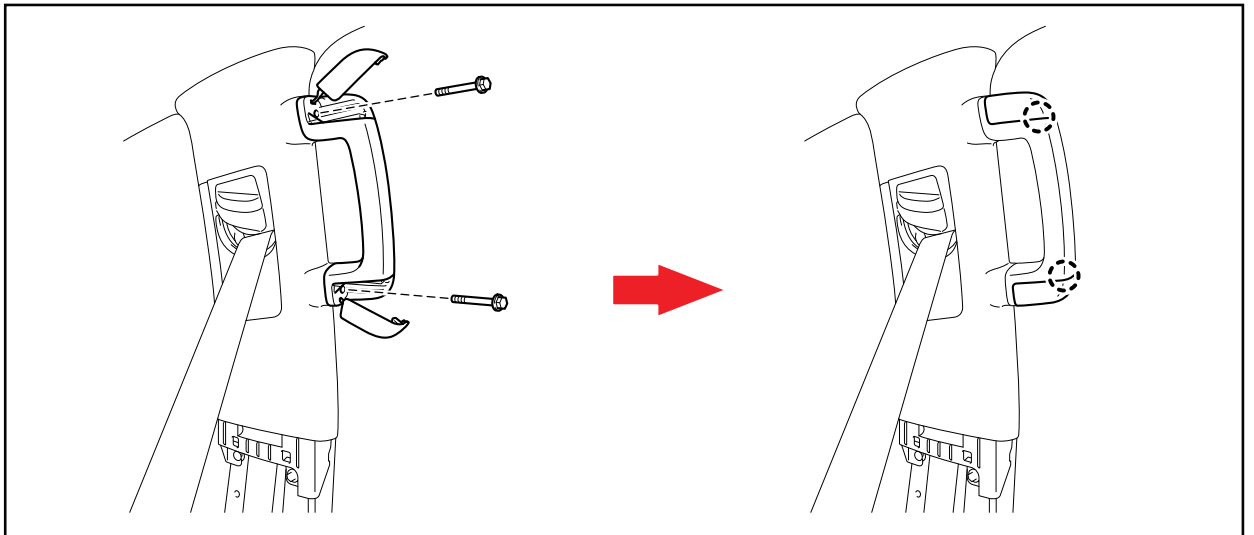
Figure 9.

9. Install the rear assist grip assembly to the Center Pillar Garnish with the 2 bolts.
10. Attach the 2 claws to close the 2 assist grip covers.

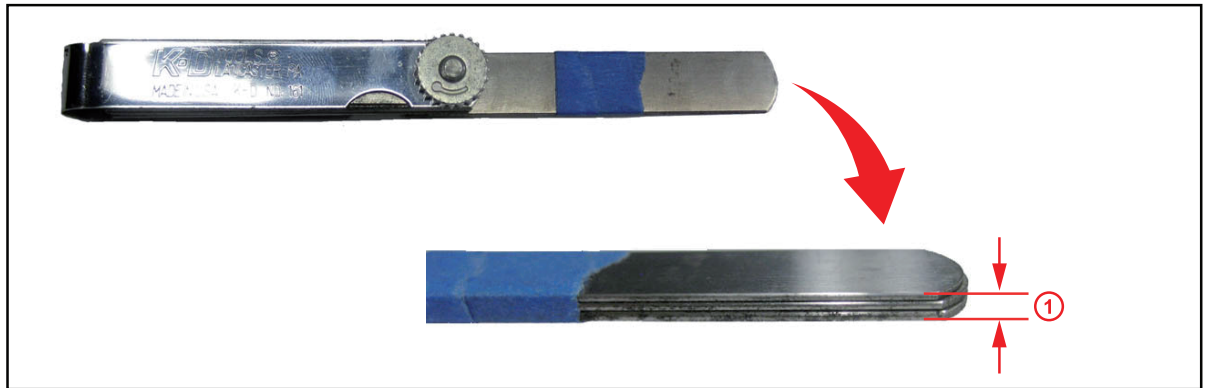
Figure 10.

- (1) Stack feeler gauges so that they are 2.0 mm thick.
- (2) Use tape to secure the feeler gauge blades together.

It may be necessary to reorganize the feeler gauge blade stack to ensure that the feeler gauge blades have no gap between them.

1	2.0 mm Thick
----------	---------------------

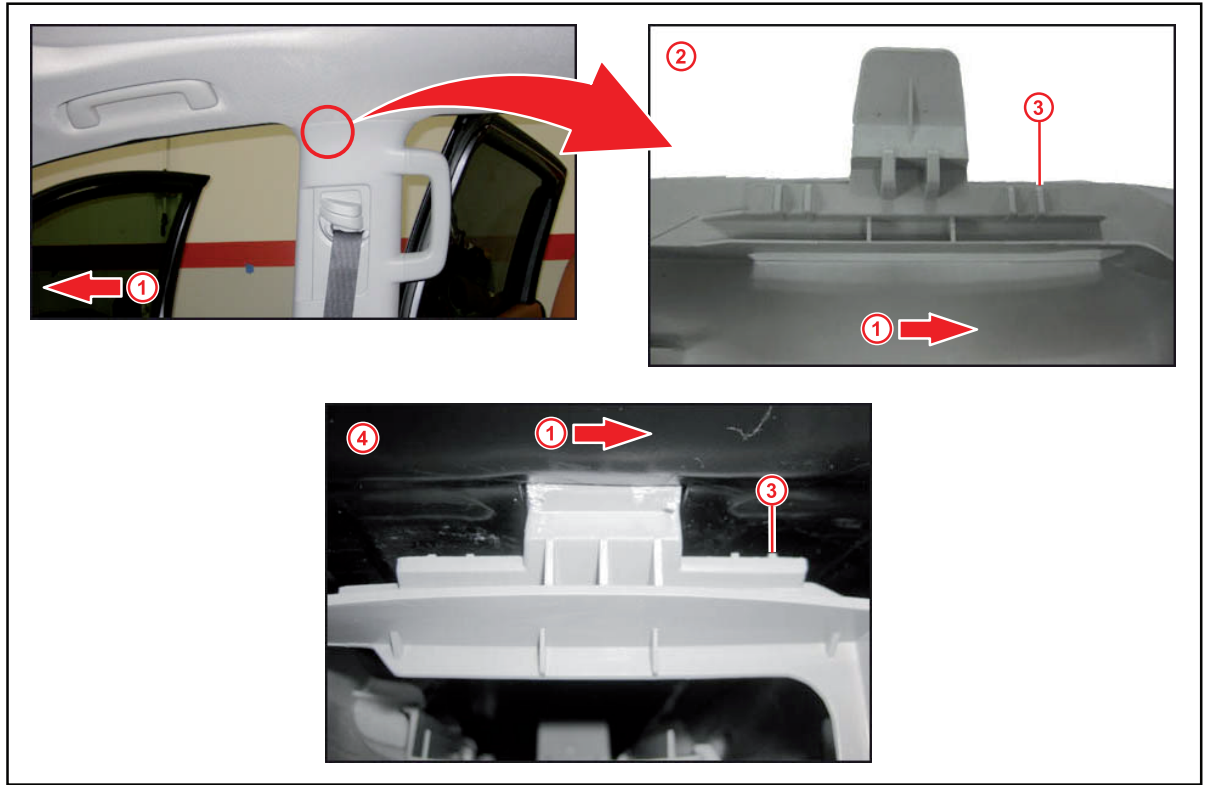
B. Check the front upper reinforcement rib closest to the front door (passenger side shown).

Figure 11. Inspection Location of Center Pillar Garnish

1	Front of Vehicle
2	Backside View of Garnish

3	Front Upper Reinforcement Rib
4	Top View of Garnish Installed on Center Pillar

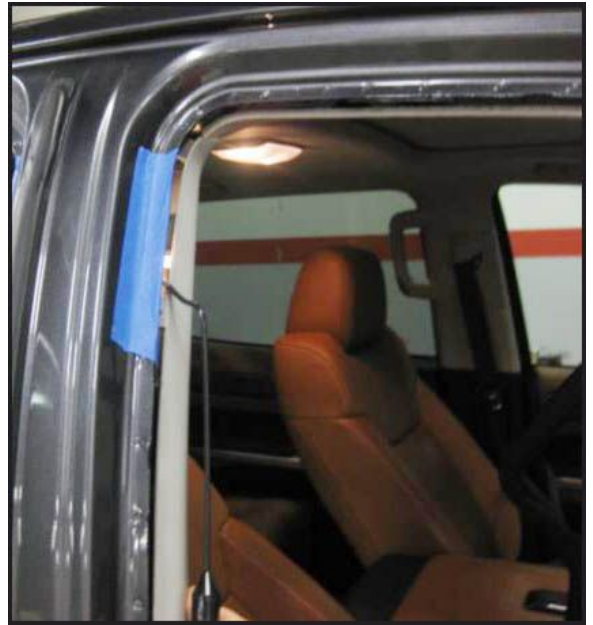
Figure 12.

- (1) Using a small flashlight or penlight illuminate the back side of the garnish so you can locate the reinforcement ribs.

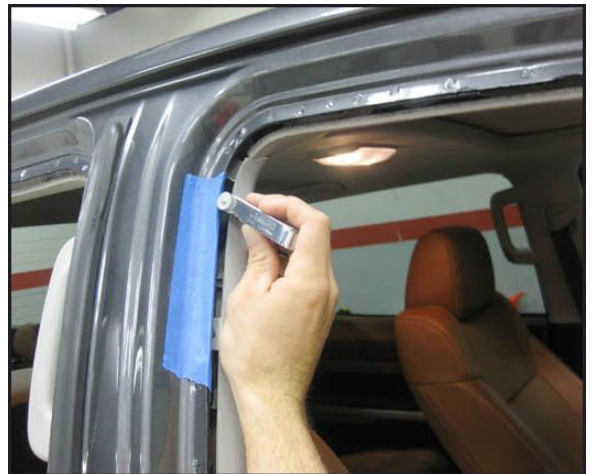
Figure 13.

- (2) From the front door check the clearance between the Center Pillar Garnish tab front reinforcement rib and the body structure using the feeler gauge.

When checking the gap between the front rib and the body structure, ensure that you are measuring at the correct location as shown.

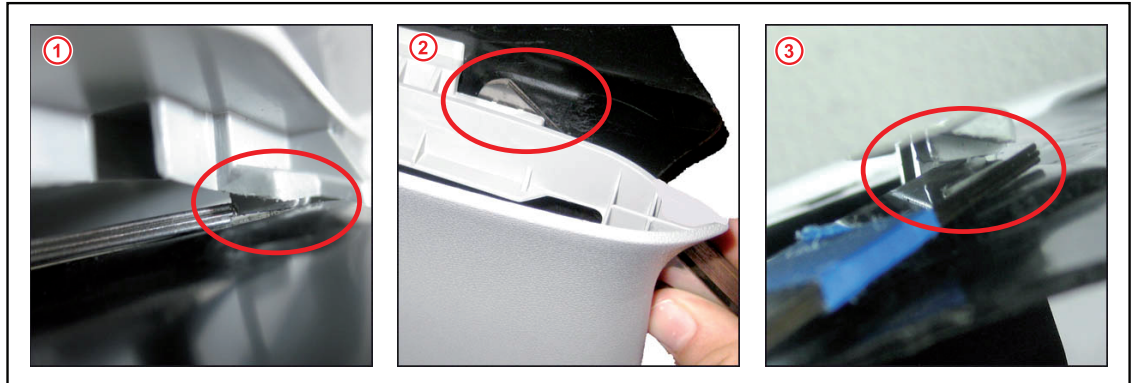
- (3) The position checked on the Center Pillar Garnish must pass the criteria below.

Figure 14. Examples of GOOD and NG Conditions

1	GOOD: Feeler Gauge Interferes with Ribs
2	GOOD: Feeler Gauge Fits with Tension

3	NG: Feeler Gauge Fits Loosely
----------	--------------------------------------

If condition is NG, reinstall the Center Pillar Garnish.
