Service Bulletin

INFORMATION

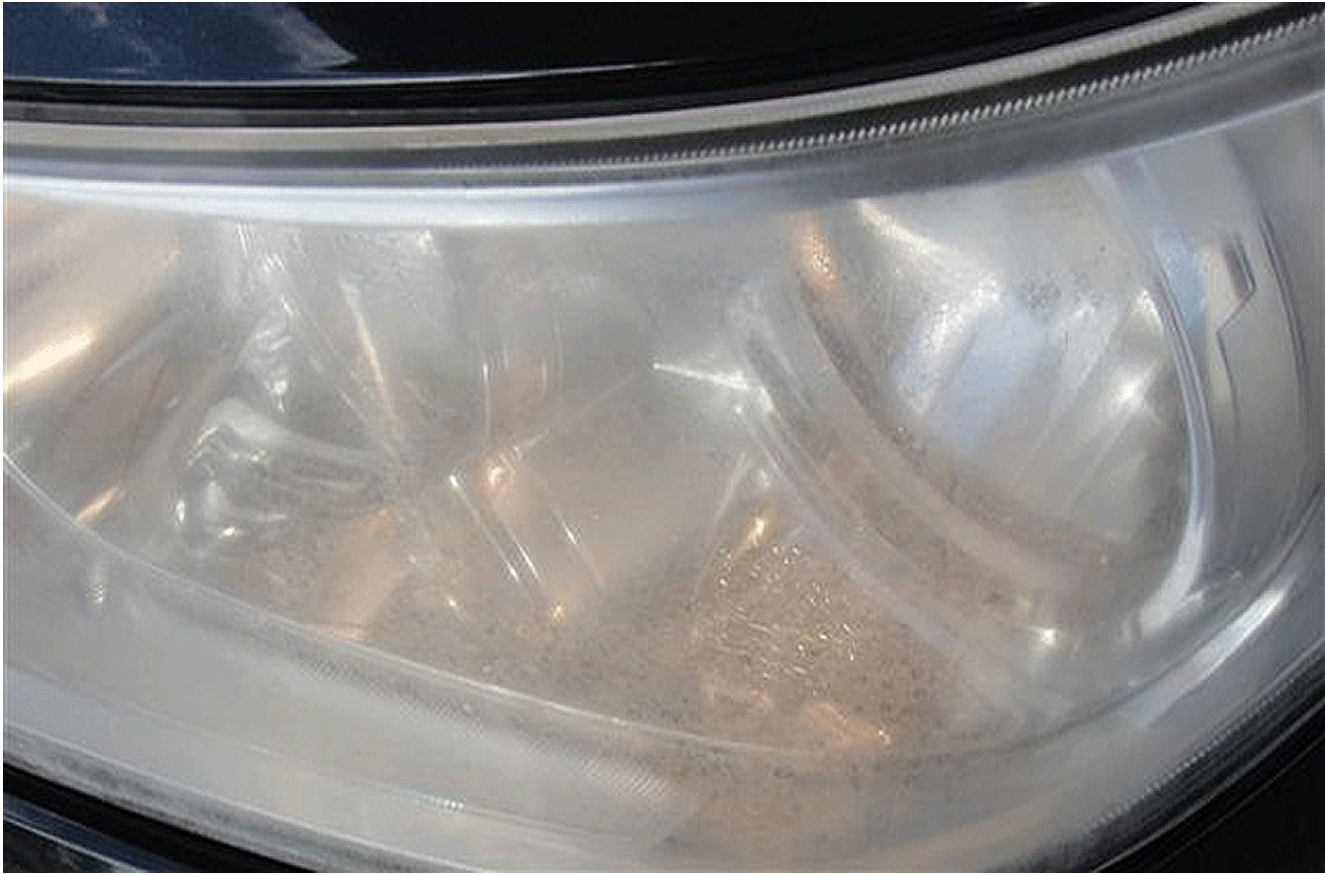
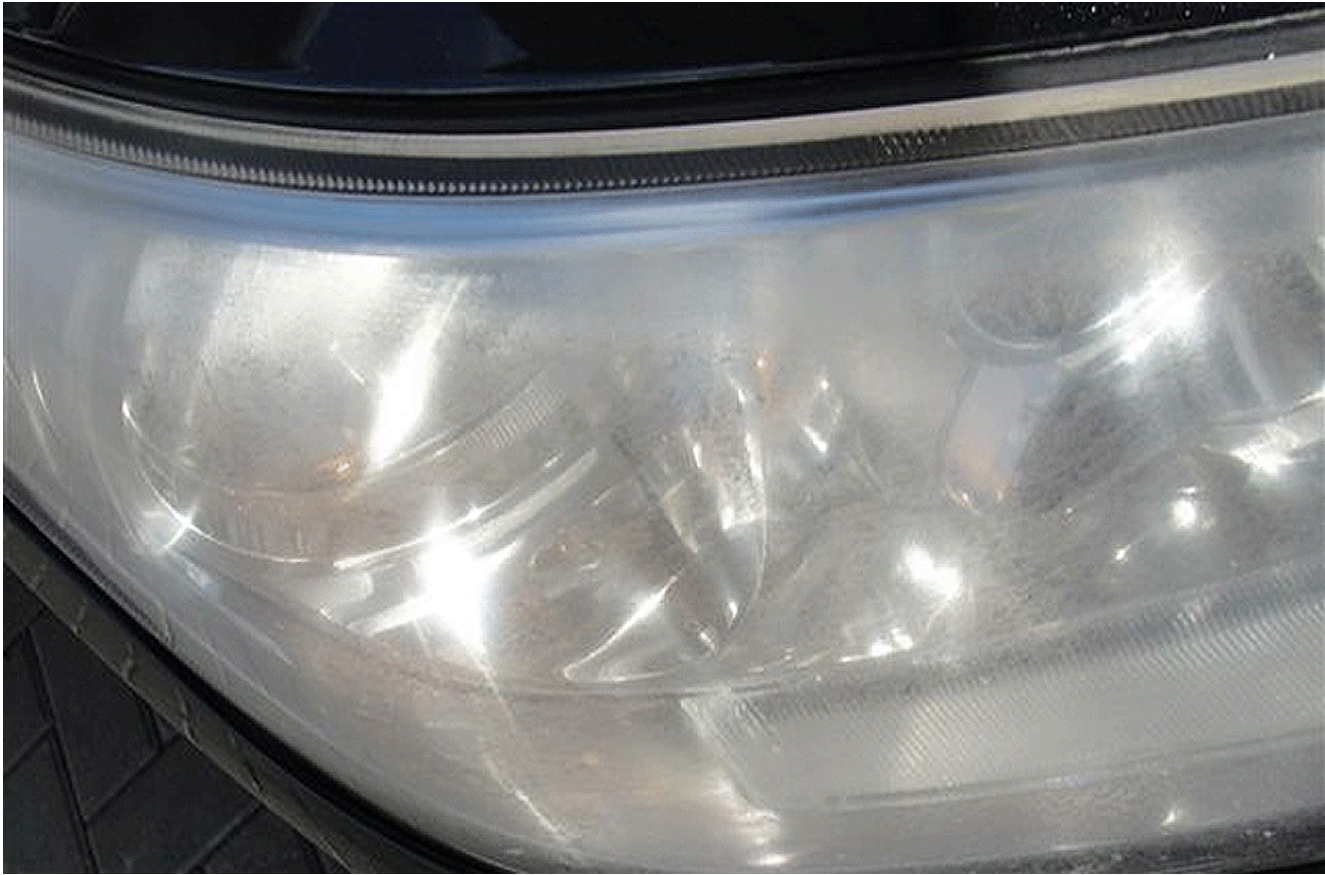
- The headlamps above show glazing caused by spray-on vehicle cleaner.

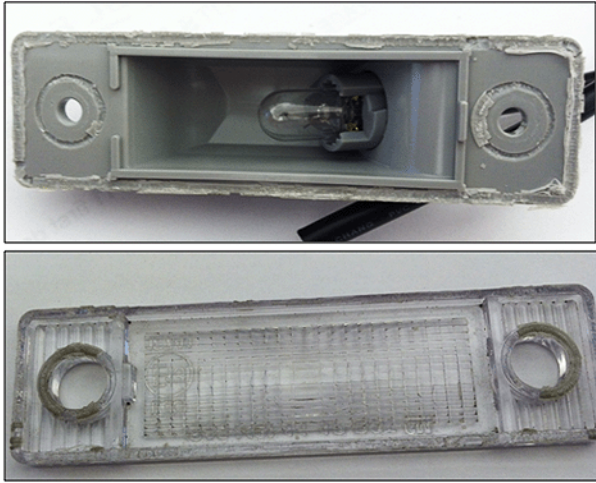
- The license lamp above exhibits a separation of the bond of the lens and housing, and a clouding of the polycarbonate lens. This condition was the result of applying chrome cleaner to the rear bumper and license lamp.

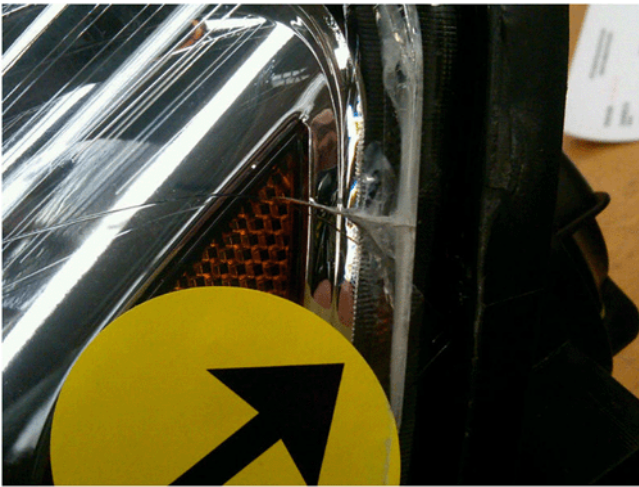
- This lamp shows some effects of chemical damage. Notice the milky color along the edge and the fracture. This was caused by a solvent used to prep the body for pin striping.

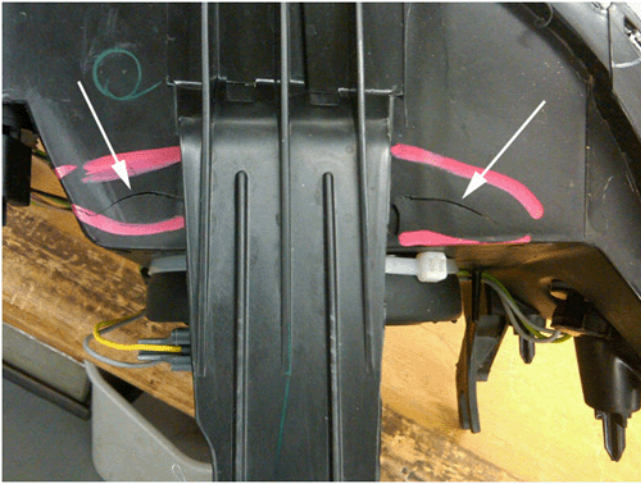
This housing is cracked across the top of the housing just below the mounting tab. Not shown is the dent at the upper edge of the lens where it impacted an object.

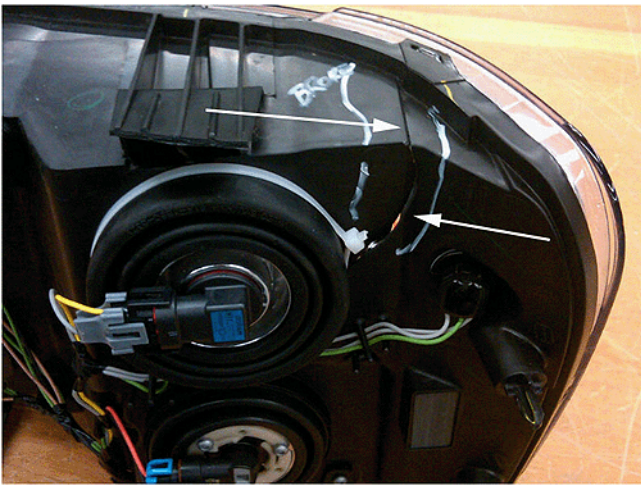
This housing shows a broken upper mounting tab and a fracture in the rear housing. This lamp had no visible marks on the lens.

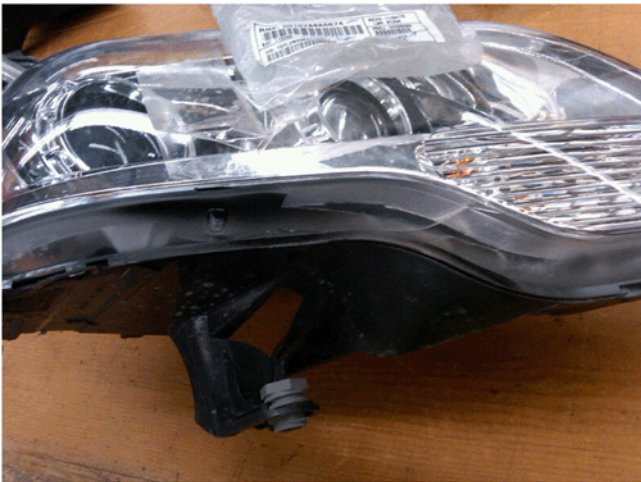
This lamp shows paint over spray along the lower edge where it would marry to the front fascia. The lower mounting tabs were also all fractured at the housing due to impact.

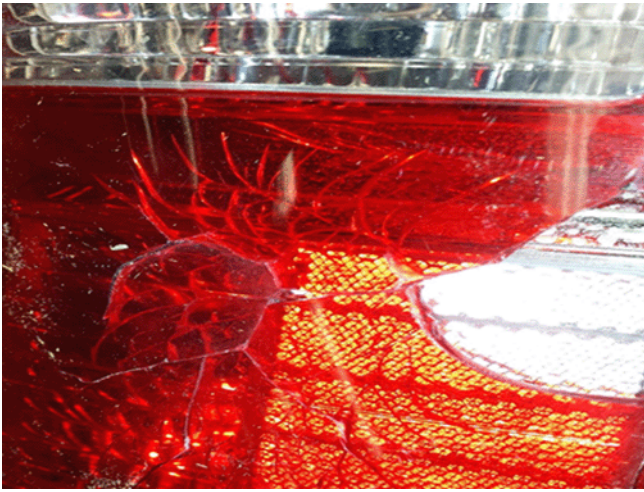
This lamp shows impact damage and internal cracking of the lens.

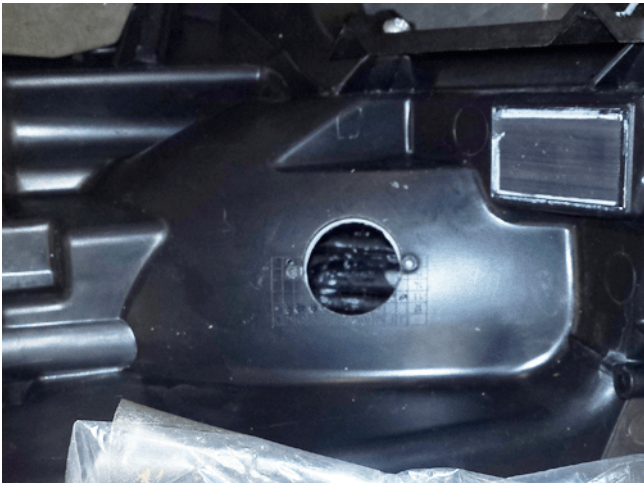
This housing shows a hole which was drilled in the lamp to accept an accessory modification.

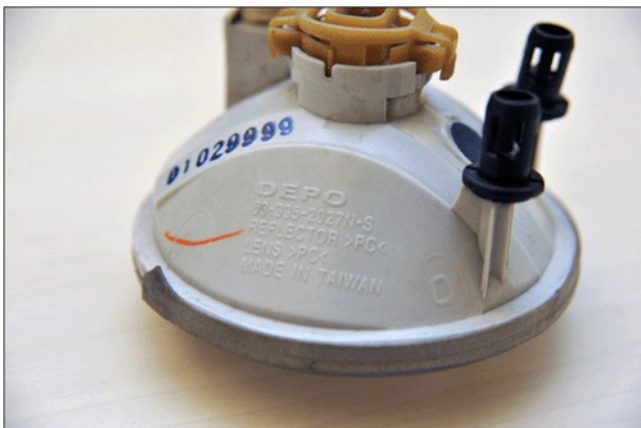
This fog lamp was returned for retaining moisture. As you can see it is marked with the Depo brand (it is also called out on the front lens).

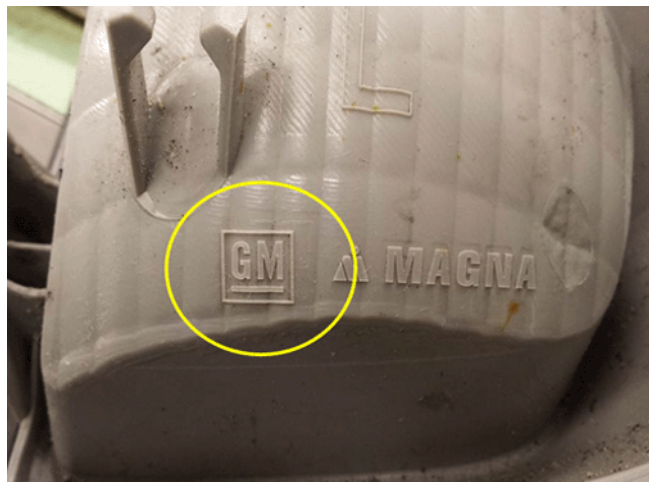
Heat Damaged Fog and Head Lamp Assemblies Caused By High Output Bulbs

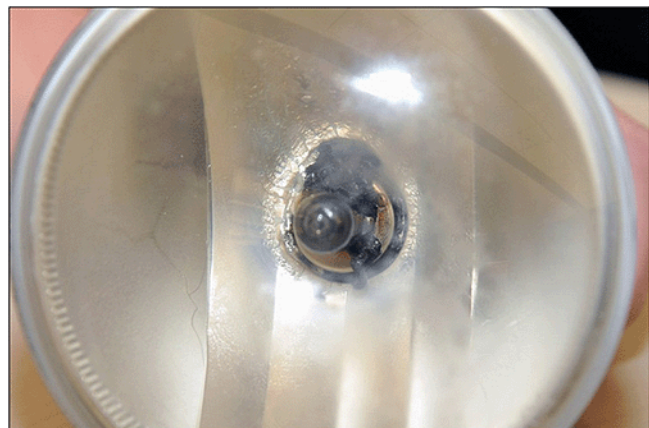
Notice: When servicing any exterior lighting assembly, be sure to transfer any electrical connection seals to the new part. They are often on the body side of the harness connection, but may have stayed on the part being replaced. If not transferred to the new part, the connection may corrode due to water entry.
