Service Bulletin

Subject: Information for Repairing Engine Front Cover Oil Leak, Sealing Surface Preparation and Applying RTV Sealant

Models: 2006-2015 GM Passenger Cars and Trucks (Including Export Vehicles)
Equipped with V6 Engine – RPO LAU, LF1, LFW, LFX, LLT, LP1, LY7 or LF3

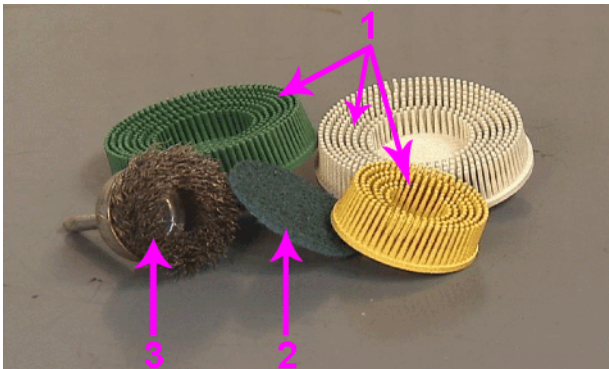
Notice: DO NOT use bristle discs (1), abrasive pads (2), wire wheels (3) or surface conditioning discs to clean the sealing surfaces of engine components.

Abrasive pads and bristle discs are embedded with abrasive material. The bristle discs wear down as they clean, continually exposing fresh abrasive to the surface of the component. These types of devices should not be used because they produce a very fine grit that the oil filter is unable to remove from the oil. **THIS GRIT IS ABRASIVE AND IS KNOWN TO CAUSE INTERNAL ENGINE DAMAGE.**

- Abrasive pads, wire wheels and bristle discs can remove enough metal to affect the engine front cover, cylinder head, engine block, oil pan rail, and intake manifold runner surface flatness, which can then result in engine coolant leaks, engine oil leaks and air leaks. It takes about 15 seconds to remove 0.203mm (0.008in) of metal with an abrasive pad.

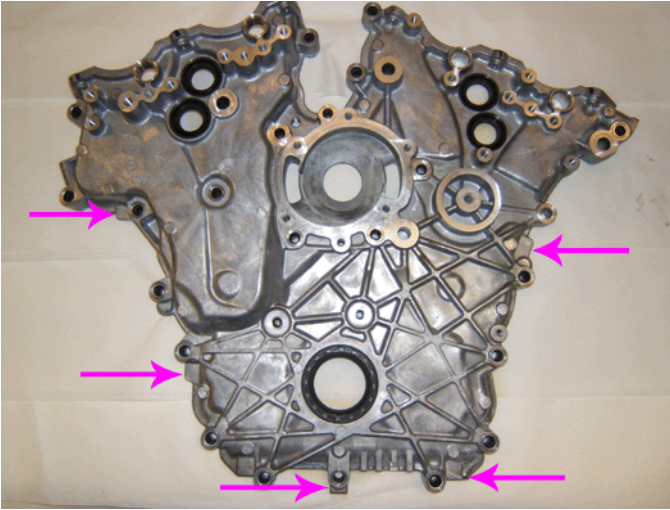
- Use the incorporated pry points to separate the engine front cover from the engine block.
- The pry points are positioned so that other vital engine components are not damaged when the pry points are used.
- Do not try to separate RTV sealed components by prying against other engine components.

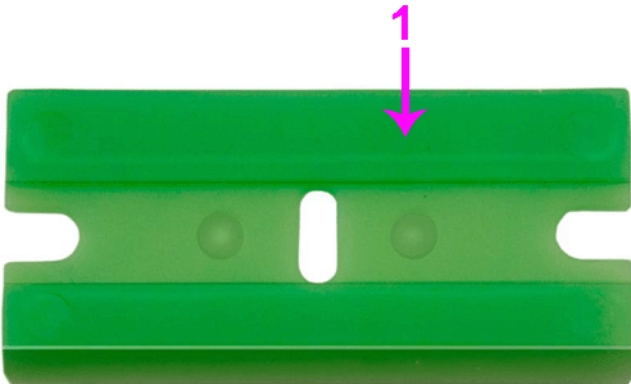
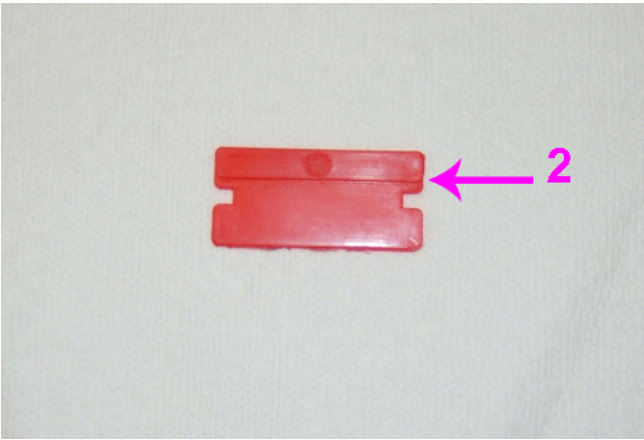
- Use a plastic razor blade (1), that mounts in a scraper device or a hand held plastic razor blade (2), to remove old RTV sealant from a sealing surface. Use a new blade for each corresponding engine component surface. Hold the blade as parallel to the flat surface as possible.

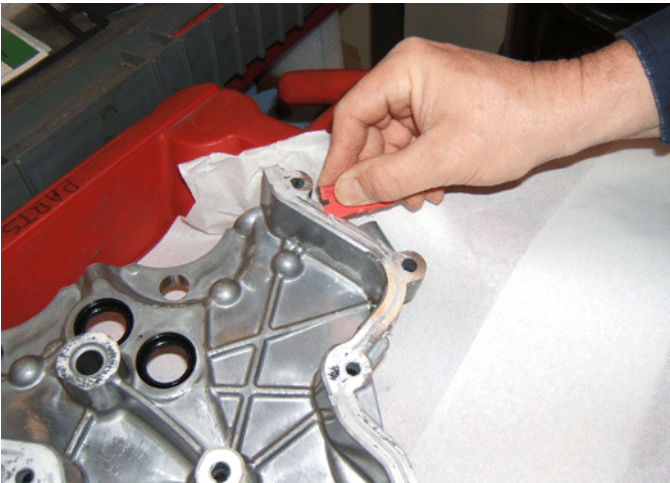
- Position and work the blade back and forth in the grooved areas of the component to loosen and remove the old RTV.

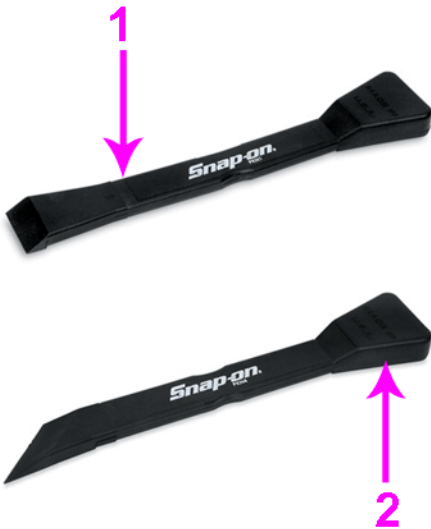
- When using a plastic gasket scraper with a straight blade (1) to remove old RTV sealant from a sealing surface, hold the scraper as parallel to the flat surface as possible.
Use a plastic gasket scraper with an angle blade (2) and work the blade back and forth in the grooved areas of the component to loosen and remove the old RTV.
- Clean the engine front cover in solvent.
- Dry the engine front cover with compressed air.

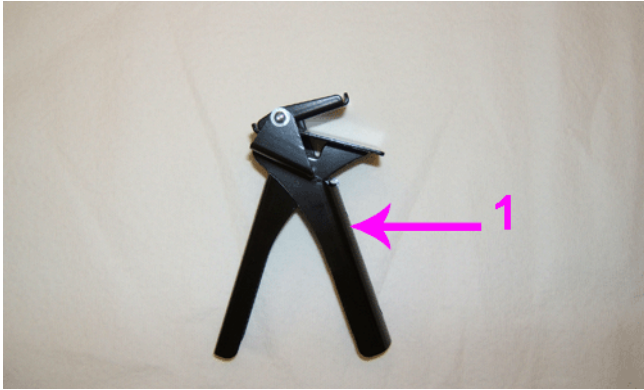
- Use a Tube Grip® dispensing device (1) or an equivalent to apply the new RTV sealant for the following reasons:
 - A precise application of the RTV sealant bead to the component, in the specified amount.
 - The dispensing device will squeeze 35 % more material out of the tube, reducing waste.
 - Using the device will eliminate most cleanup.

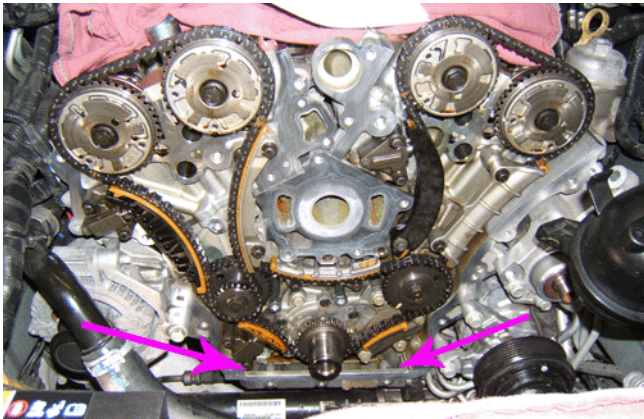
4. Insert a piece of cardboard at the front of the oil pan in the area shown to prevent any contaminants and debris from falling into the oil pan.

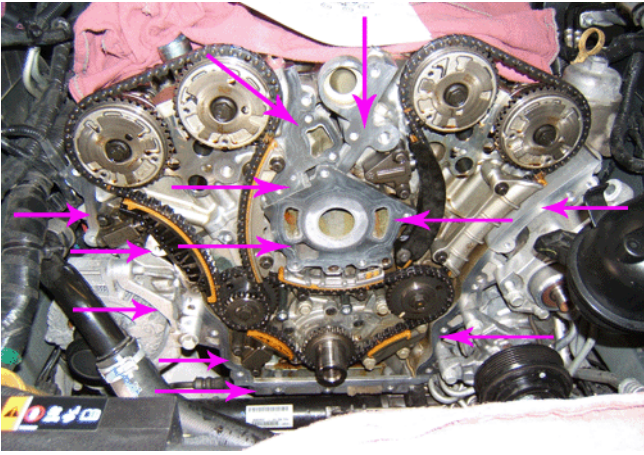
5. Using the tool or tools as outlined in this bulletin, carefully clean the front cover sealing surfaces on the **engine**.
6. Clean out any debris from the bolt holes for the front cover fasteners in the **engine**.

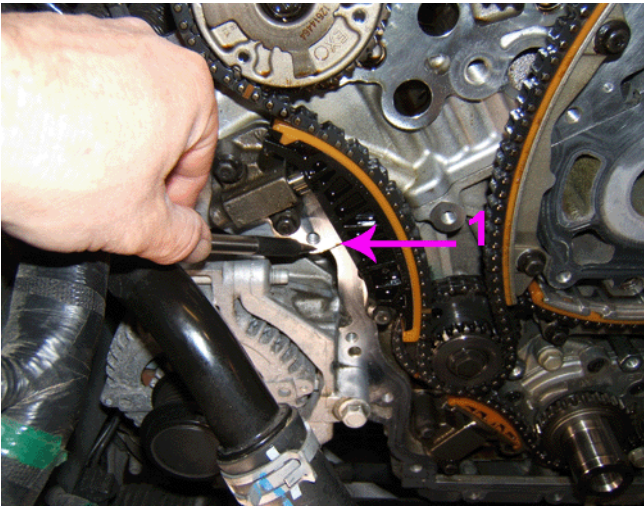
7. Clean out any debris from the T-joint (1) where the left side of the cylinder head meets the engine block.

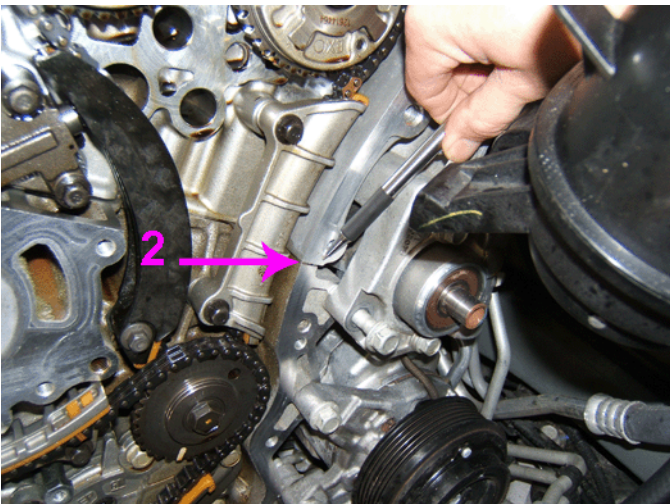
8. Clean out any debris from the T-joint (2) where the right side of the cylinder head meets the engine block.

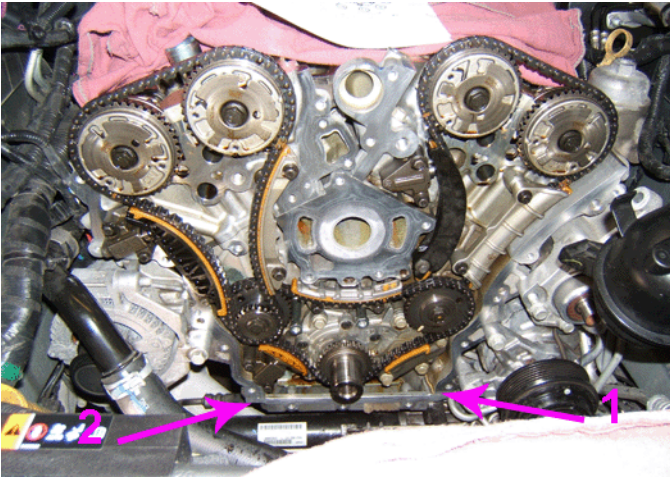
9. Clean out any debris from the T-joint (2) where the left side of the oil pan meets the engine block.

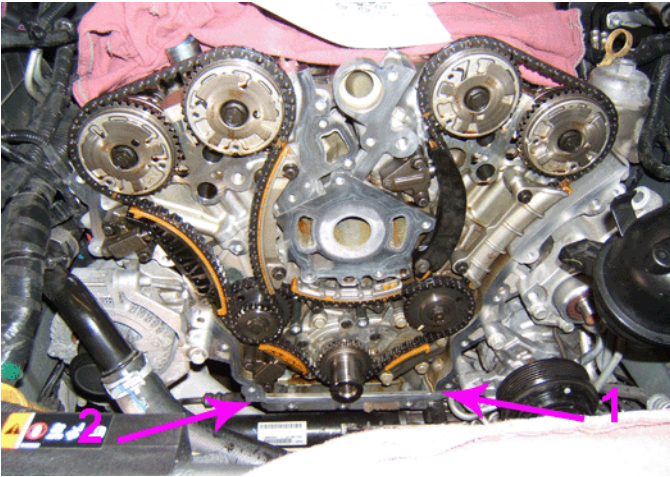
10. Clean out any debris from the T-joint (1) where the right side of the oil pan meets the engine block.
11. Spray GM Low VOC Cleaner, P/N♦19287401 (in Canada, P/N 88901247) or an equivalent, on the mating surfaces of the **engine** side for the front cover and allow it to soak in for 5 minutes.

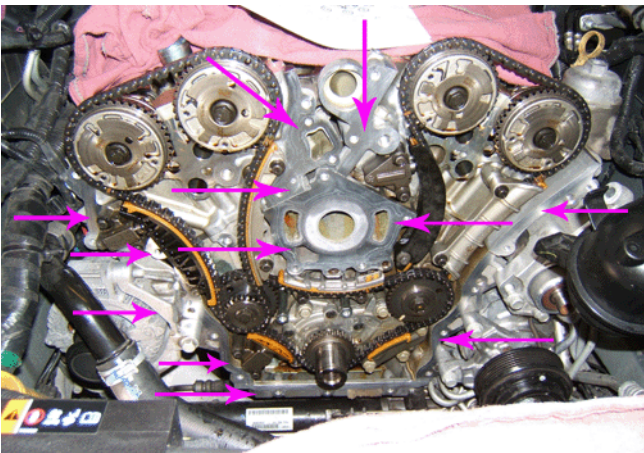
12. Wipe the front cover mating surfaces on the **engine** with a folded lint free shop cloth. Rotate the shop cloth until there are no more visible signs of contamination on the cloth.
13. Spray GM Low VOC Cleaner, or an equivalent, on the mating surfaces of the front cover and allow it to soak in for 5 minutes.

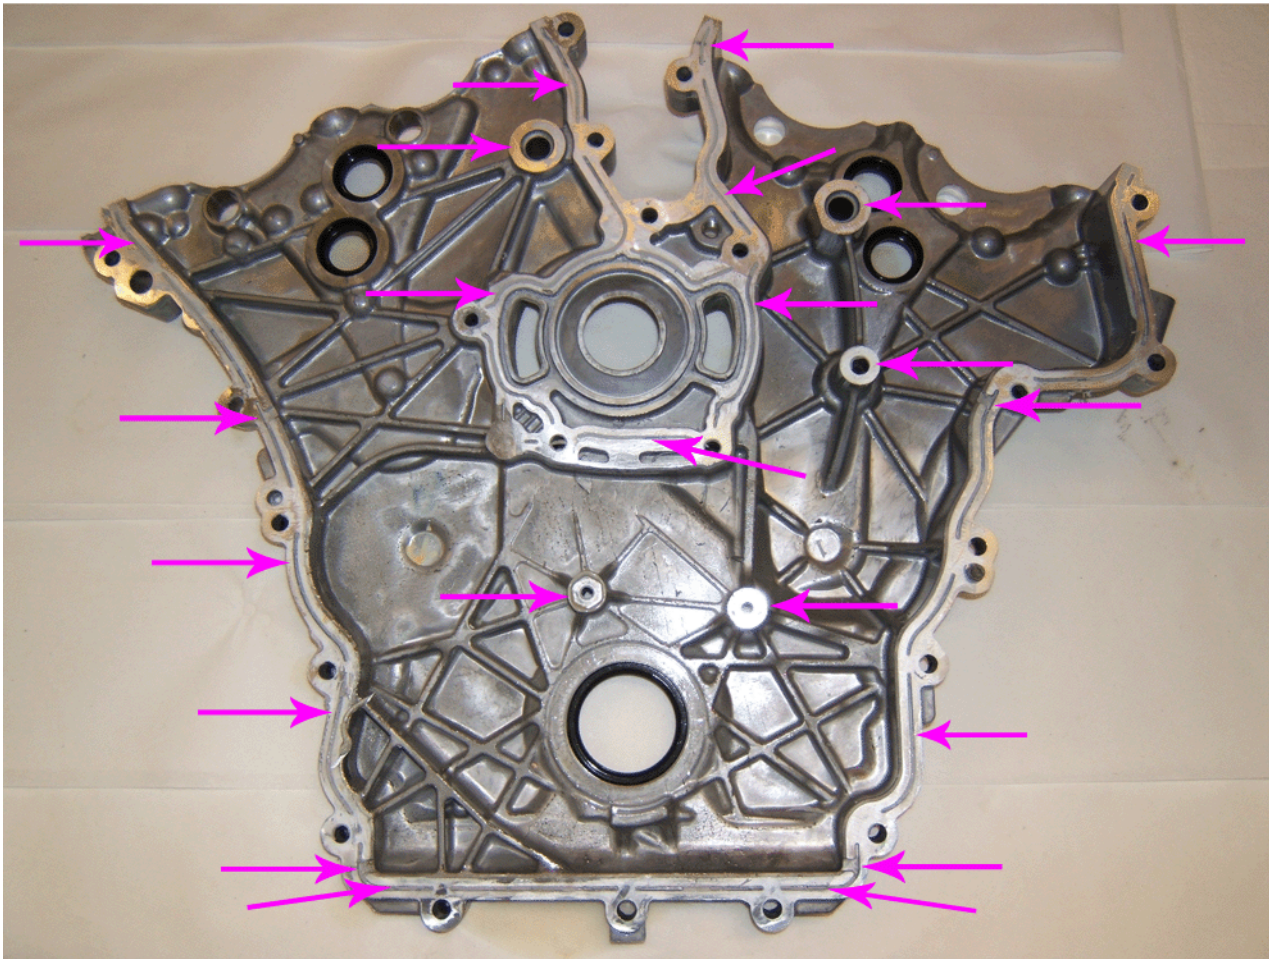
14. Carefully clean the front cover sealing surfaces and grooves.
15. Clean out any debris from the bolt holes for the front cover fasteners.
16. Drain and wipe the remaining oil from the front cover.
17. Dry the front cover with compressed air.

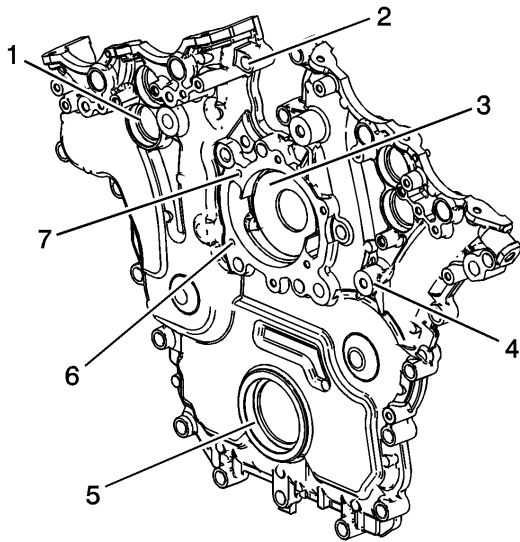
18. Inspect the exterior of the front cover for the following conditions:
 - Damage to the camshaft position actuator valve oil seal bores (1).
 - Damage to any bolt holes (2).
 - Damage and/or corrosion to the engine coolant passage (3).

- Dents or damage to the exterior (4).
 - Damage to the crankshaft front oil seal bore (5).
 - Gouges or damage to the water pump sealing surfaces (6).
 - Damage to the water pump bolt hole threads (7).
- ⇒ If any of the above conditions are found, repair or replace the front cover as necessary.

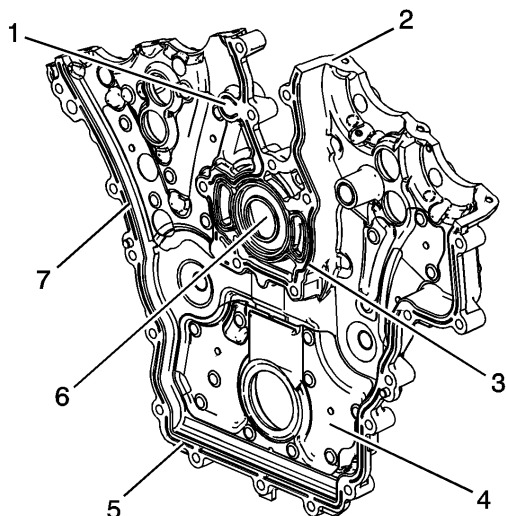
19. Inspect the interior of the front cover for the following conditions:

- Damage to any bolt holes (1).
- Gouges or damage to the cover sealing surfaces to the engine block (7), oil pan (5) and camshaft covers (2).
- Gouges or damage to the water pump seal area (3).
- Loose or damaged deadener plates (4).
- Damage and/or corrosion to the engine coolant passage (6).
- Damage to the crankshaft front oil seal bore.
- Gouges or damage to the O-ring sealing areas.

⇒ If any of the above conditions are found, repair or replace the front cover as necessary.

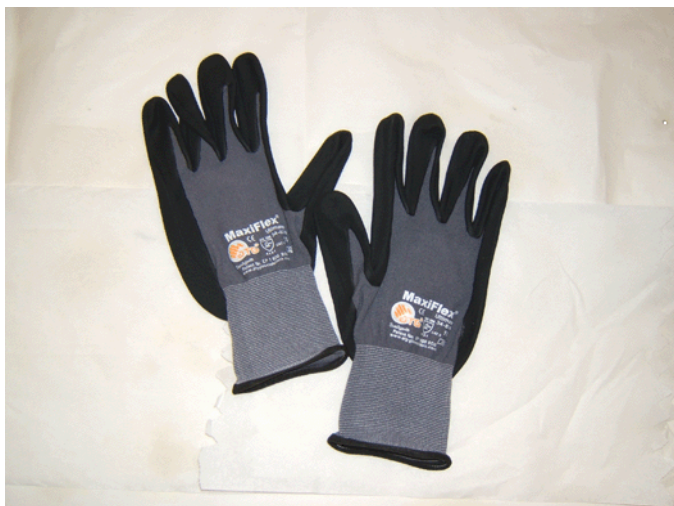
Notice: Wear Gloves. After the final cleaning with GM Low VOC Cleaner and before reassembly, DO NOT touch the cleaned surfaces with your bare hand. The oils from your skin WILL CONTAMINATE the surfaces and prevent proper bonding of the new RTV sealant.

20. Clean the sealing surface prior to reassembly by spraying GM Low VOC Cleaner, on a folded lint free shop cloth. Wipe the mating surfaces and rotate the shop cloth until there are no more visible signs of contamination on the cloth.

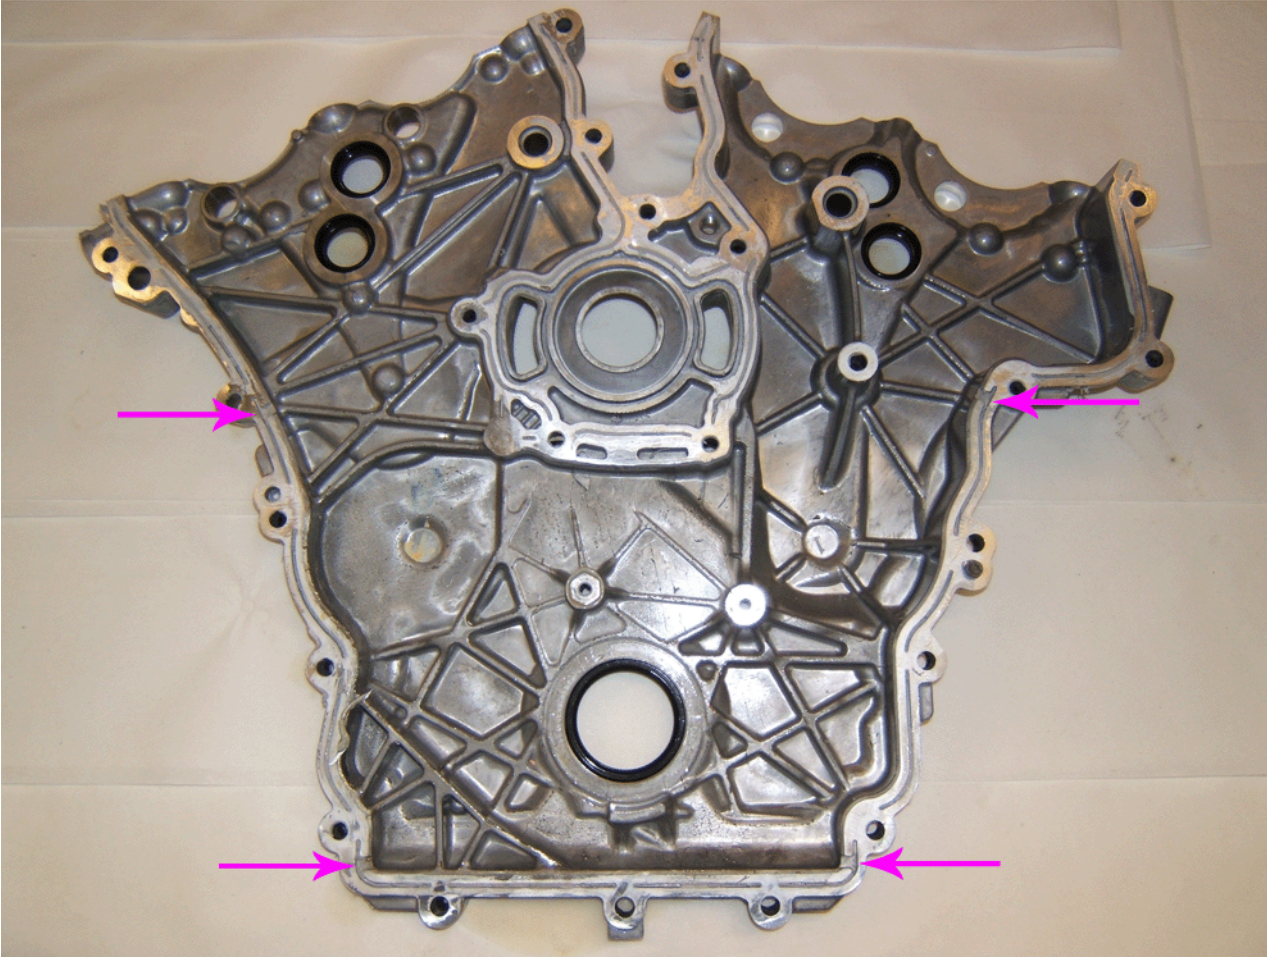
Oil leaks at the T-joints are one of the most common conditions encountered.

23. Apply a 5 mm bead of RTV sealant to the **T-joints** on the front cover in order to ensure that there is enough sealant to extend into the joint.

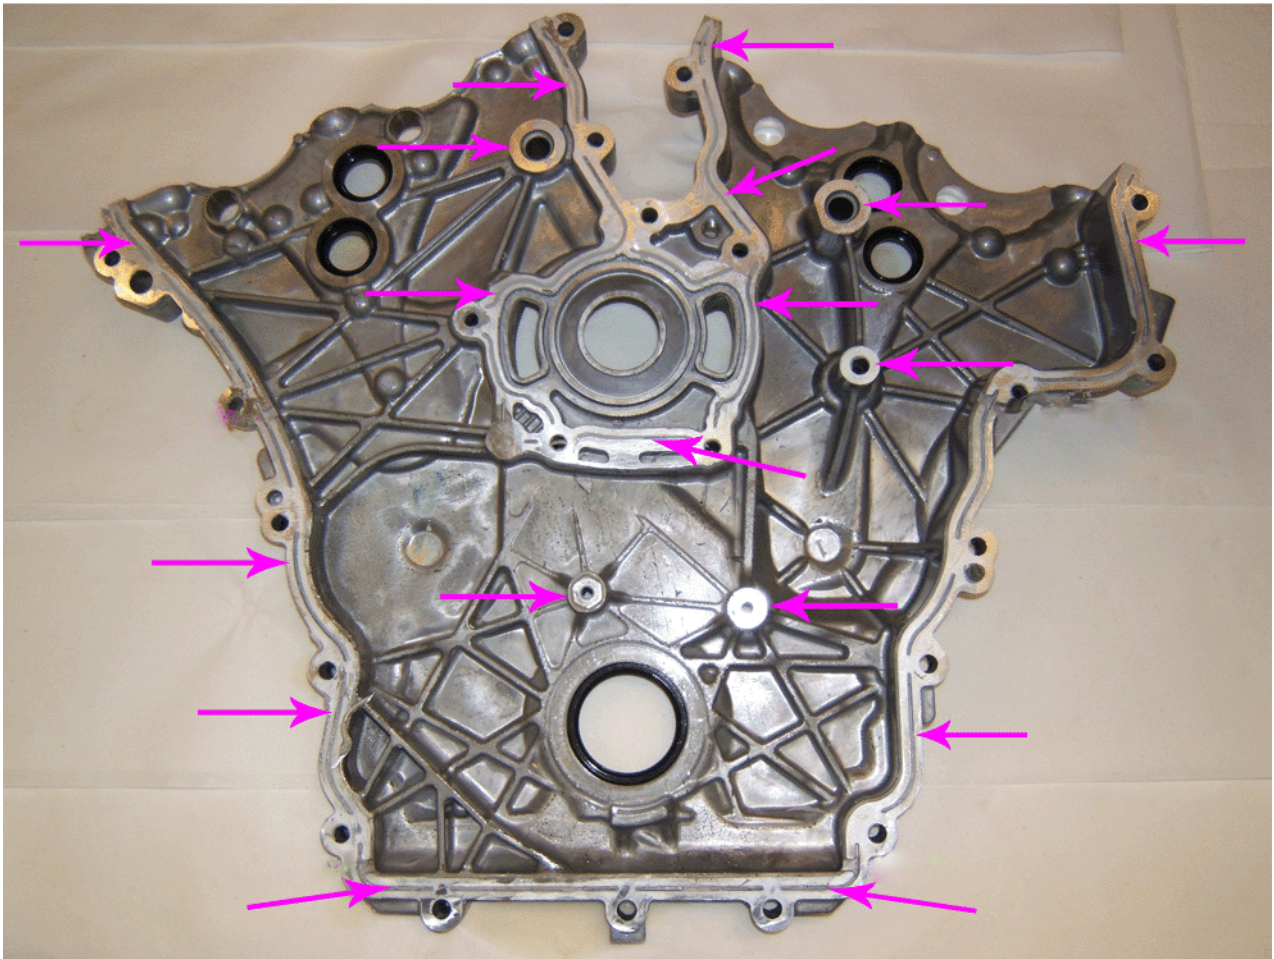
24. Apply a 3 mm bead of RTV sealant to the remaining front cover sealing surfaces.

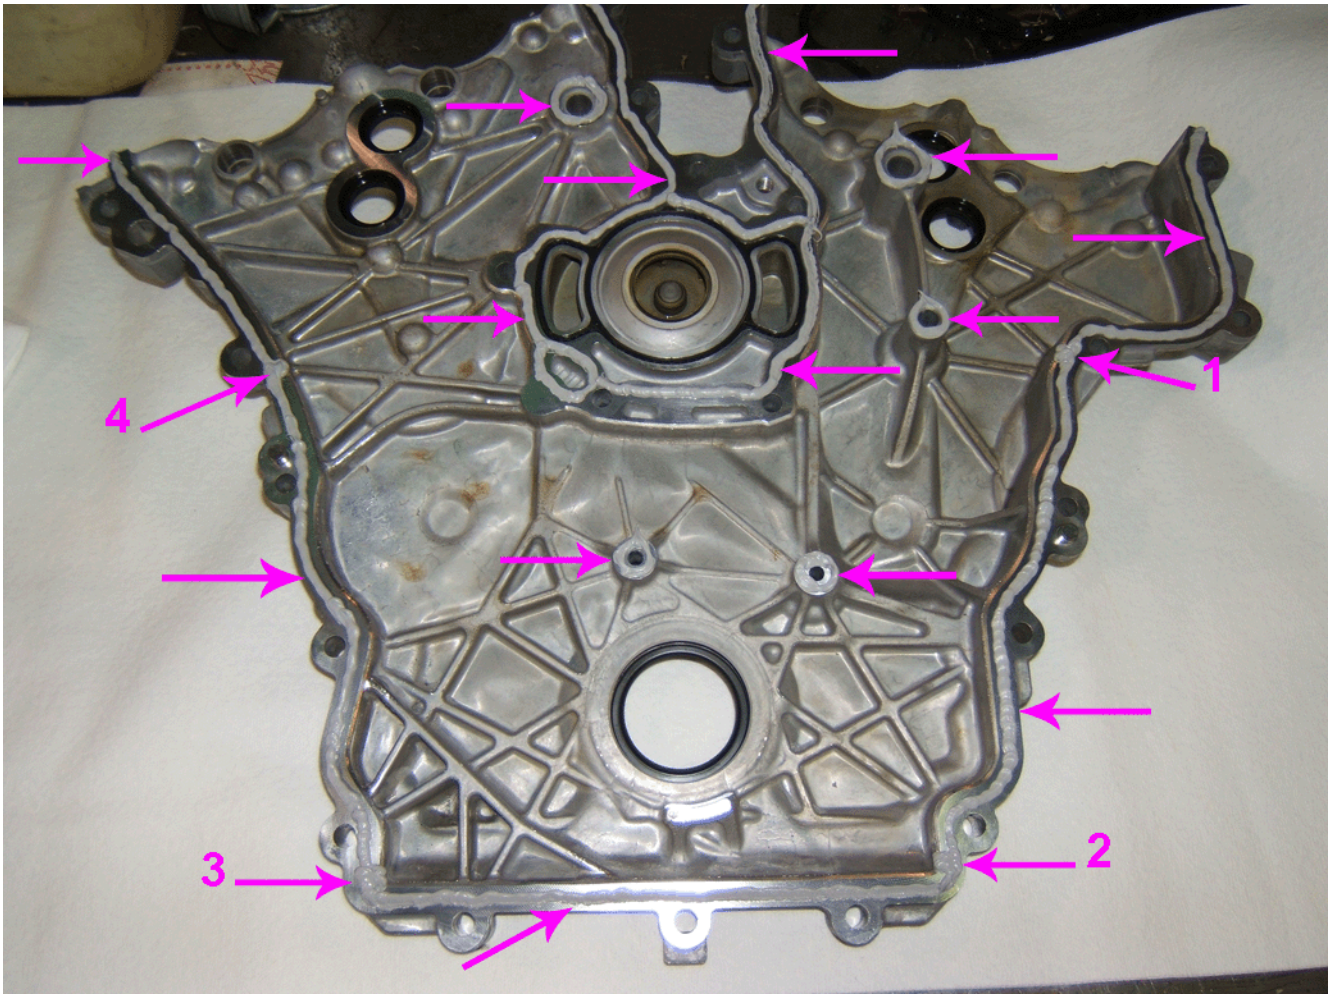
25. This is a typical view of the proper application of the RTV sealant to the front cover, with a 5 mm bead of RTV sealant to the T-joints (1, 2, 3, 4) and a 3 mm bead of RTV sealant to the rest of the sealing surfaces.
