ATB 51971-01292 REV5 (1412)

## Recall: Driver's Airbag Inflator May Produce Excessive Pressure After Long-Term Exposure to High Absolute Humidity

Supersedes 14-045, dated November 18, 2014, to revise the information highlighted in **yellow**

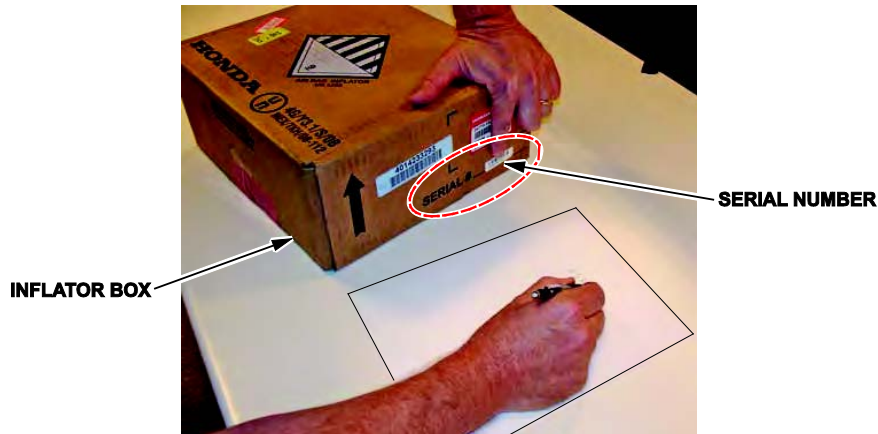
1. Remove the driver's airbag.
  2. Write down the serial number located on the right side of the new inflator's box. For the warranty claim to be paid, your warranty clerk must enter this serial number in the Diagnostic Trouble Codes field on the warranty claim.

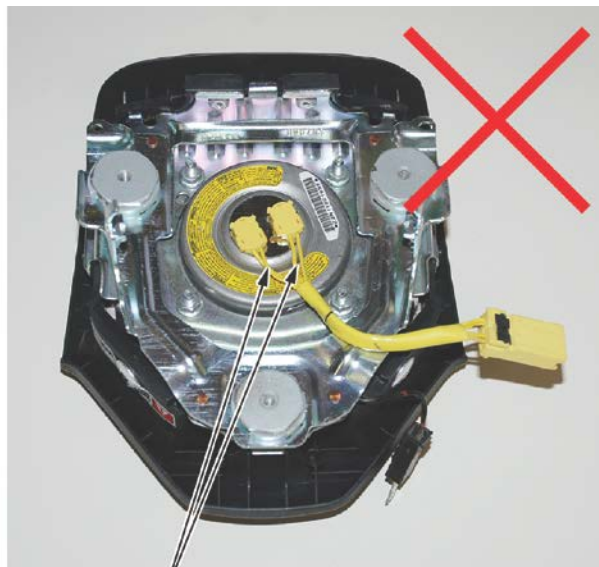
3. Place the airbag, face down, on a clean shop towel.
4. Visually inspect the airbag and the inflator for any unusual writing or markings.
  - If there is nothing unusual about the airbag or the inflator, go to step 5.
  - If there are any unusual markings, like an incorrect label or a model year written in marker, the airbag and inflator may not be the correct airbag and/or inflator for the vehicle or it may be a counterfeit part. For more information about counterfeit airbags, you can refer to [safercar.gov](http://safercar.gov), enter keywords **MANAGING COUNTERFEIT**, and select **Recommended Dealer Guidance for Managing Counterfeit Air Bags** from the list. **If you suspect that the airbag or inflator is counterfeit, do not continue this procedure.** Contact your DPSM for assistance.
