**Number:** FS-2017-03

**Subject: Maintenance Instructions On Neway 29' Bus Rear Suspension**

## ADLSD Suspensions

### ADLSD Shim and Spacer Installation, Bushing Inspection and Equalizing Blade Wear

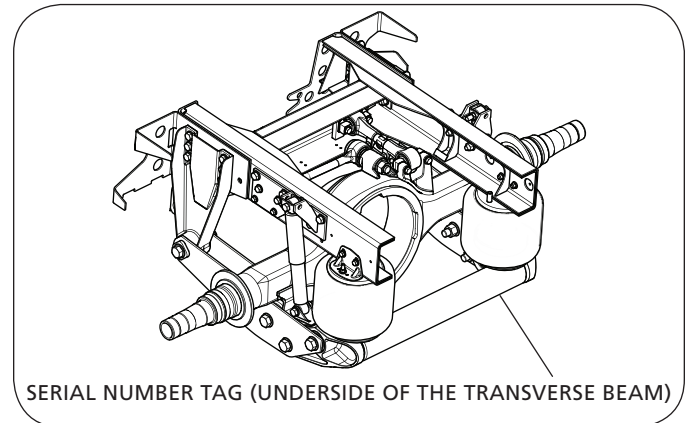
Figure 1

The serial tag is found on the underside of the transverse beam (**Figure 1**). The serial tag contains important suspension information including the part number (**Figure 2**). The affected part numbers are as follows:

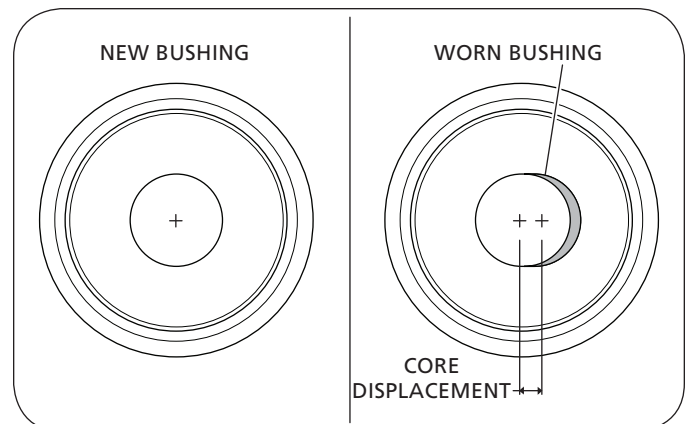
Figure 3

Suspension bushing inspection is required during regularly scheduled preventative maintenance. If any of the pivot, axle adapter, or transverse beam bushings appear to be worn showing permanent core displacement it is recommended to replace the bushings. The allowable radial bushing core displacement is 0.20" (5.0 mm) (**Figure 3**). The service kit shown on Page 6 was created for Gillig ADLSD bushing replacement.

**IMPORTANT:** The use of oil-based lubricants, brake fluid or never-seez<sup>®</sup> will lead to degradation of bushing rubber resulting in accelerated wear out or separation from core. SAF-HOLLAND recommends International Products P80 or similar "rubber friendly" products to aid in bushing insertion.

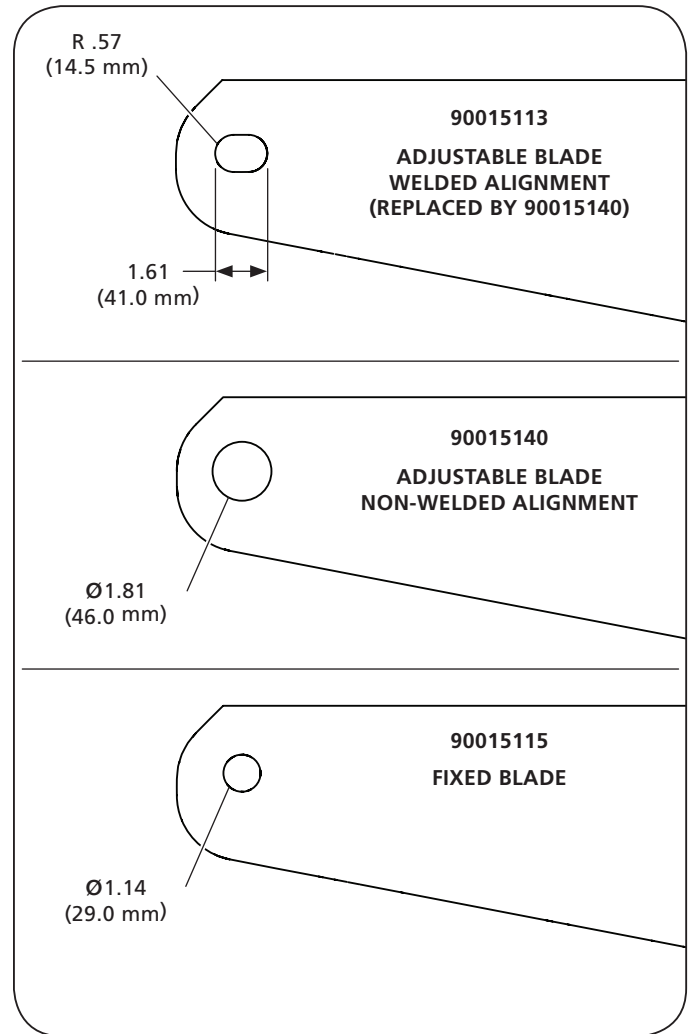
**Figure 5**

During a regularly scheduled preventative maintenance inspection, inspect the equalizing beam blades for wear at all connection points. Some surface wear is acceptable and is only considered excessive if the wear is deeper than .06" (1.6 mm) from the normal surface. If the wear is deemed excessive, equalizing beam blade replacement is recommended. Determine the equalizing beam type (fixed or adjustable) to determine which service kit to use (**Figure 5**).

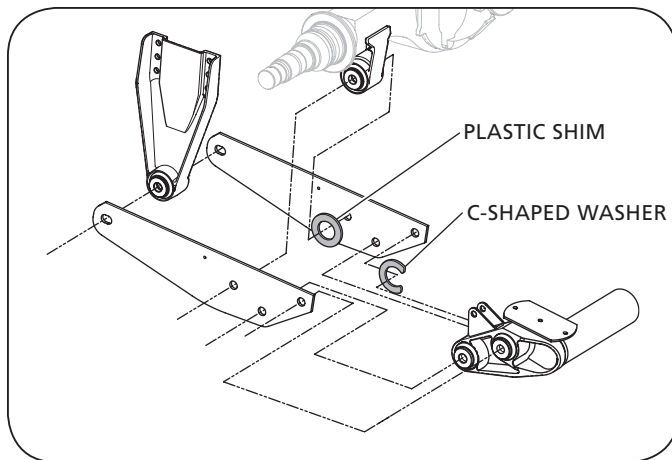
**Figure 4** shows the correct placement for both the C-Shaped washer and the plastic shim.

**IMPORTANT:** The use of additional washers or shims in any other locations than shown will restrict the suspension movement which could lead to blade failure.

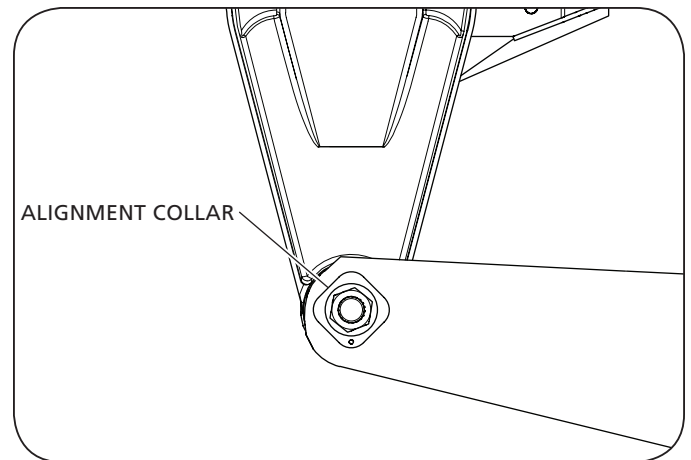
**Figure 6**

**NOTE:** If your suspension has a welded alignment, the replacement will be a non-welded alignment style blades and include an alignment collar (**Figure 6**). Service kits shown on pages 4 and 5 were created for Gillig ADLSD blade replacement.

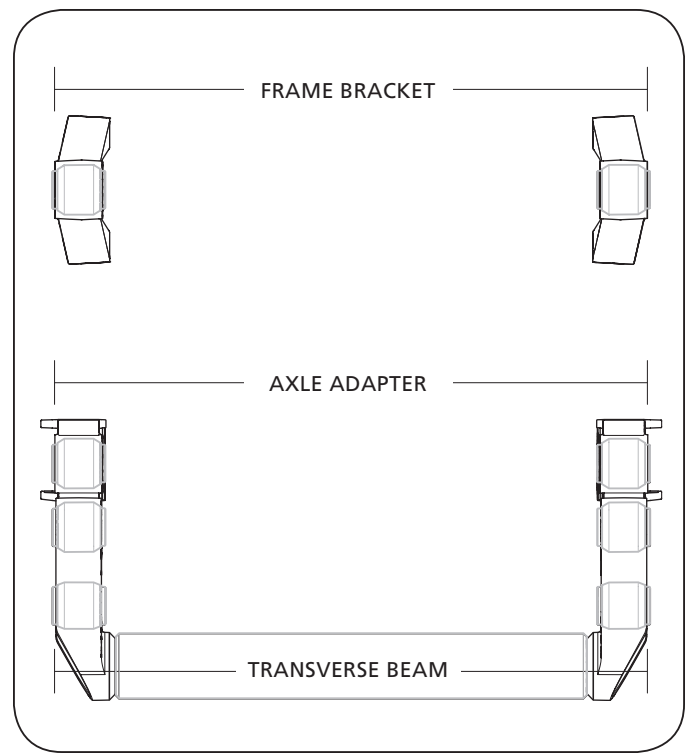
Figure 7

Prior to replacing equalizing beam blades, measure all connection points as illustrated (**Figure 7**).

**IMPORTANT:** Measurement should not include bushing core offset and should be outside widths of castings as close to bushing receptacle edges as possible.

If the axle adapter is greater than .25" (6.4 mm) wider than other attachment points a bushing shim kit is required. Refer to Page 7 for bushing shim service kit and shim location.

**NOTE:** The purpose of the shim is to get the frame bracket, axle adapter and transverse beam connections within .25" (6.4 mm) or less measured across their widths.

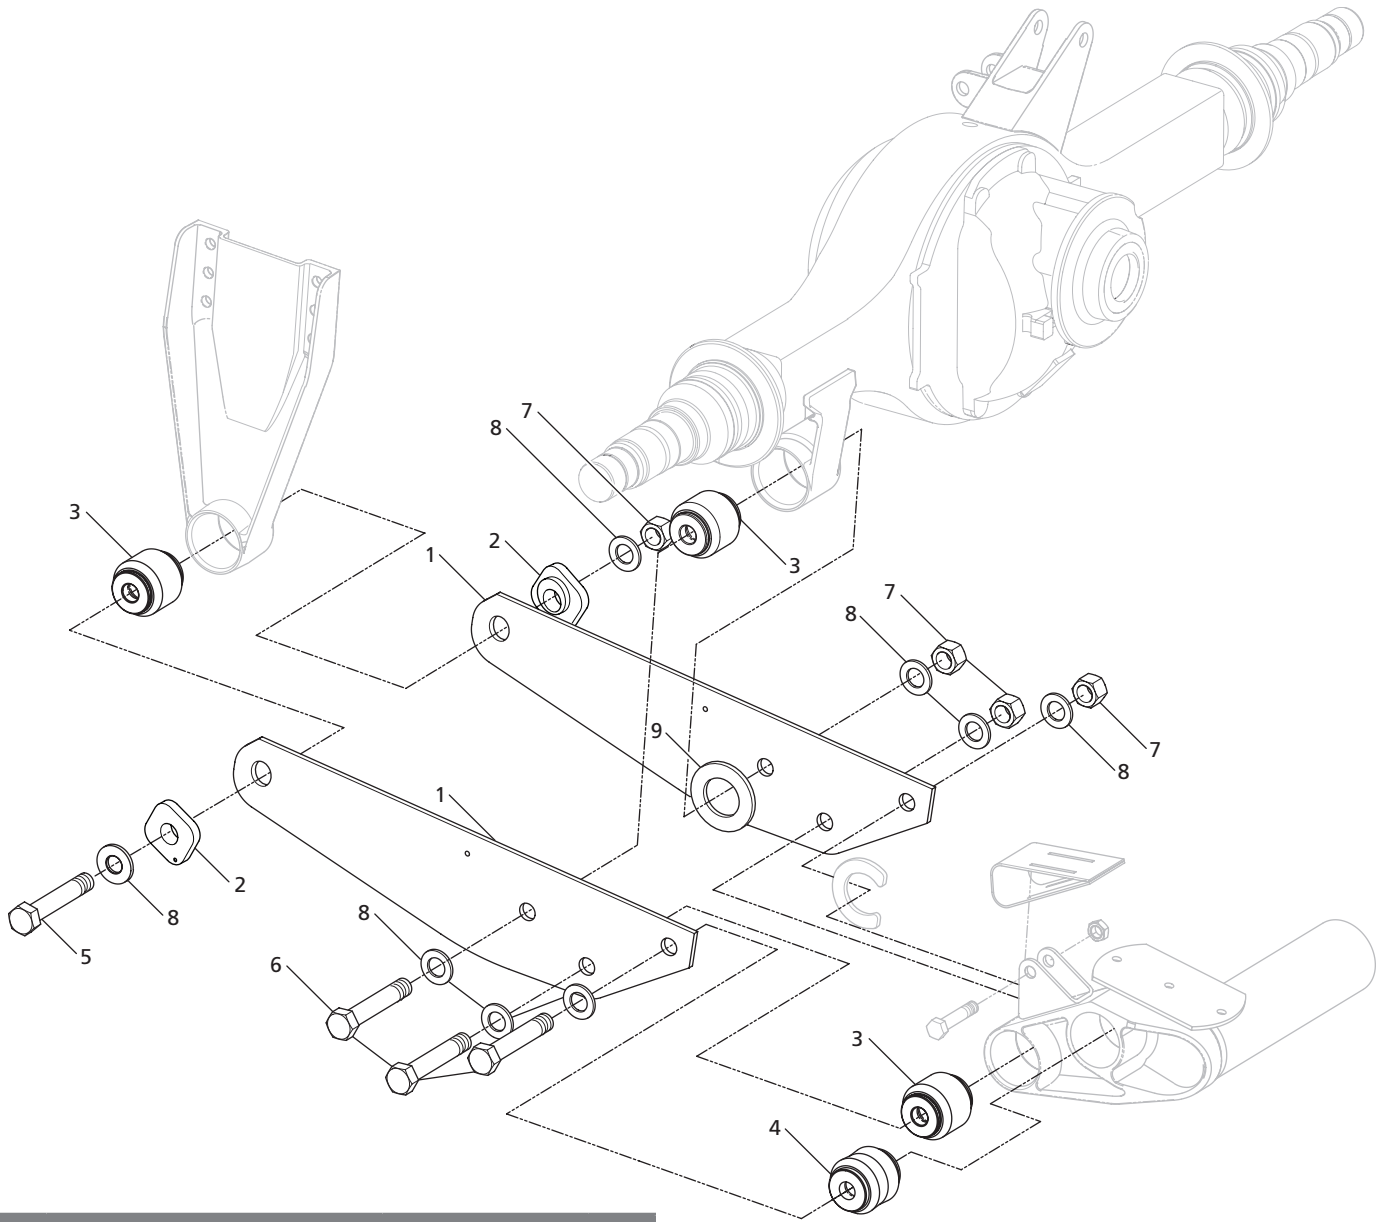
ADJUSTABLE BEAM: 48100665, SRK-799			
ITEM	DESCRIPTION	PART NUMBER	QTY.
1	Beam, Equalizing – ADJ	90015140	2
2	Block, Alignment	90008268	2
3	Bushing	90008191	3
4	Bushing	90008241	1
5	Bolt, Hex – 1.13-7 x 7.5 GR 8	93004541	1
6	Bolt, Hex – 1.13-7 x 7 GR 8	93004529	3
7	Nut, Hex – 1.13-7 GR C	93400506	4
8	Washer, Flat – 1.13 Narrow	93600174	8
9	Shim, Pivot	90036268	1
10	Service Bulletin (Not Shown)	XL-AS200735B-en-US	1

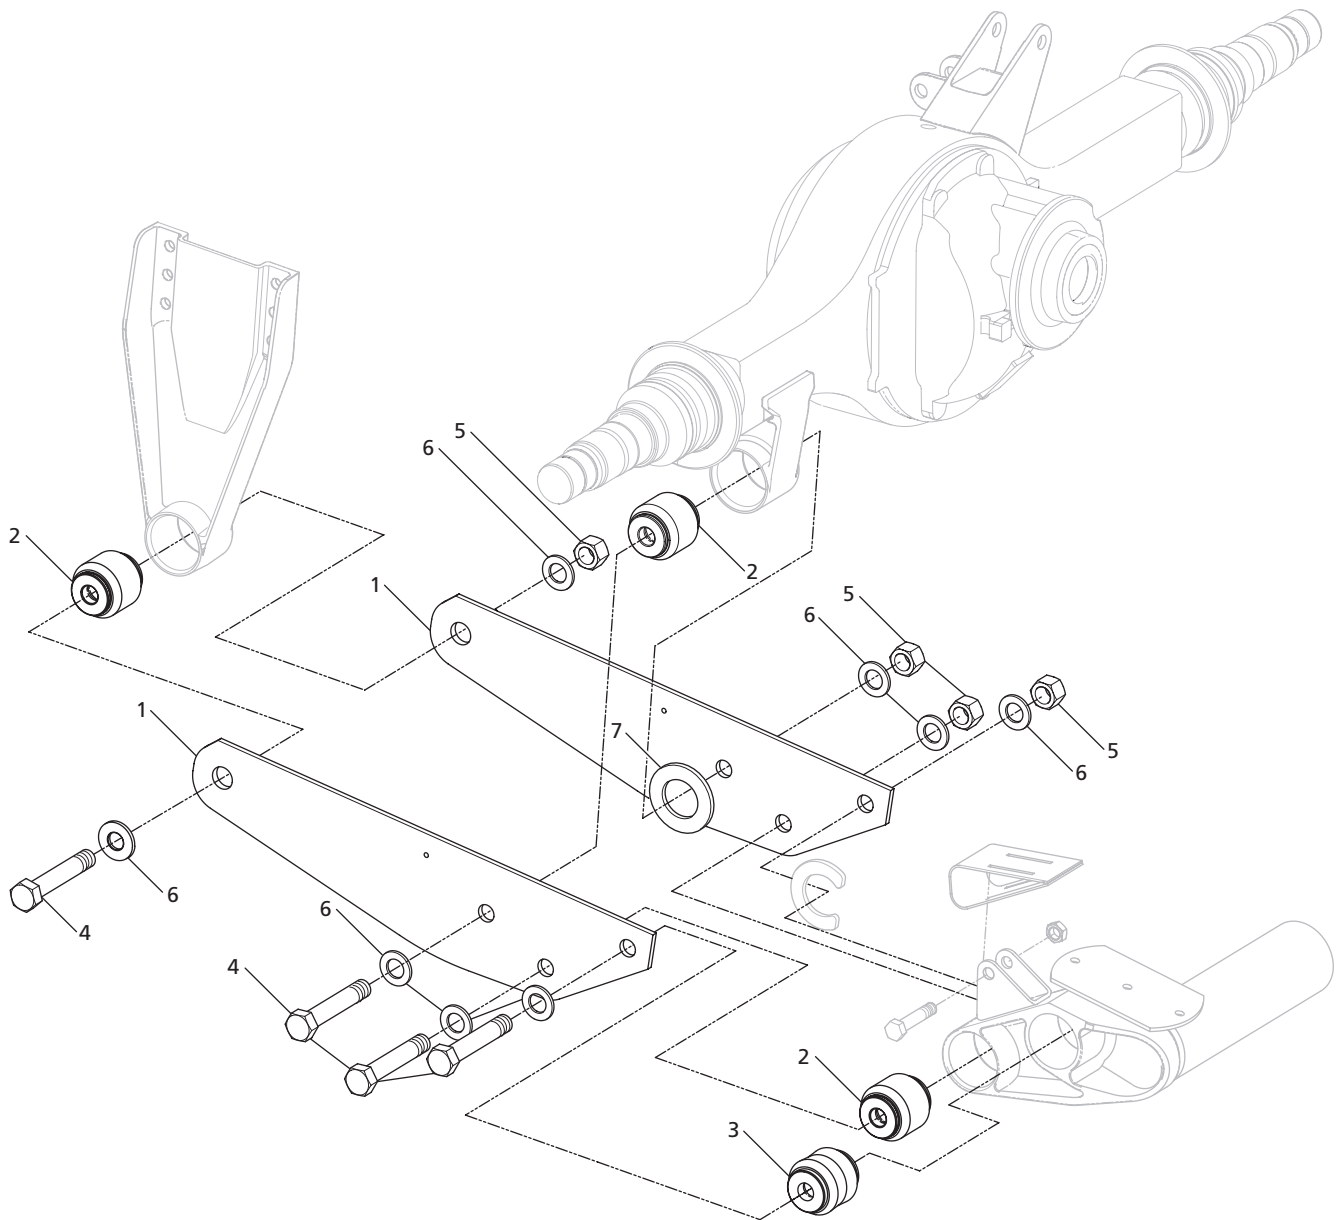
FIXED BEAM: 48100666, SRK-800			
ITEM	DESCRIPTION	PART NUMBER	QTY.
1	Beam, Equalizing – FIXED	90015115	2
2	Bushing	90008191	3
3	Bushing	90008241	1
4	Bolt, Hex – 1.13-7 x 7 GR 8	93004529	4
5	Nut, Hex – 1.13-7 GR C	93400506	4
6	Washer, Flat – 1.13 Narrow	93600174	8
7	Shim, Pivot	90036268	1
8	Service Bulletin (Not Shown)	XL-AS200735B-en-US	1

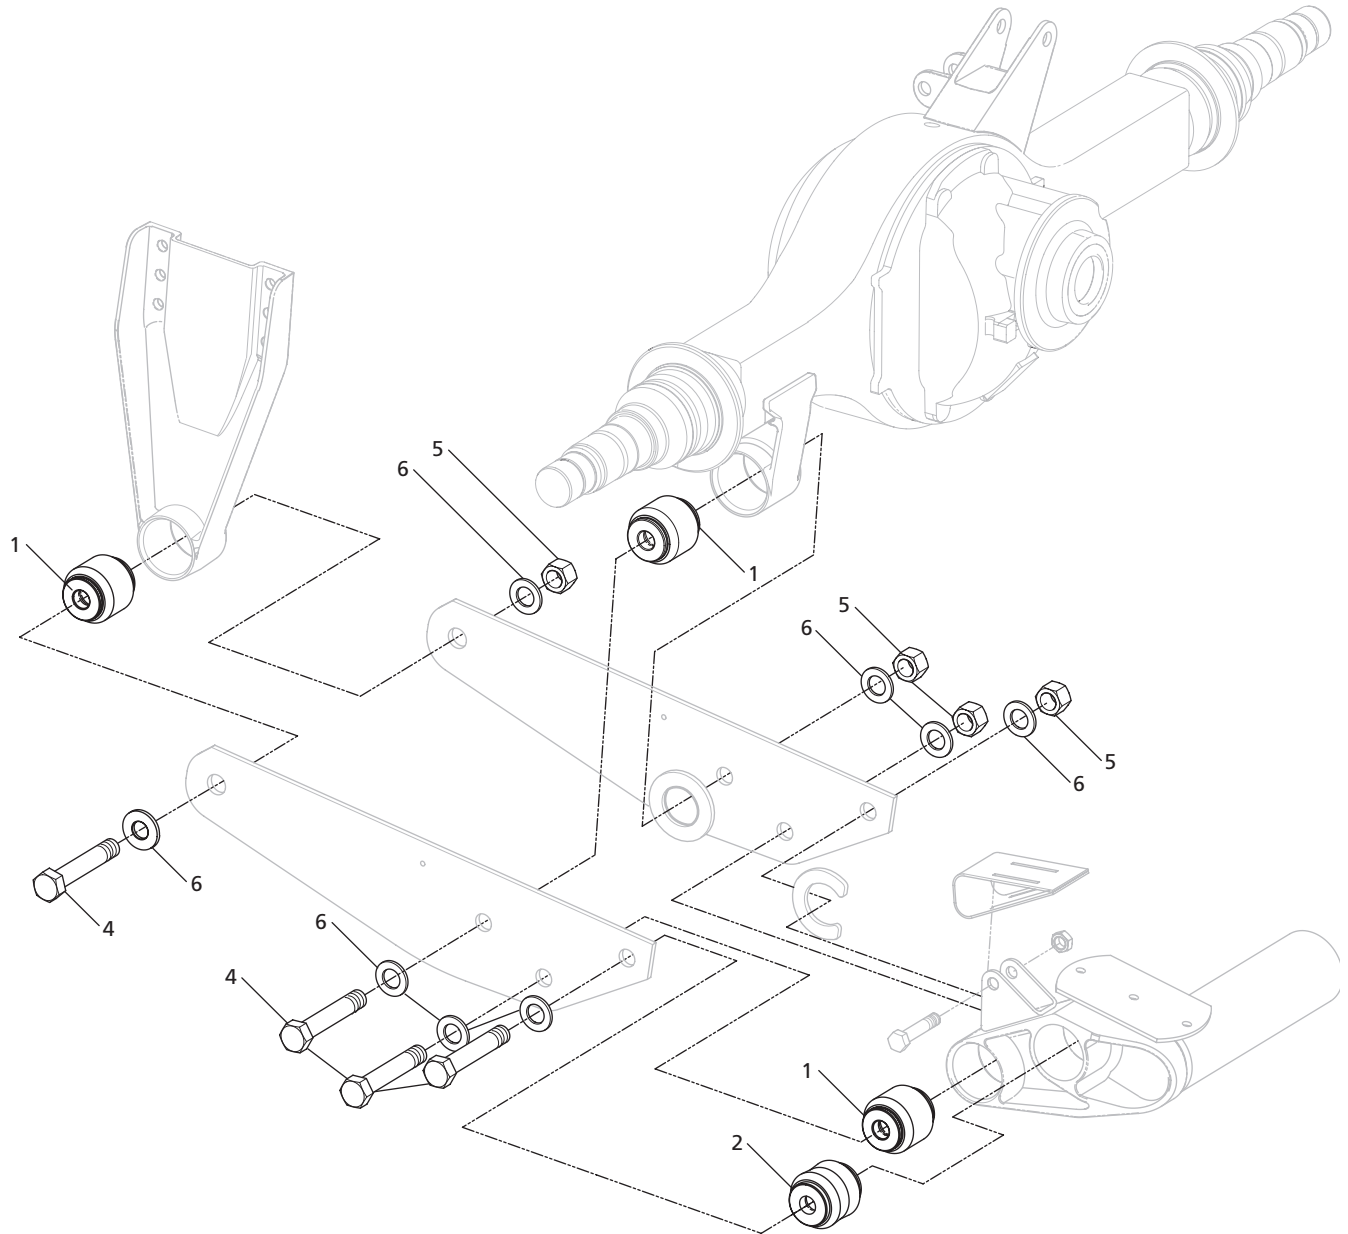
BUSHING KIT: 48100667, SRK-801			
ITEM	DESCRIPTION	PART NUMBER	QTY.
1	Bushing	90008191	6
2	Bushing	90008241	2
3	Bolt, Hex – 1.13-7 x 7.5 GR 8	93004541	1
4	Bolt, Hex – 1.13-7 x 7 GR 8	93004529	7
5	Nut, Hex – 1.13-7 GR C	93400506	8
6	Washer, Flat – 1.13 Narrow	93600174	16
7	Service Bulletin (Not Shown)	XL-AS20073SB-en-US	1

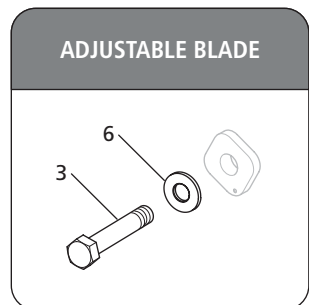
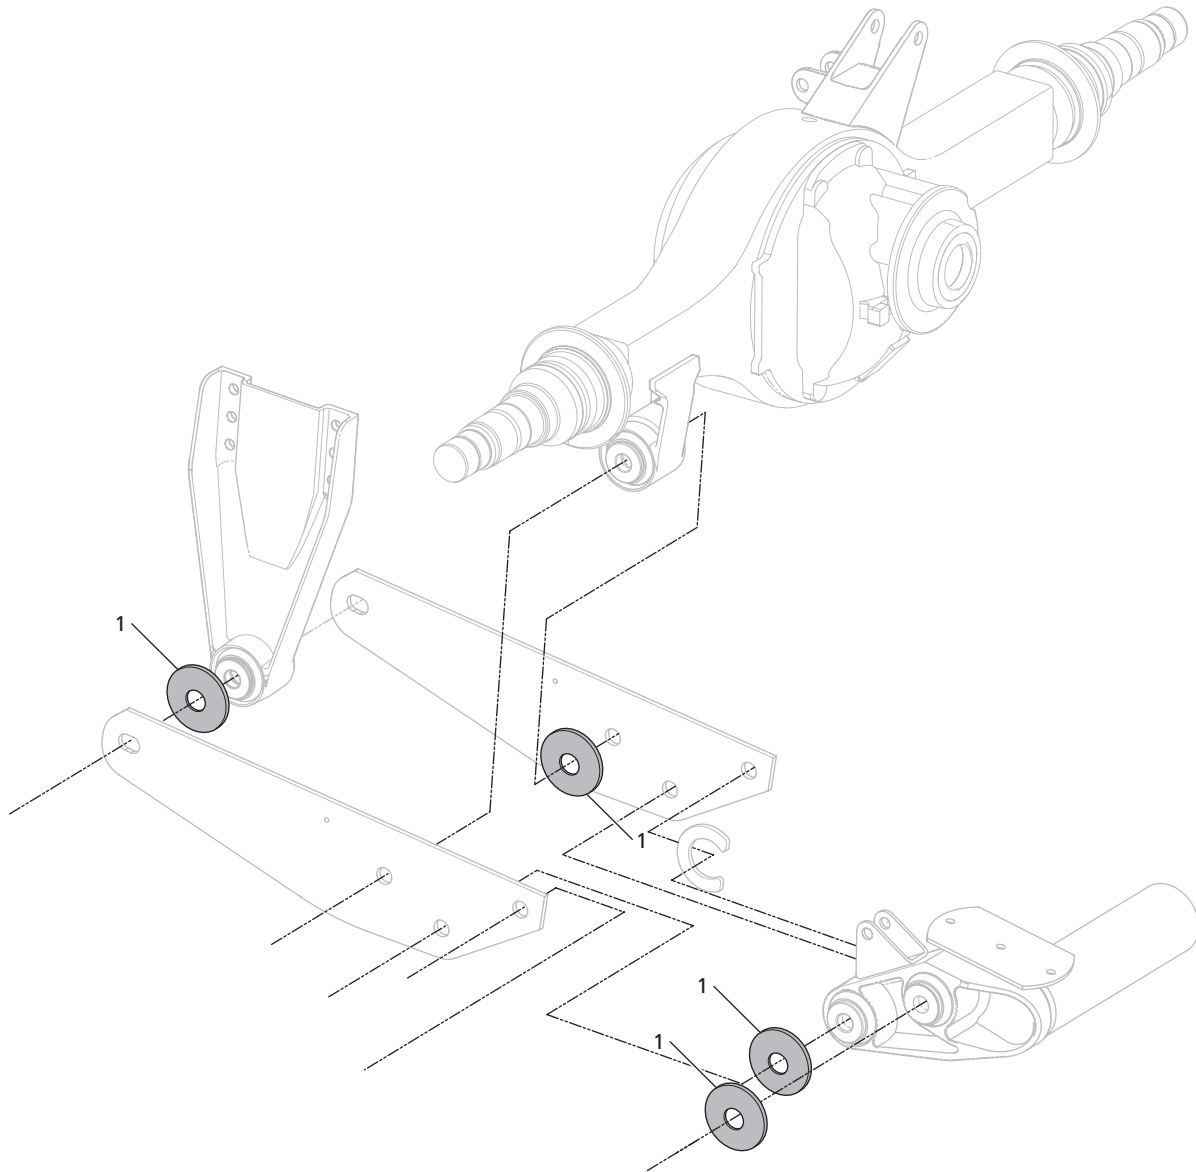
**BUSHING SHIM KIT: 48100668, SRK-802**

Bushing shims are to be clamped between bushing core and equalizing beam blades.

ITEM	DESCRIPTION	PART NUMBER	QTY.
1	Spacer, Bushing	90036309	8
2	Service Bulletin (Not Shown)	XL-AS20073SB-en-US	1
