Technical Service Bulletin

JUNE, 2017	ALL
DATE	MODEL(S)
BODY ELECTRICAL	17-BE-006
GROUP	NUMBER

GUIDE FOR WIRING HARNESS AND CONNECTOR REPAIR

This bulletin supersedes TSB 15-BE-004 to update the wiring connector ordering information.

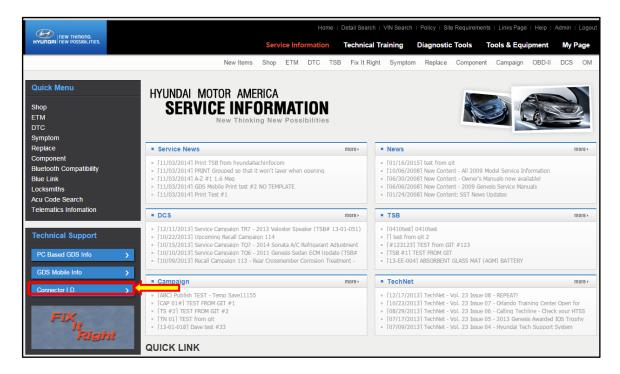
1. Go to www.hyundaitechinfo.com and Select Connector I.D.

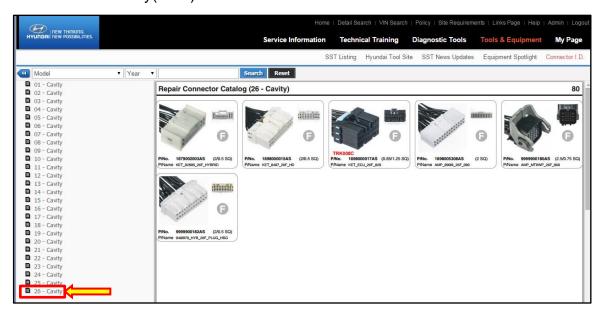
TSB #: 17-BE-006 Page 6 of 13 2. Select the number of cavity(slots).

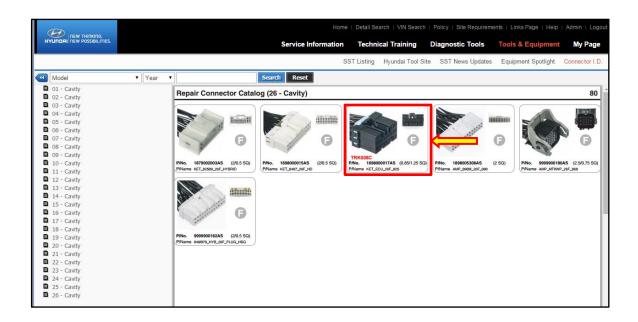
3. Select the connector which matches your search.

If a red part number is provided, then the connector can be found in the TRK, WRK, or WRKII wire connector kit.

If a red part number is not provided, then order the connector through Mobis using the provided part number in black.

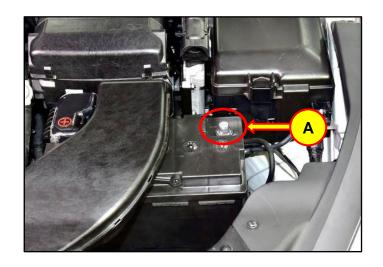
1. Disconnect the battery negative (-) terminal (A).

Record the customer's AM, FM and XM radio stations before disconnecting the terminal.

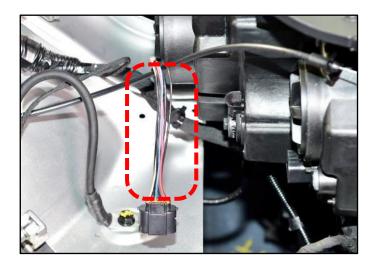
2. Strip off the friction tape wrapped around the connector or wire to be repaired.

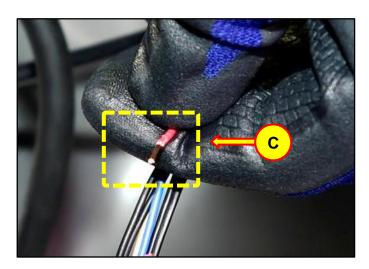
4. Using a wire stripper, strip off about 10mm (C) of the vinyl coating of each end of wire.

Make sure that the wire-stripping and gauge-crimping slots are properly matched.

If the slots do not match, the wire may be damaged and may not fit into the connector.

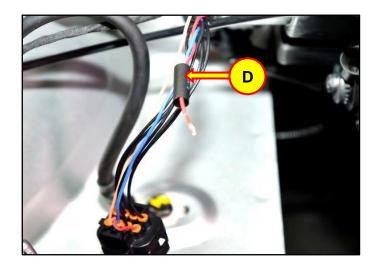
5. Insert the shrink tube (D) into the wire of the connector to be repaired.

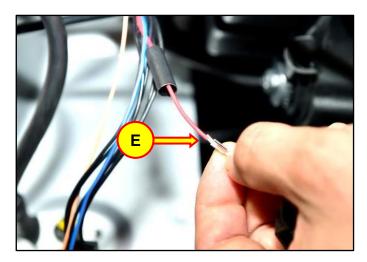
6. Using the inline connector (E), connect the wire from the vehicle side to the wire from the repair connector side.

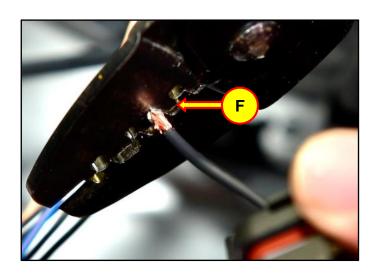
7. Crimp the inline connector (F) by using the multi-purpose crimper.

Choose the correct gauge-crimping slot for the repair; otherwise, it may cause damage to the wire.

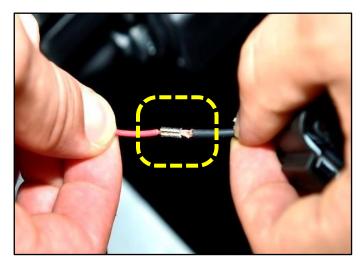
8. Gently pull both ends of the wires to check that the wires are tightly secured.

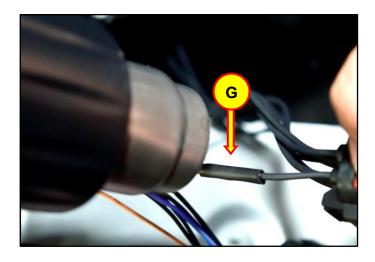
Reposition the inserted shrink tube (G) centering over the middle of the pressed solder connector and shrink the tube by using a heat gun.

Fully cover the repaired area with the shrink tube.

The shrink tube should be securely wrapped around the soldered connector.

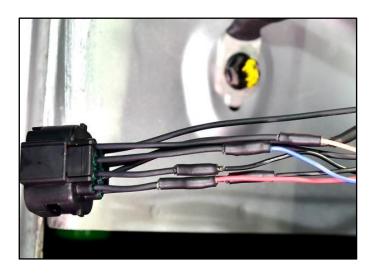
Before applying the tape, verify that each wire is connected to its proper location.

If the electrical tape is applied too closely to the end of the repair connector, the wires may become dislodged from the connector due to stress.

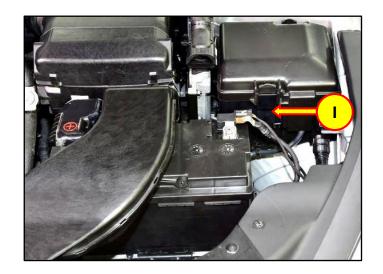
14. Connect the negative (-) battery terminal.
