BTB 00406 (1412)

Safety Recall: Front Passenger's Airbag Inflator May Produce Excessive Pressure After Long-Term Exposure To High Absolute Humidity

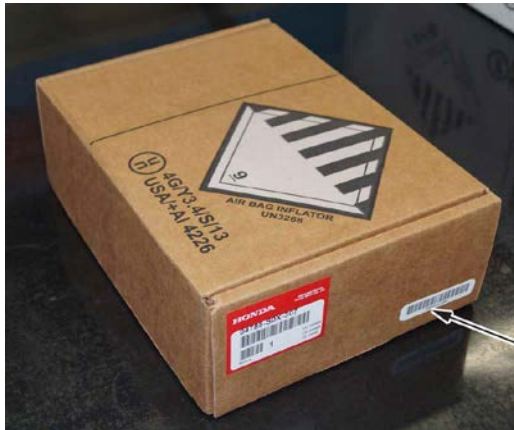
SERIAL NUMBER

- If the VIN status inquiry indicates that the vehicle is subject to any open safety recalls, including the driver's airbag inflator, make sure to also complete those recall repairs before returning the vehicle to the client. If you are unable to complete any open recall, advise the client of the recall status and when the recall could be completed.
 - Be careful not to damage any parts when replacing the inflator, and **follow the procedure exactly**.
 - If, before removing the airbag, you suspect that it may be the incorrect airbag for the vehicle or a counterfeit, **do not remove the airbag**. Contact your DPSM for assistance.
1. Write down the serial number located on the right side of the new inflator box. For the warranty claim to be paid, your warranty clerk must enter this serial number in the Diagnostic Trouble Codes field on the warranty claim.

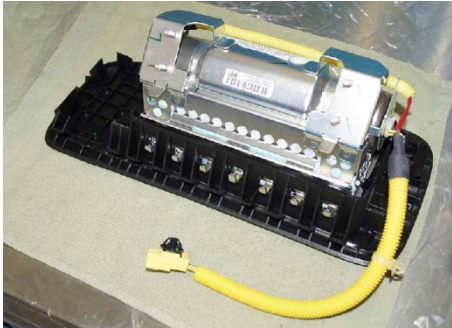
2. Remove the front passenger's airbag.
3. Place the airbag face-down on a clean shop towel as shown.

- The orientation of the airbag is critical because if the inflator is installed incorrectly, the harness will be too short when you reinstall the airbag.
- The brackets between the various models are similar but may differ from the example shown.

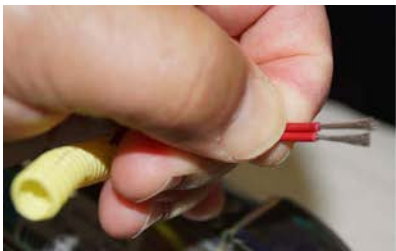
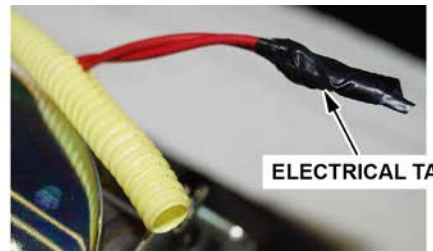
- Strip away about 1 inch of the wire insulation, then twist the wires together.

- Tape the twisted ends with electrical tape.

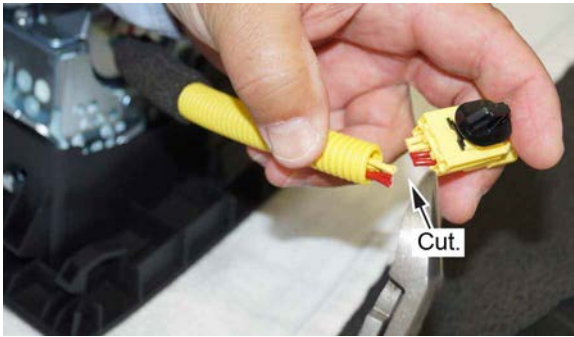
7. Cut off the connector and short the yellow wires.

- Cut all four wires to remove the connector.

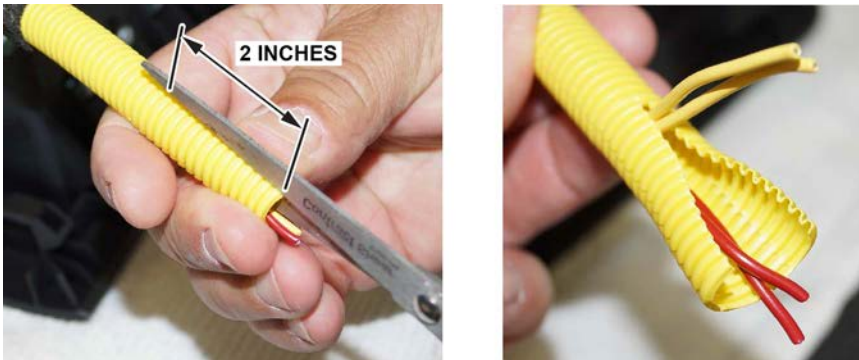
- Cut about 2 inches of the corrugated tube, then pull out the yellow wires.

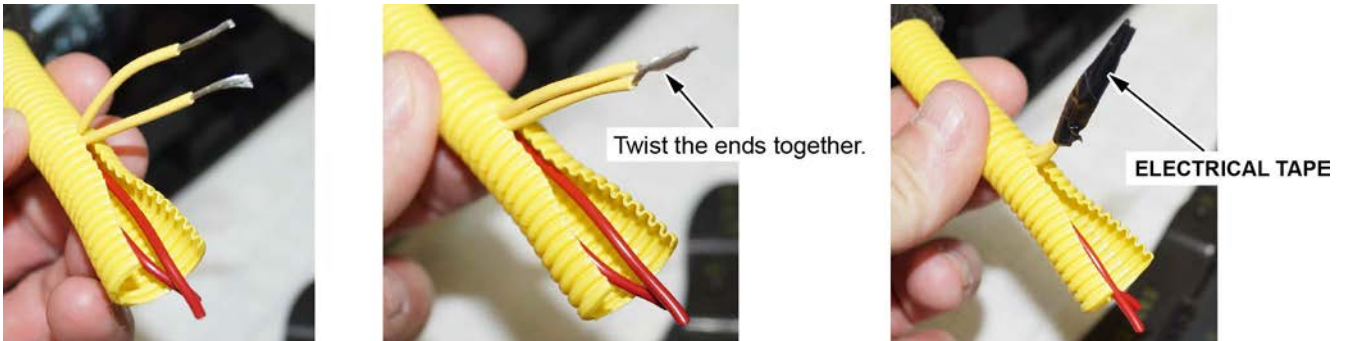
- Strip away about an inch of the wire insulation, then twist the wires together.

- Tape the twisted ends with electrical tape.

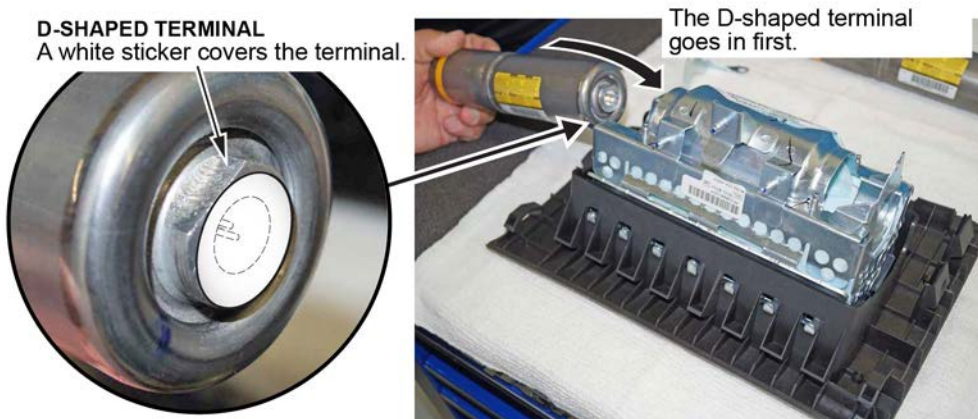
11. Install the new inflator.

- One connector looks like a “D” whereas the other connector is a circle. Make sure you insert the “D” shaped terminal into the airbag first.

NOTE: There is a yellow band marking on the circle side.

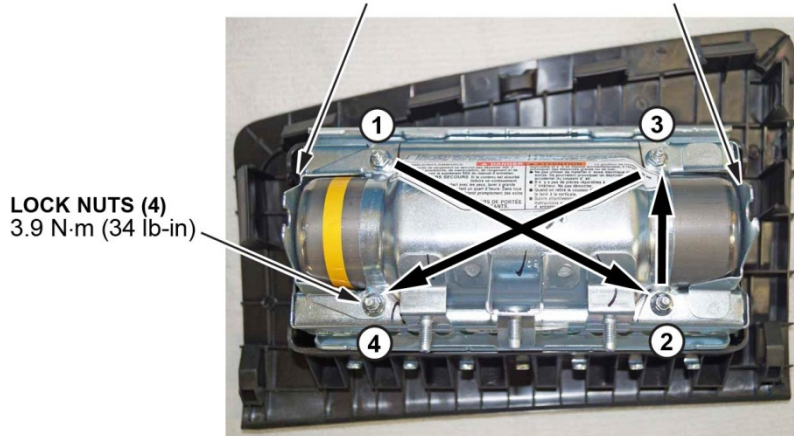
- Install the new 5 mm locknuts and torque them in sequence to **3.9 N•m (34 lb-in)**.
Be sure there are no gaps between the inflator ends and the inflator brackets.

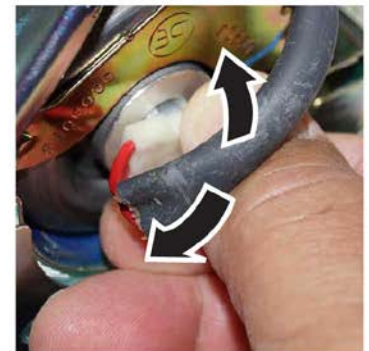
③ Wiggle the connector to make sure it's secure.

- After you hear each connector click, wiggle it to make sure it is secure.

NOTE: If the connector is not properly aligned, it will come out.
