Service Bulletin

Subject: Visible Rust on Replacement Wheel Bearing P/N 13582664

Brand:	Model:	Model Year:		VIN:		Engine:	Transmission:
		from	to	from	to		
Chevrolet	Impala	2010	2010

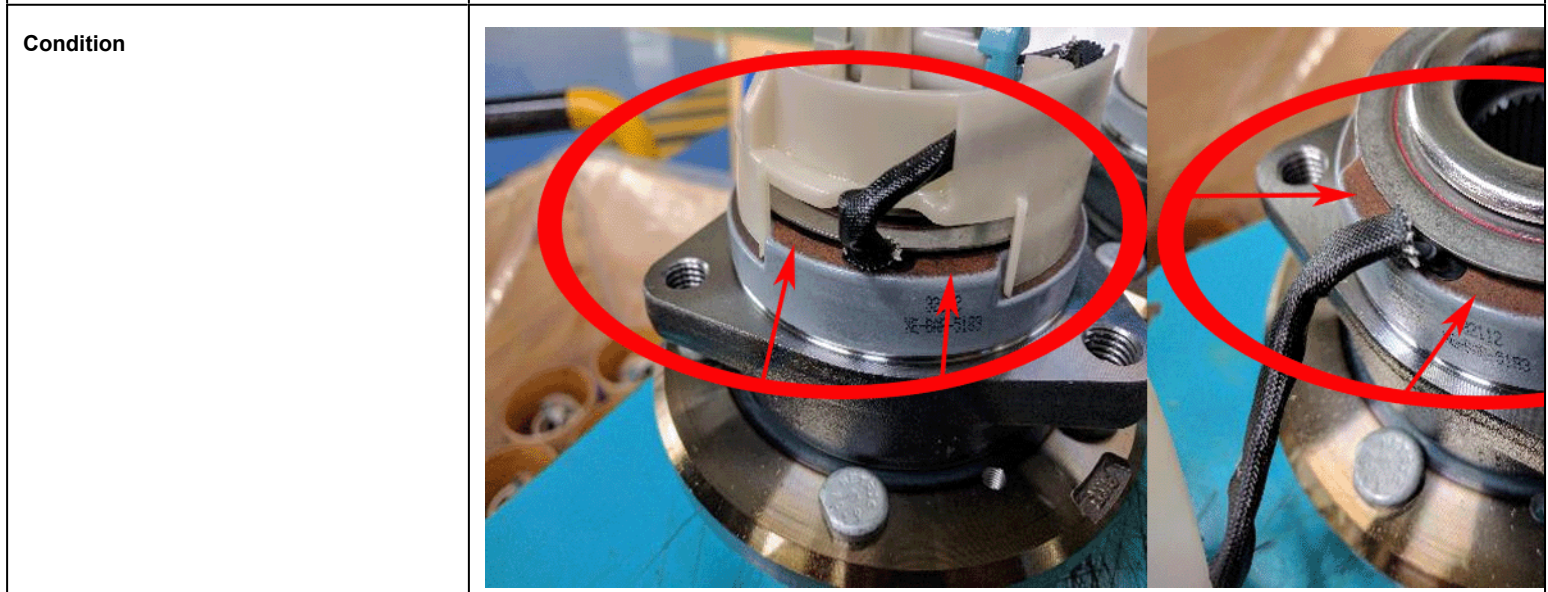
Technicians may comment when receiving wheel bearing P/N 13582664, a light rust coating is present under the white shipping cap once removed.

Cause	This condition is a known issue with the wheel bearings that are being shipped.
--------------	---

Correction	Engineering has determined no action should be taken and the wheel bearing is acceptable to use as received.
-------------------	--
