TECHNICAL BULLETIN
LTB01022NAS1
04 NOV 2016

SECTION: 501-00

'Rattle' Noise From Glovebox Area / Loose BCM Cover

Discovery Sport (LC)

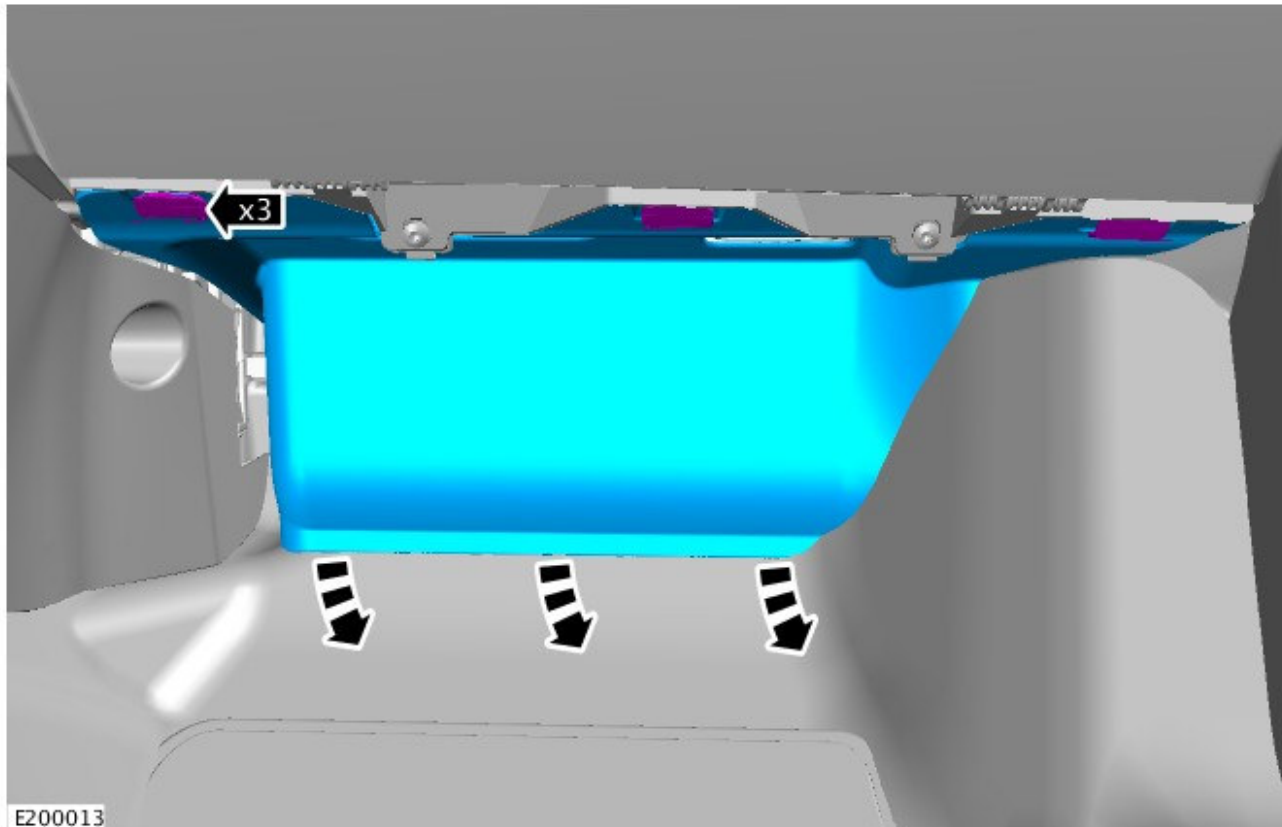
1. Open the front right door.
2. Remove the Body Control Module (BCM) cover from the passenger footwell.

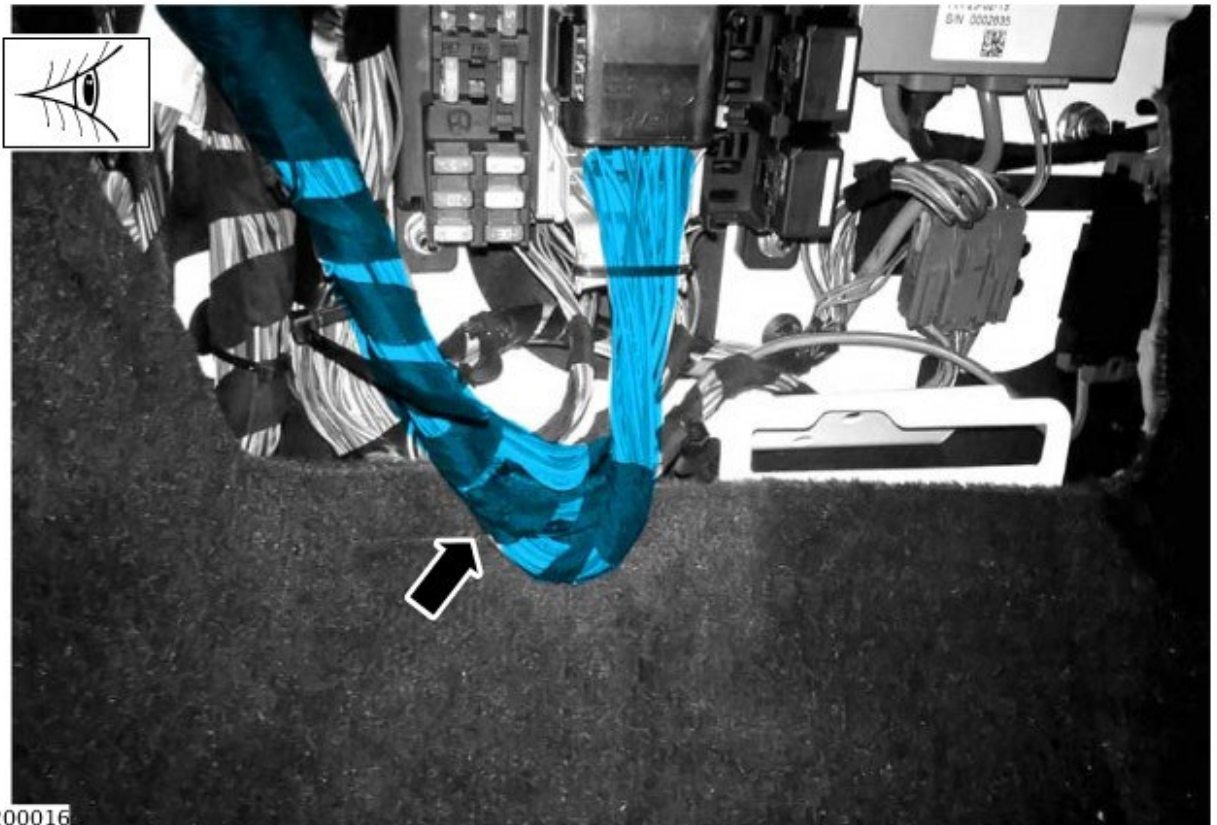
E200016

3. Visually inspect the position of the wiring harness as it may be positioned over the floor carpet as illustrated.

- If the wiring harness is not positioned over the floor carpet, go to Step 5.
- If the wiring harness is positioned over the floor carpet, go to Step 4.

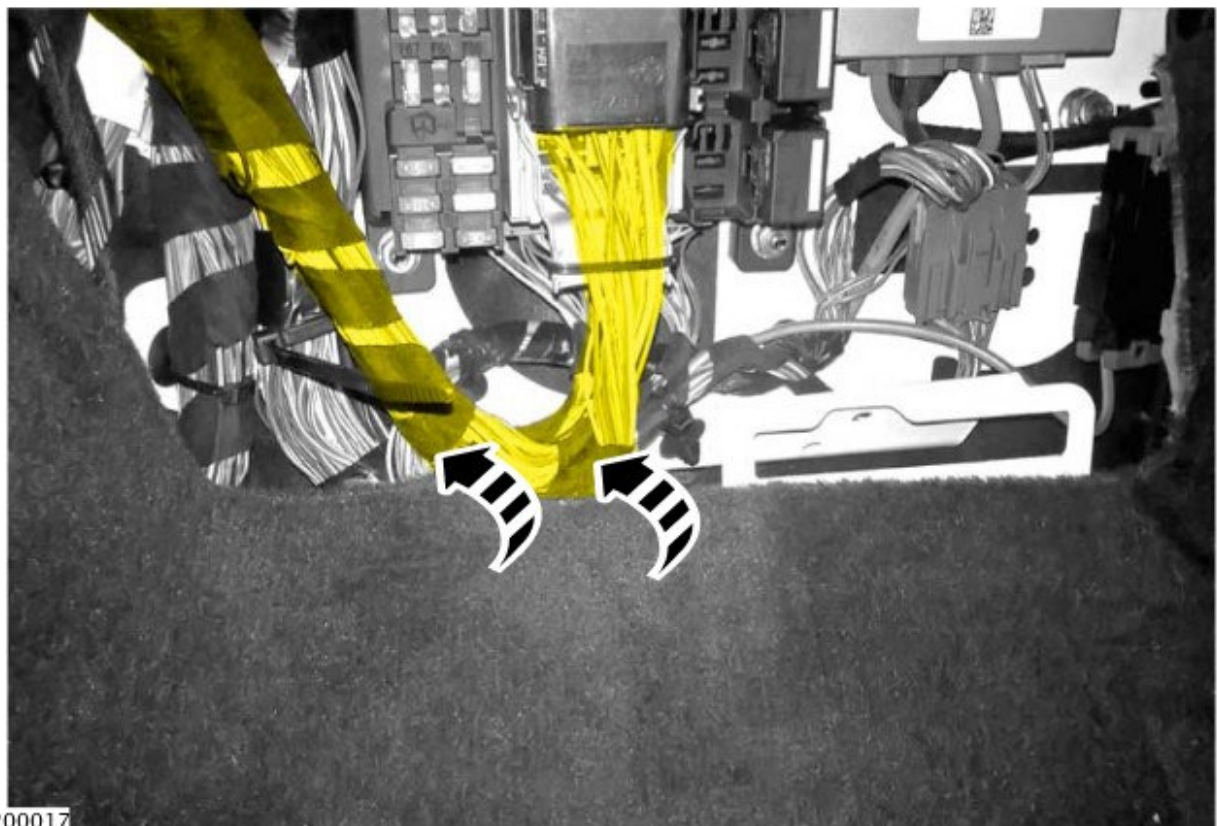
E200017

4. Position the wiring harness behind the floor carpet as illustrated.

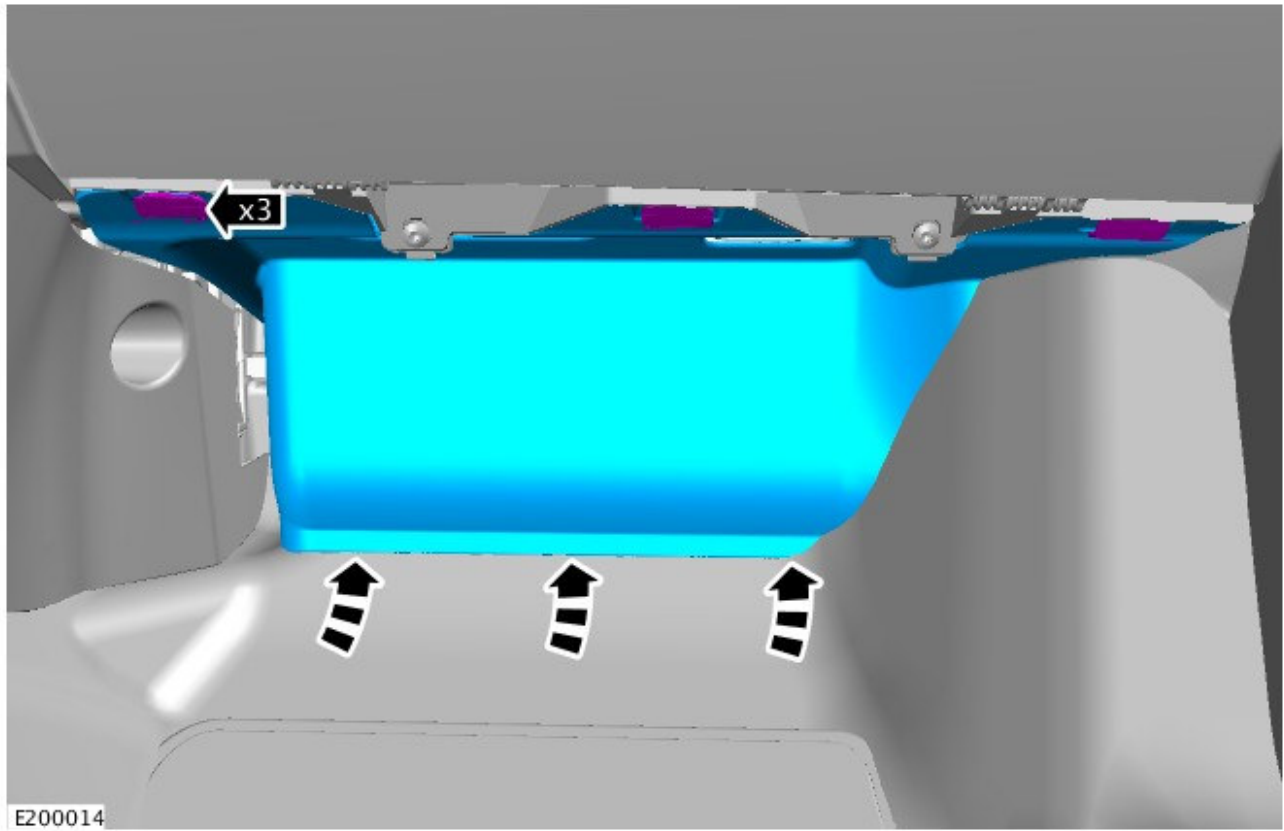
5. Install the BCM cover in the passenger footwell.

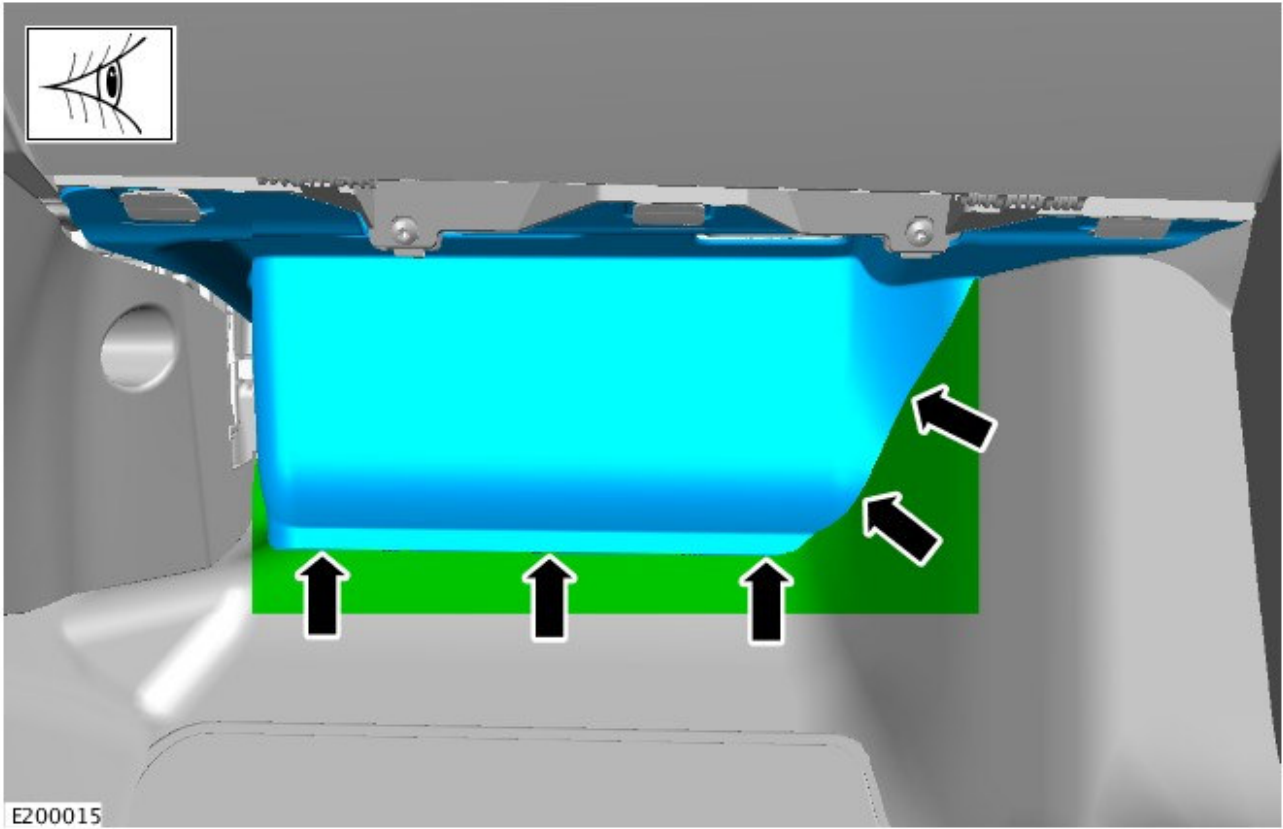
6. Visually check that there is no gap between the BCM cover and the floor carpet and that it is securely installed.
