Product Upgrade Bulletin 161103REV

YEAR(S) AFFECTED:
2016-2017

PRODUCT(S) AFFECTED:
American Allegiance,
American Dream,
American Eagle,
American Heritage,
American Tradition

SUBJECT:
Inspection of Air Inlet Screen and Removal of "Duck Bill" Drain valve to prevent engine damage

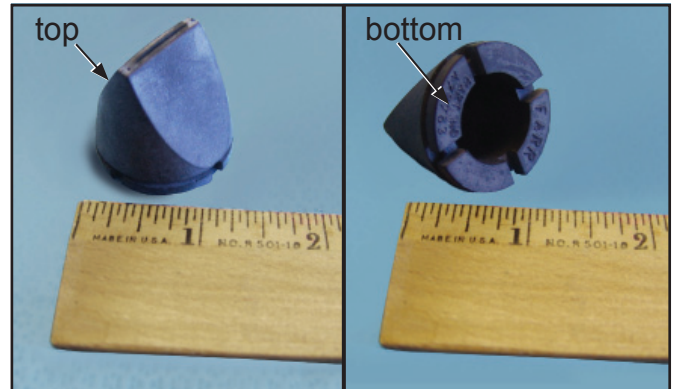
The air box "duck bill" drain valve (shown in Figure 1) may become clogged with debris. **If the engine is started prior to removal of the "duck bill", water may enter the engine and cause extensive engine damage, and may render the engine inoperable.**

Figure 1 - "duck bill" drain valve

4. Open the rear motor access door and look directly up into the center of the opening at the top. See Figure 1. Locate the access panel with 1 ½” opening in it. Insert a pair of needle nose pliers up approx. 1” inside the opening in the access panel. Grasp the rubber portion of the “duck bill” with the pliers and pull down to remove it from its mounting plate. This completes the procedure.

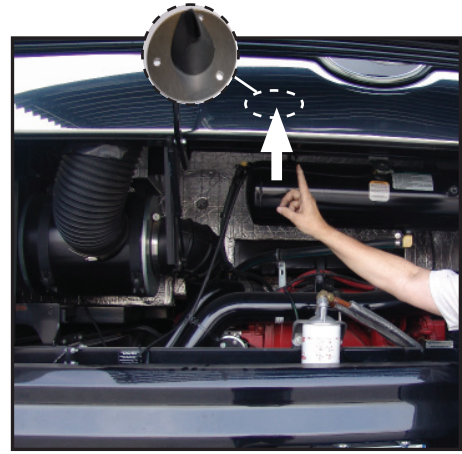
Figure 2

The “duck bill” will be mounted to a metal plate in the opening of the access panel
